Metallurgical evaluation of creep-failed superheater tubes

P.P. Psyllaki^{a,*}, G. Pantazopoulos^b, H. Lefakis^a

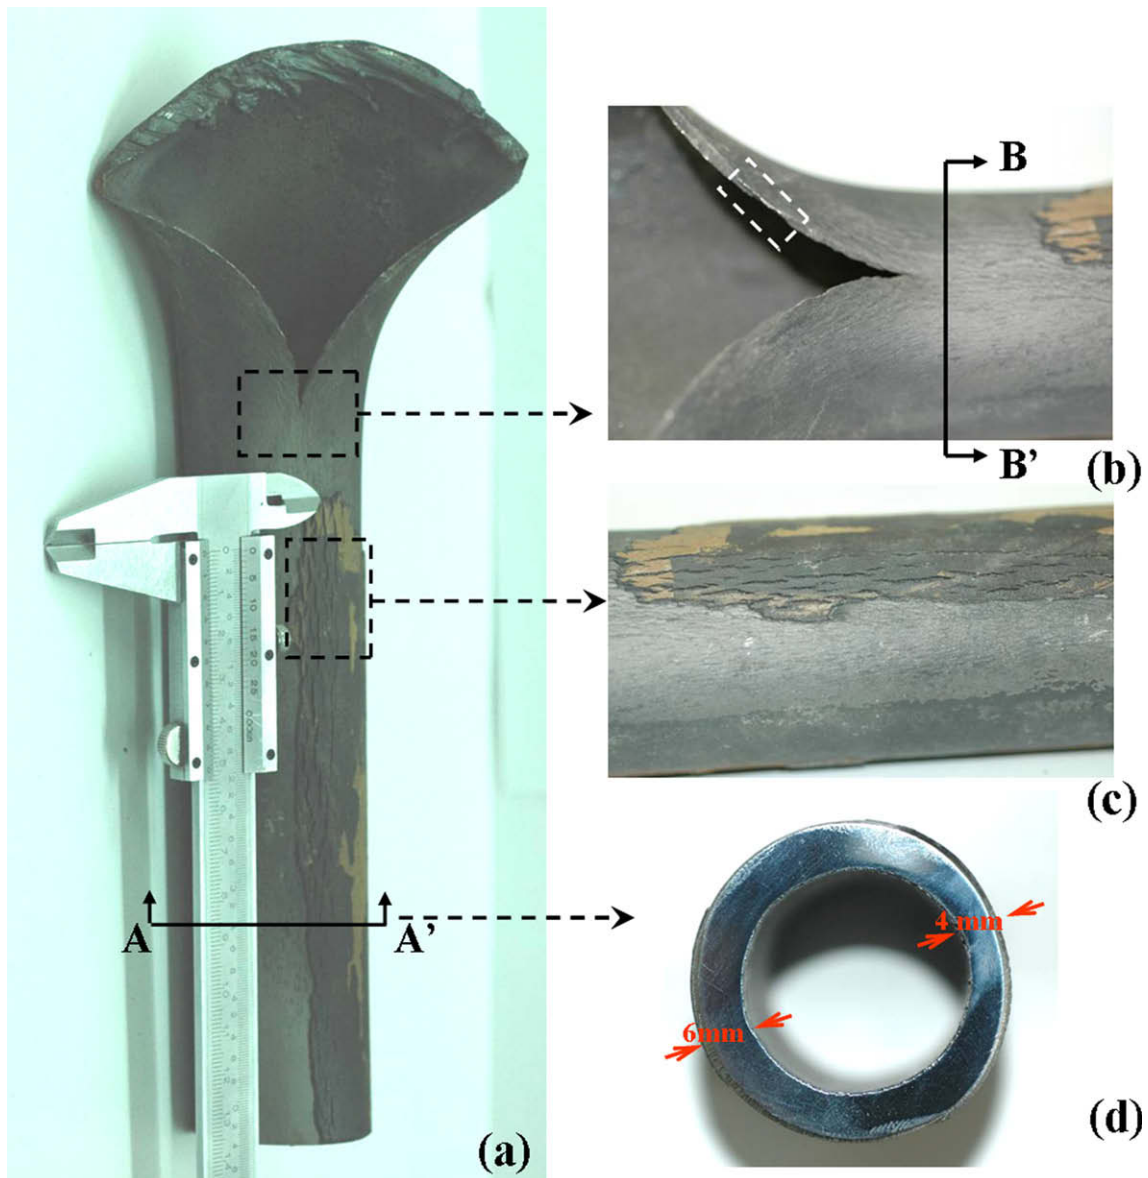
Fig. 1. Macrographs of the failed-tube retrieved from a curved area of the pipeline: (a) total view of the retrieved part, indicating “fish-mouth” rupture; (b) zooming of (a), at the area of the tip of the rupture lip; (c) zooming of (b), at the area of tube swelling and (d) cross-section ring along the line AA' of (a).

The failed parts retrieved from curved pipeline areas exhibit the typical “fish-mouth” thin-lip rupture (Fig. 1a), commonly observed in cases of creep-induced failure of superheater and reformer tubes [3,4].

In the particular case, rupture occurred always at the inner wall of the curved tube. The wall thickness at the tip of the “fish-mouth” was diminished from its original value of 6 mm down to about 1 mm, whilst the typical metal plastic flow striations could also be clearly observed along the tube axis (Fig. 1b). At a distance of about 30 mm from the rupture tip, a bump on

the inner wall had occurred, partially covered by a characteristic oxide layer (Fig. 1c, brown areas) exhibiting an “orange-peel” effect. On the oxide layer, yawning of intermittent secondary rupture cracks in the direction of the tube axis can be recognised. The secondary rupture cracks can be also observed as slight openings (Fig. 1c), at areas where the base metal is revealed due to

detachment of the cracked oxide layer, most likely caused during the maintenance works. Similar features have been observed in the case of creep failure of turbine blades [5]. Such oxide layers were also present on the diametrically opposite area of the outer wall of the curved tube; however they were much thinner, free of cracks and well adhered to the parent metal. Wall thinning extending to a distance of about 120 mm from the rupture tip was observed; at this location the thickness of the inner wall was measured at 4 mm, corresponding to a 33% reduction of its original dimension (Fig. 1d).

Furthermore, with regards to the case of failure at curved areas of the pipeline, it has been extensively reported about the influence of geometry change on creep failure life for pressurised pipe bends [8], mainly using finite element analysis (FEA). In our particular case, where failure always took place at the inner curved wall of the tube, special care should also be given to the surface of the rollers used for bending, as their roughness could harm the tube surface integrity and induce structural defects.

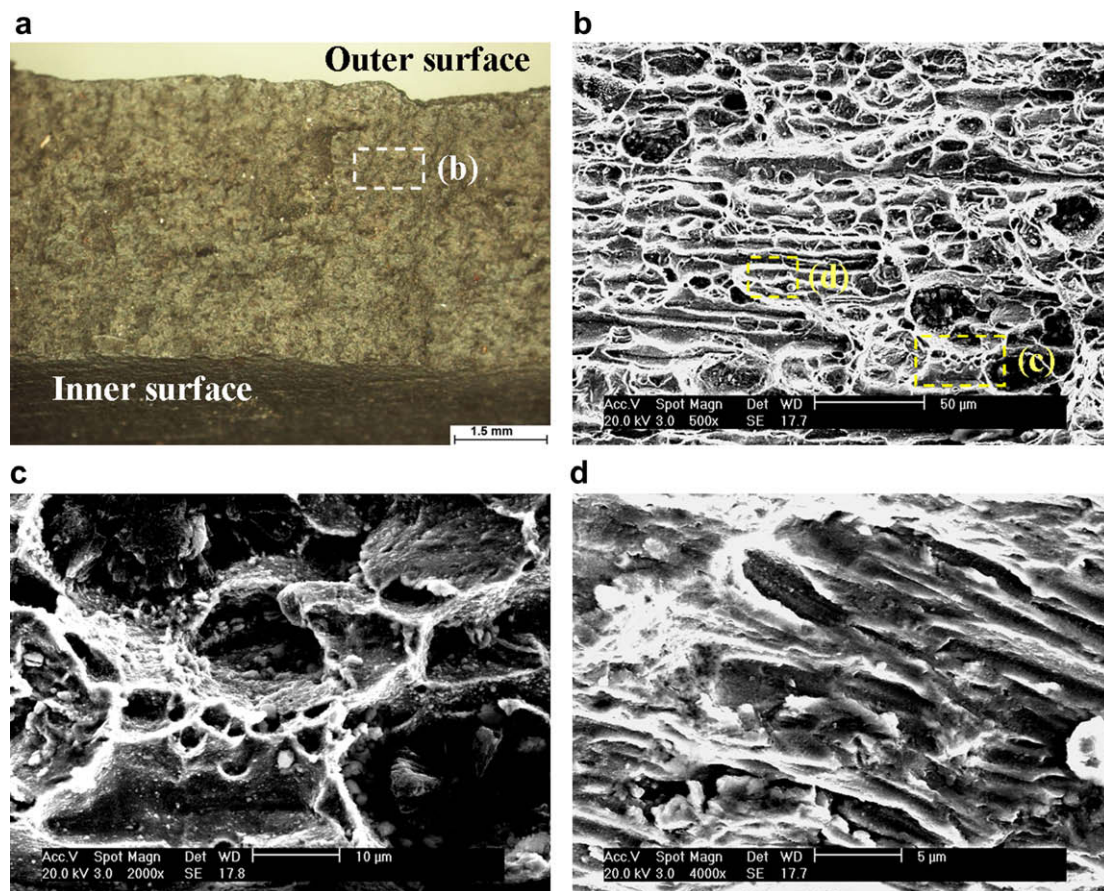
Fig. 2. Fracture surface of the rupture lips, indicated in Fig. 1a with a dashed rectangle: (a) stereo-graph of the dimpled fracture surface; (b) SEM image of the zoomed area indicated in (a); (c) SEM image of micro-voids, present on the fracture surface and (d) SEM image of dimples oriented along the initial direction of the material's grains.

Stereo- and SEM-photographs of the rupture-lips' (Fig. 1b, marked area) are shown in Fig. 2. On the dimpled fracture surface (Fig. 2b), two co-existing features can be clearly distinguished:

- Large equiaxial voids arising from the coalescence of creep voids of smaller dimensions (Fig. 2c).
- Elongated dimples corresponding to the initial orientation of the material's grains due to the unidirectional tube forming process (Fig. 2d).

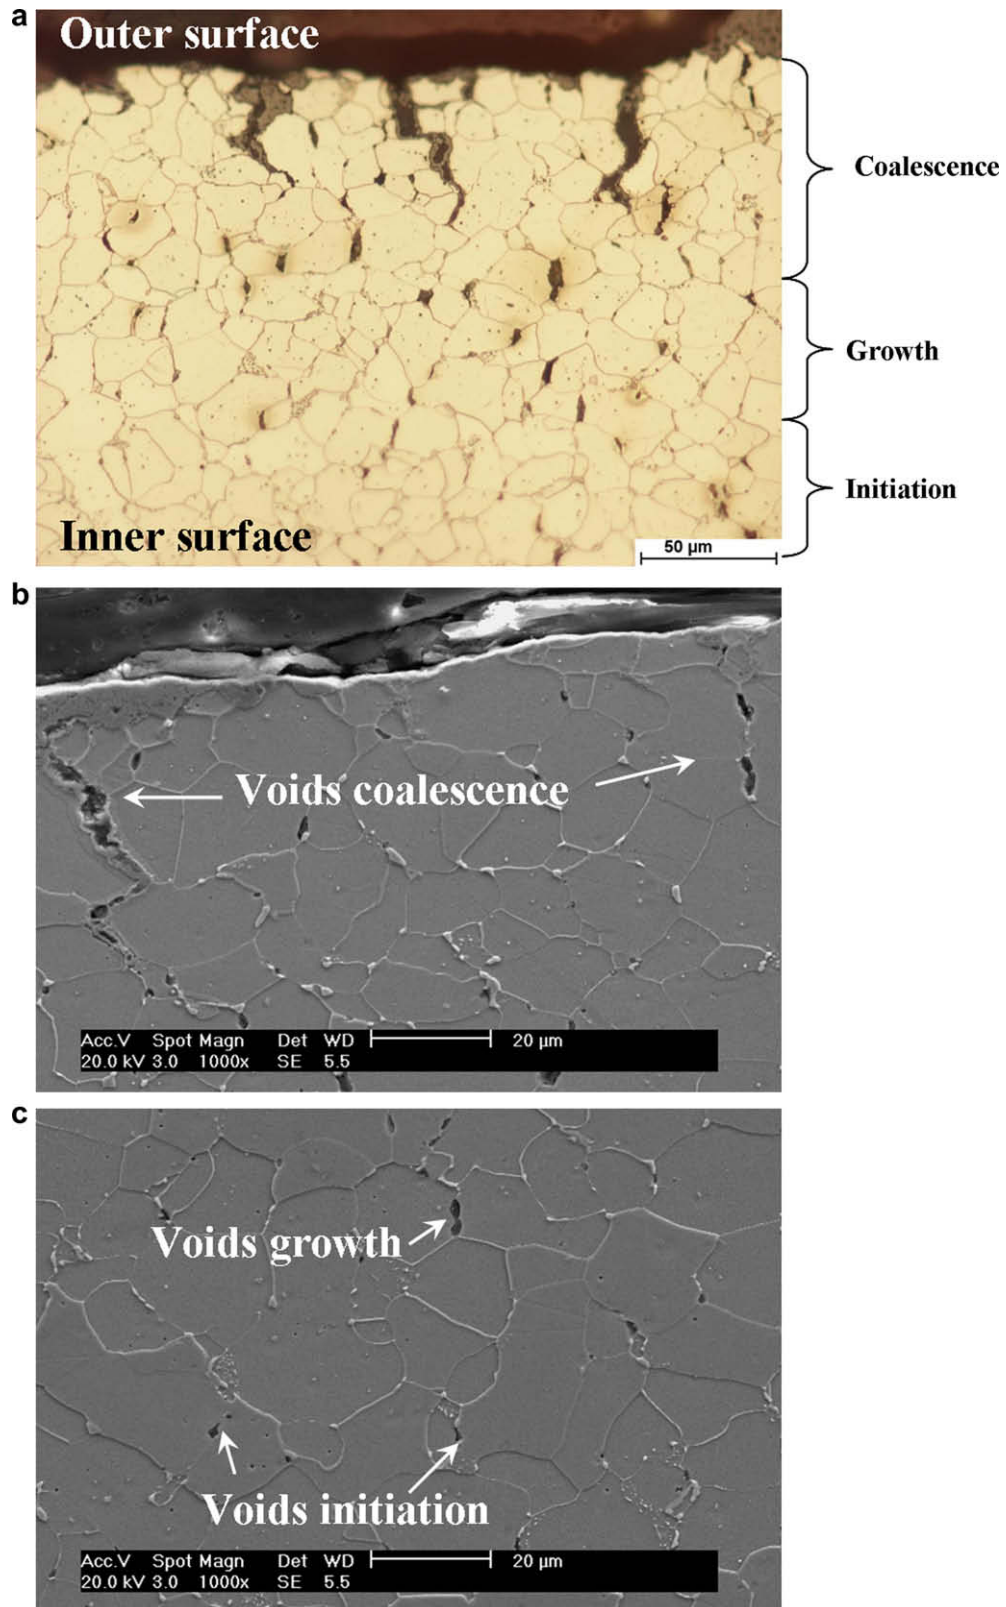
Fig. 3. Cross-sections along the line BB' of Fig. 1b: (a) optical micrograph of the failed-tube wall; (b) SEM image of outer surface of the failed-tube wall and (c) SEM image of inner surface of the failed-tube wall.

The creep void evolution across the tube wall is presented in Fig. 3a. At the outer surface of the tube, void coalescence (Fig. 3b) resulted in intergranular surface cracks of a mean length of 50 μm , filled with oxidation products. Consequently, a second zone of creep void growth can be observed, extending from a depth of about 70 μm to about 130 μm (Fig. 3c); whilst toward the inner surface of the wall, initiation of individual voids appeared along the grain boundaries (Fig. 3c) [6,7]. The co-existence on the same tube cross-section of the three stages in creep void evolution: initiation/growth/coalescence is indicative of a temperature gradient across the wall through which heat exchange is taking place between the hot lignite combustion gases in contact with the outer surface of the tube and the high-pressure steam flow in contact with the inner surface of the tube.

The tube material identification was obtained by applying both metallographic observation and EDAX microanalysis; which showed that it was a low-alloy ferritic steel, probably corresponding to the 15Mo3 grade proposed by the designers of the pipeline. Precipitates observed at the grain boundaries (Fig. 3b and c) indicated cementite spheroidisation, due to the prolonged heating of the material during operation, at a temperature close to A_{C1} .

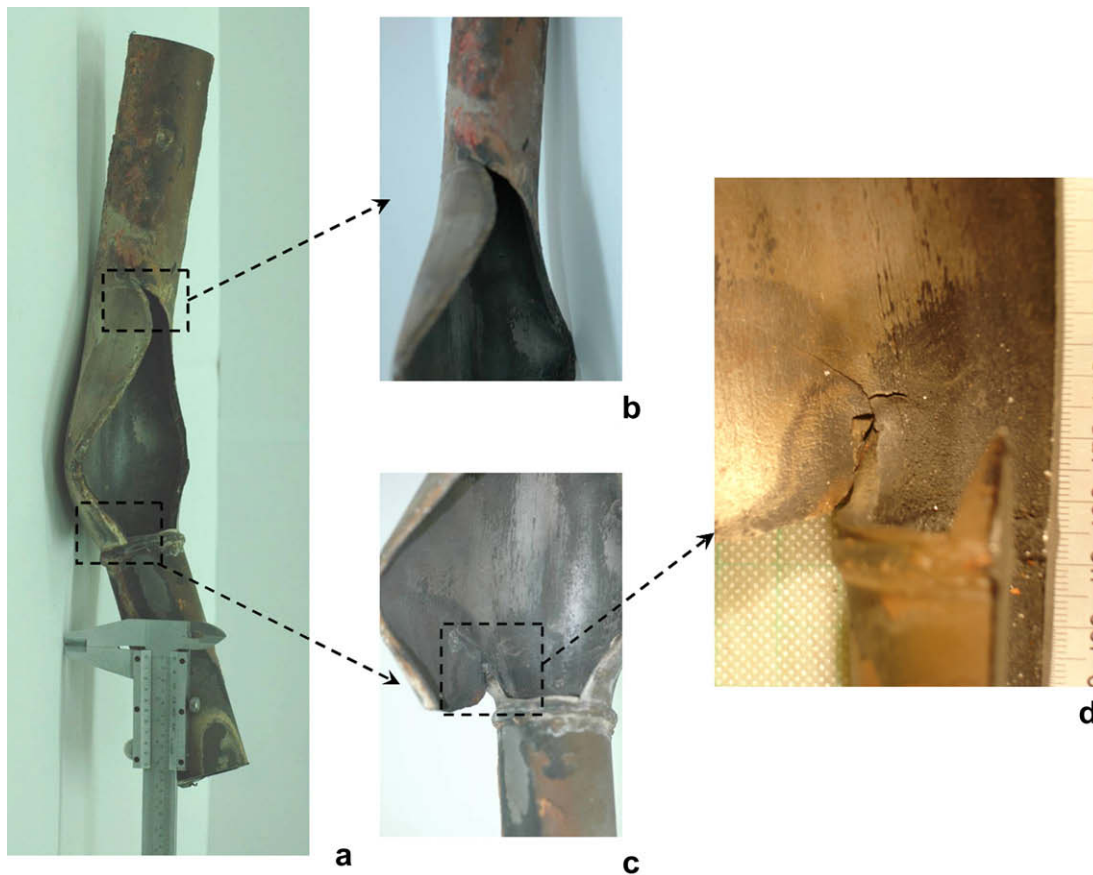
Fig. 4. Macrographs of the failed-tube retrieved from area of the pipeline with circumferential weldment: (a) total view of the retrieved part, exhibiting a “cobra” appearance and (b–d) zooming of characteristic areas, indicated in (a).

The failed parts of the pipeline retrieved from areas near circumferential weldments (Fig. 4) exhibit a “cobra” appearance [3], with fracture cracks initiating near the seam (Fig. 4c) and propagating within one of the joined tubes, in a direction almost parallel to its axis (Fig. 4d).

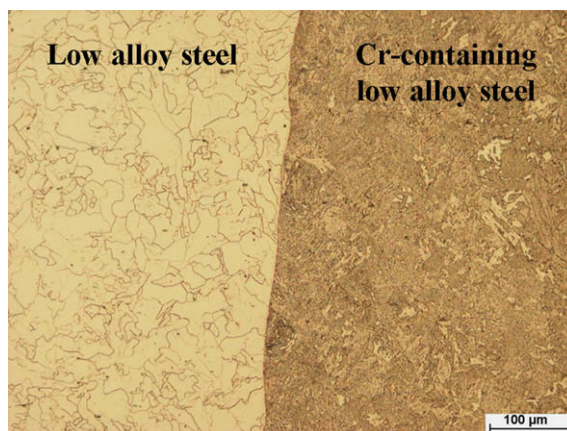
Fig. 5. Optical micrograph of a cross-section perpendicular to the circumferential weldment, revealing solid-state welding of dissimilar steel grades.

Metallographic observations of the weldment's cross-section (Fig. 5) revealed both the materials' dissimilarity of the joined tubes, as well as the absence of fusion zone or filler material, which indicate that a high-temperature solid-state welding technique was applied. EDAX microanalysis indicated that one of the tubes was a Cr-containing steel, probably corresponding to the 13CrMo44 or 10CrMo910 grades also proposed by the designers, whilst the other one, within which fracture cracks had propagated, was a low-alloy ferritic steel, as in the previous case. Although there is a clear boundary between the two welded parts and there is no apparent metallurgical bonding between the two joined surfaces, the seam nevertheless can be characterised as one of excellent quality, since failure initiation was clearly located outside of it.

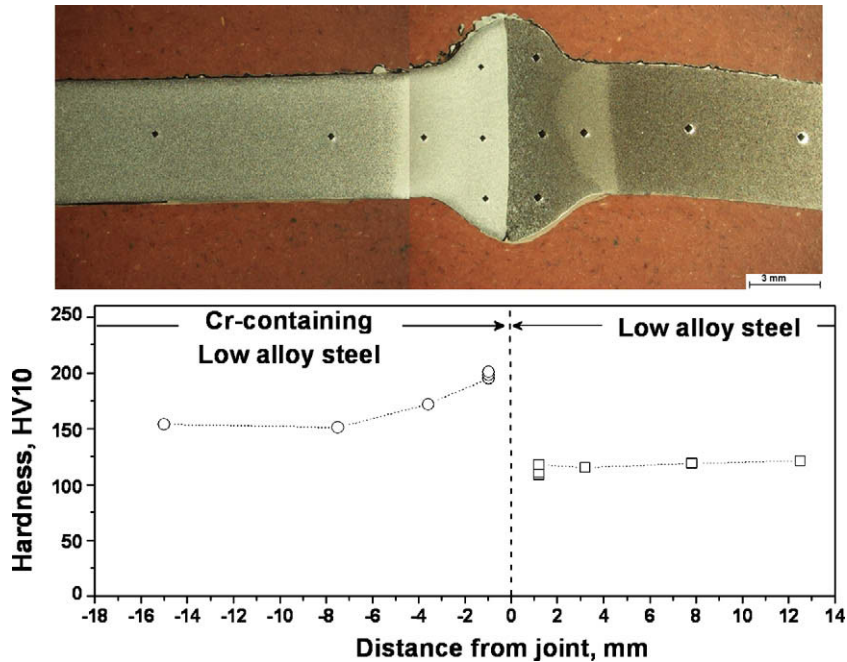
Fig. 6. Stereo-graph of a cross-section perpendicular to the circumferential weldment, areas and values of the Vickers hardness measurements performed.

Vickers hardness measurements performed along the direction of the tube's axis (perpendicular to the seam, Fig. 6) revealed a substantial drop in hardness values between the two sides adjacent to the seam:

- In the case of Cr-containing steel grade, the area near the seam exhibited a mean hardness of 200 HV10; at a distance of 3.5 mm from it the value dropped to 170 HV10 and further away, to that of the parent material (~ 150 HV10).
- In the case of ferritic steel, hardness exhibited a slight increase from 110 HV10 near the seam to 120 HV10 at the parent material.

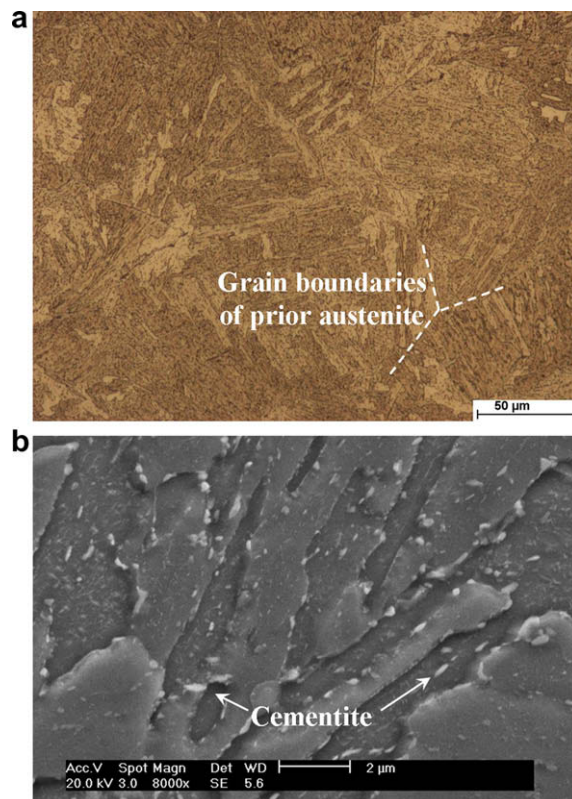
Fig. 7. Optical (a) and SEM (b) images of the Cr-containing steel grade, from cross-sections in the neighbourhood of the joint boundary.

In the case of Cr-containing steel grade, the area close to the joint boundary, of 2 mm width, exhibited no re-solidification features, but had the characteristic upper-bainite structure (Fig. 7), with the grain boundaries of prior austenite clearly distinguished. The adjacent area of intermediate hardness of 2.5 mm width, consisted of tempered ferrite with a fine distribution of spheroidised cementite (Fig. 8). Finally, the parent material had a microstructure of ferrite with partially spheroidised pearlite (Fig. 9). Oblong dark features within the base structure correspond to MnS inclusions, entrapped during the material production and shaped during the tube forming process.

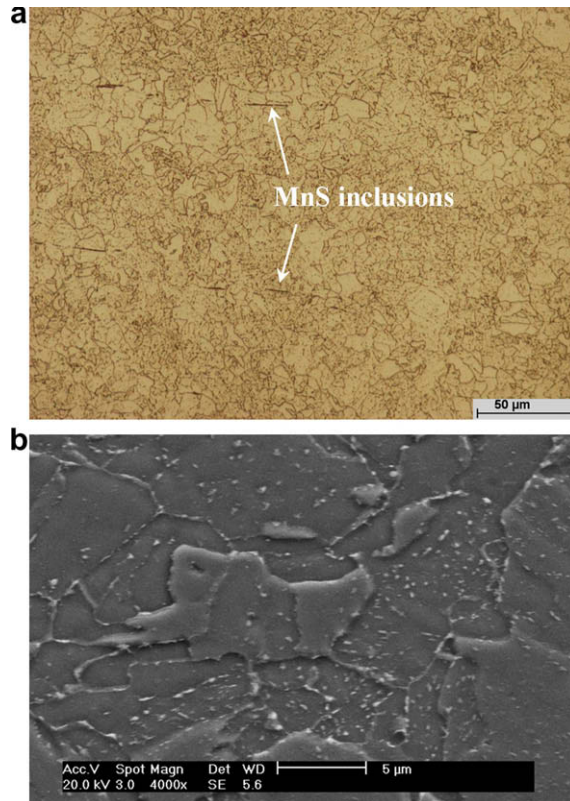
Fig. 8. Optical (a) and SEM (b) images of the Cr-containing steel grade, from cross-sections at an area of intermediate hardness.

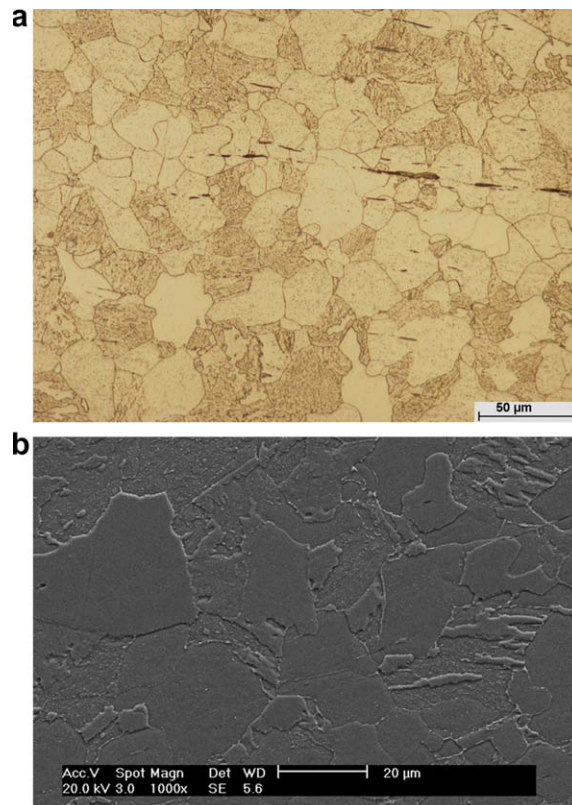
Fig. 9. Optical (a) and SEM (b) images of the Cr-containing steel grade initial structure.

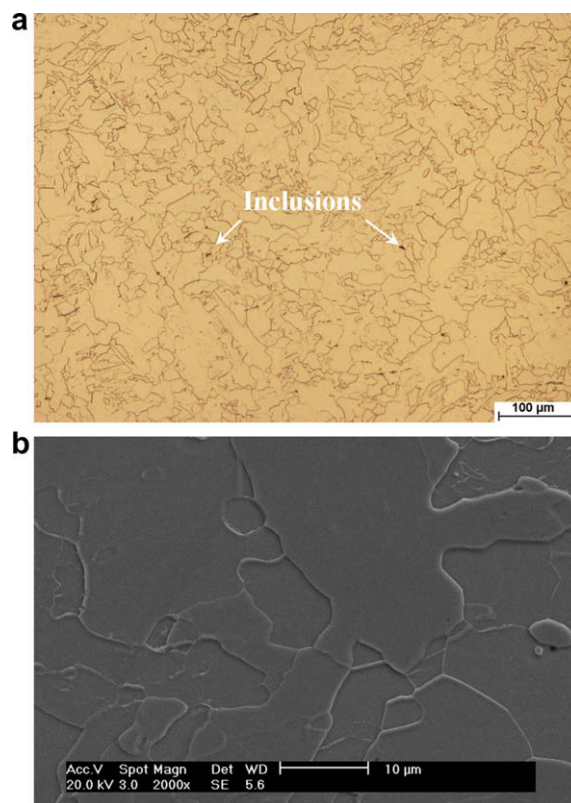
In the case of ferritic steel, the area close to the joint boundary, of 2 mm width, presented irregular ferrite grains (Fig. 10), while dark precipitations distributed within the base microstructure corresponded to residual fluxes (Al_2O_3 and/or CaO) that were entrapped during solidification of the raw material and spheroidised due to their high surface tension. The adjacent

Fig. 10. Optical (a) and SEM (b) images of the ferritic steel, from cross-sections in the neighbourhood of the joint boundary.

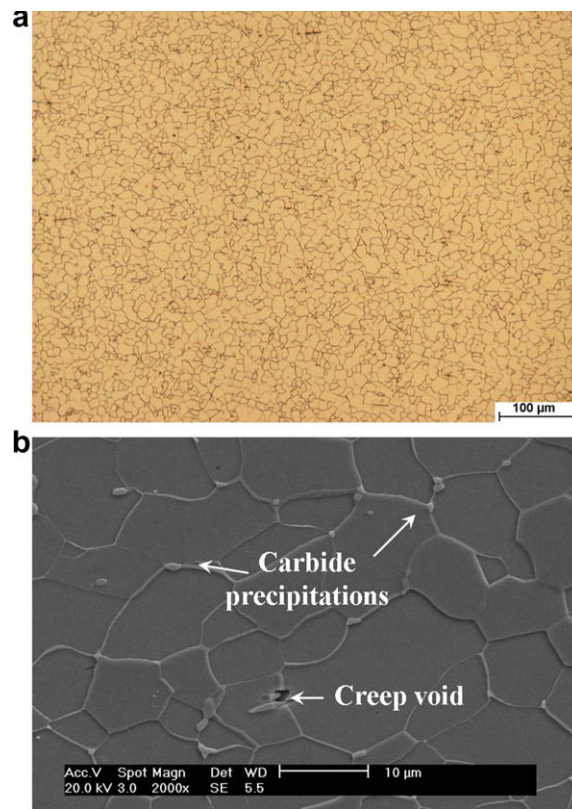
area of 2.5 mm width also consisted of equiaxial ferrite grains, of uniform distribution, which indicates that the material was re-crystallised (Fig. 11). The carbide precipitates found at the grain boundaries probably correspond to spheroidised cementite. In the same area, individual creep voids of small size were scarcely observed. The parent structure was characterised by ferrite grains (normalised ferrite) and a high distribution of creep voids (Fig. 12).

Fig. 11. Optical (a) and SEM (b) images of the ferritic steel, revealing material's re-crystallisation.

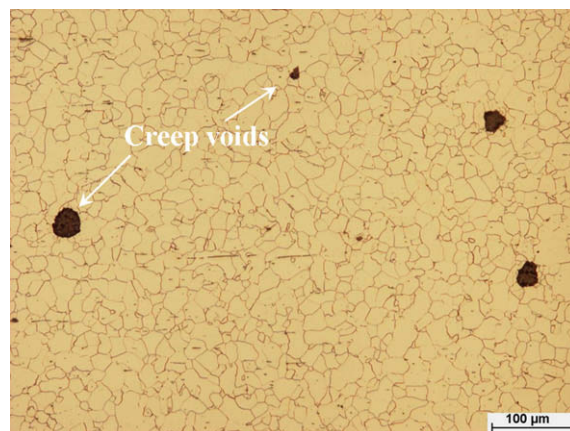
Fig. 12. Optical micrograph of initial structure of the ferritic steel.

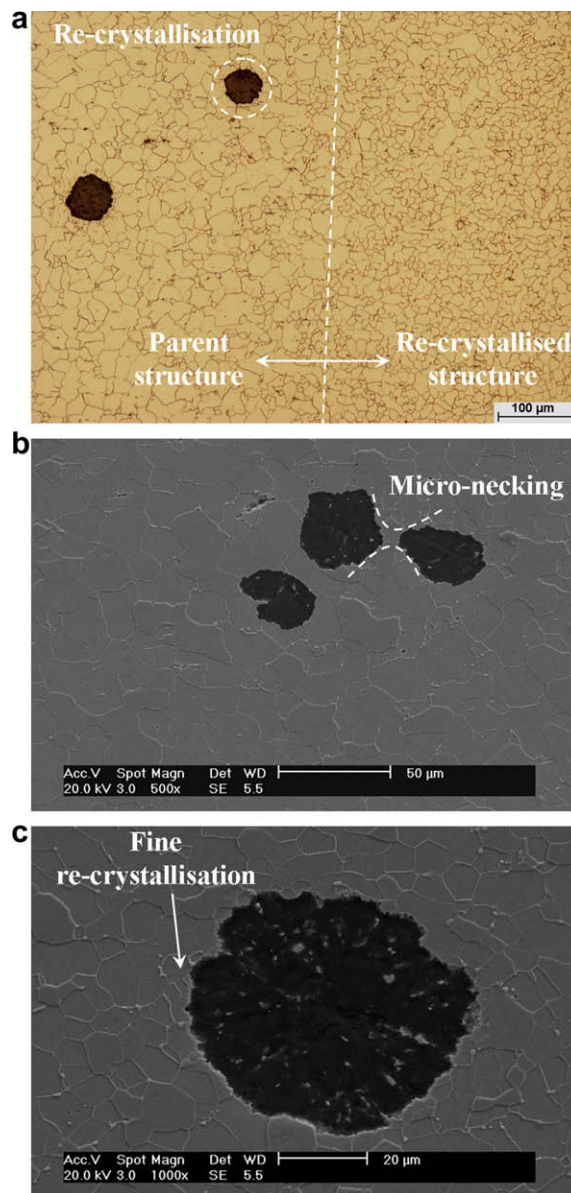
Compared to the area of re-crystallised ferrite, the parent material exhibited large ferrite grains, of almost double the size; and round, trans-granular creep voids with an average diameter of 0.05 mm (Fig. 13a). A close view on this area revealed that the growth and coalescence of creep voids was taking place through micro-necking between two adjacent voids of crucial size (Fig. 13b). Around the voids at this area, a circular zone can be observed with clear evidence of the material dynamic re-crystallisation (Fig. 13a and b), which is attributed to ferrite straining caused during void growth.

Fig. 13. (a) Optical micrograph of the boundary of the re-crystallised/initial structure of the low-alloy steel grade; (b) SEM micrograph of the parent material, indicating micro-necking between adjacent creep void and (c) SEM micrograph of the parent material, indicating fine dynamic re-crystallisation around a creep void.
