Case study

Failure analysis of axle shaft of a fork lift

Souvik Das^{*}, Goutam Mukhopadhyay, Sandip Bhattacharyya

R&D and Scientific Services, Tata Steel Limited, Jamshedpur 831 001, India

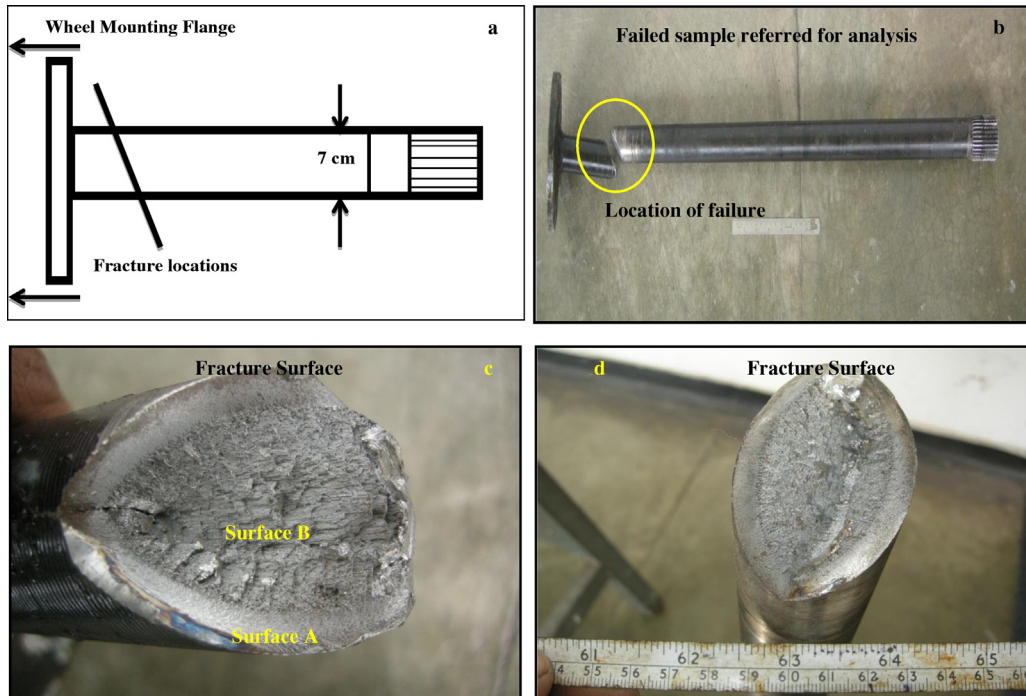
Fig. 1a is a schematic illustration of the rear axle shaft showing the approximate location of the fracture near the wheel mounting flange. A photograph of the section received for analysis is shown in Fig. 1b. The axle shaft failed in shear mode at almost 45° to the longitudinal direction under torque [2,3]. It is observed that the fracture surface consists of two distinct regions: (i) a relatively smooth annular region at periphery marked as A where the fracture was initiated, and (ii) a rough core marked as B (shown in Fig. 1c).

Fig. 1. (a) Schematic illustration of the rear axle shaft showing the approximate location of the fracture near the wheel mounting flange; (b) general view of the failed axle shaft referred for analysis; (c) closer view of the fracture surface of the failed component.

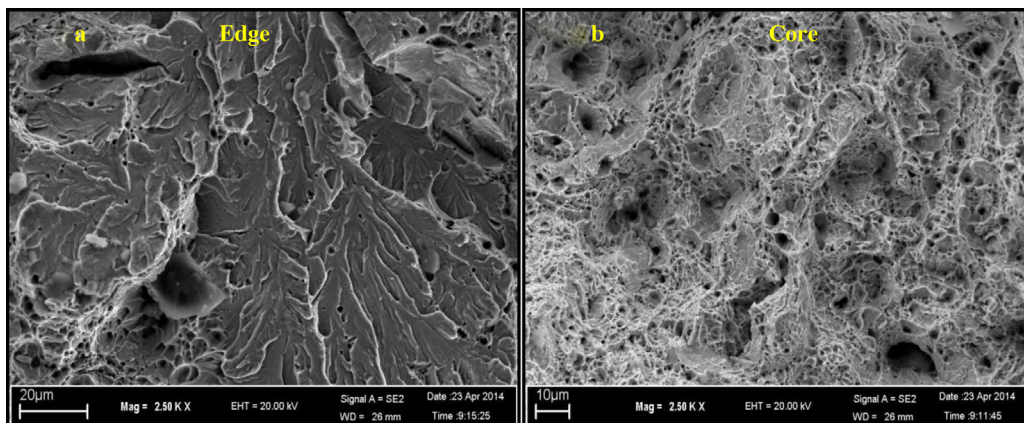
Fractography of the outer surface (region A) revealed cleavage nature of the fracture surface suggesting brittle fracture (Fig. 2a), whereas the fractography of the inner core (region B) revealed dimple nature of the fracture surface suggesting ductile fracture (Fig. 2b).

Fig. 2. (a) Fractography analysis of side A of the failed component; (b) fractography analysis of side B of the failed component.

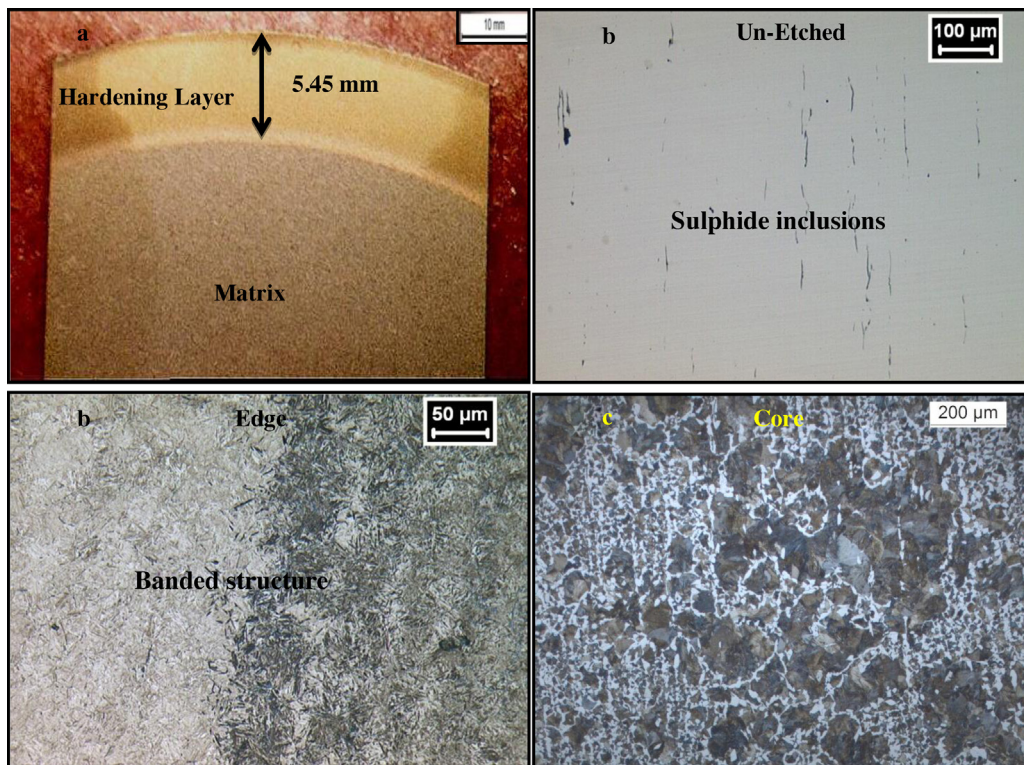
The failed sample was etched with 2% Nital solution. The macrostructure at the cross-section of the rod reveals case hardened layer as the component was subjected to induction hardening treatment (Fig. 3a). The hardening layer was non-uniform along the cross-section and in some location it was found more than the specification ($>2\text{--}3\text{ mm}$). The un-etched microstructure reveals numerous sulphide inclusions throughout the sample which indicates that the steel is not clean (Fig. 3b). The surface of the rod sample reveals in-homogeneous/banded microstructure in martensitic matrix (Fig. 3c), whereas the core reveals ferrite pearlite structure (Figs. 3b). Mixture of coarse and fine pearlite structure was observed in the core of the sample which was resulted due to improper heat treatment process.

Fig. 3. (a) Macrostructure of the cross-section of the failed shaft; (b) un-etched structure of the failed shaft; (c) microstructure of the edge of the component; (d) microstructure of the edge of the component.

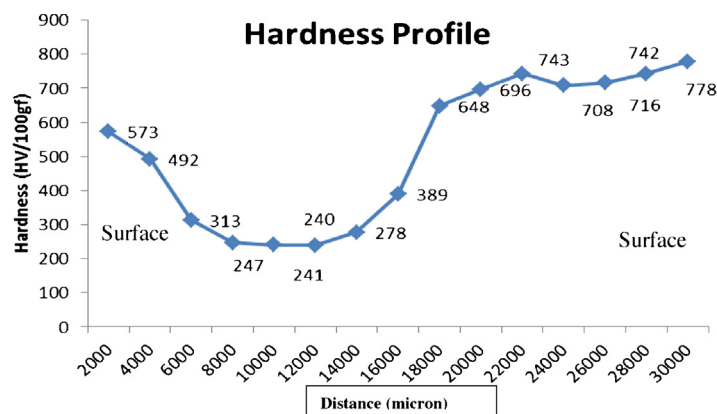
Non-uniform distribution of hardness was observed in the rod sample across the section (Fig. 5). The average hardness of the surface hardened layer is measured to be 735 HV which is very high compared to the core and also for these applications. Such high hardness is not desirable since it imparts brittleness.

Fig. 5. The hardness profile of the transverse section of the shaft.
