1. Introduction

2. Experimental procedure

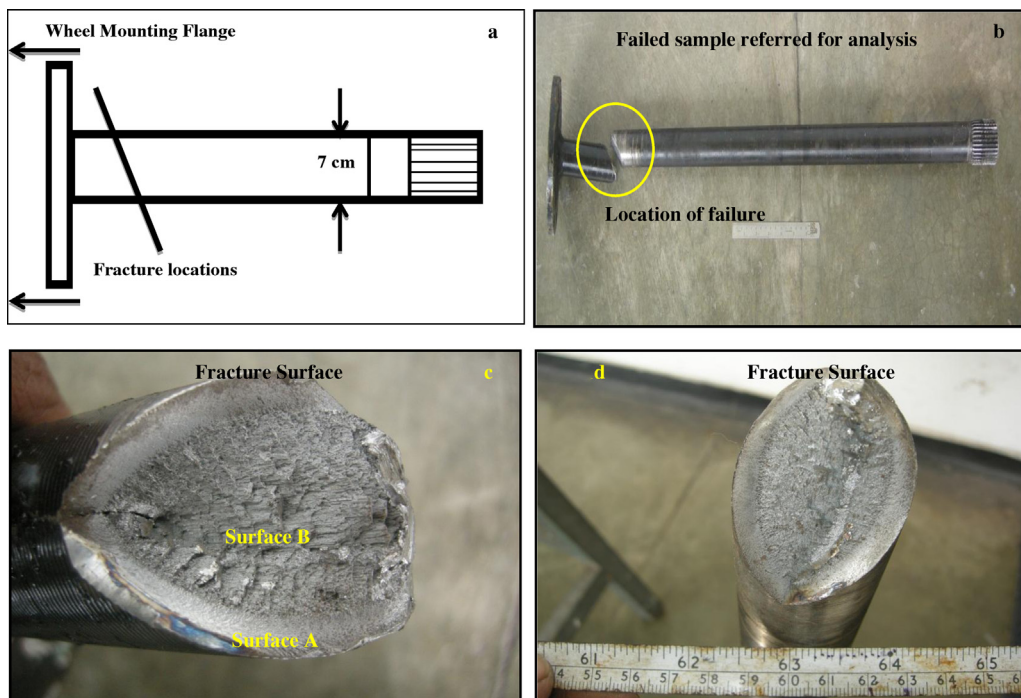
Fig. 1a is a schematic illustration of the rear axle shaft showing the approximate location of the fracture near the wheel mounting flange. A photograph of the section received for analysis is shown in Fig. 1b. The axle shaft failed in shear mode at almost 45° to the longitudinal direction under torque [2,3]. It is observed that the fracture surface consists of two distinct regions: (i) a relatively smooth annular region at periphery marked as A where the fracture was initiated, and (ii) a rough core marked as B (shown in Fig. 1c).

Fig. 1. (a) Schematic illustration of the rear axle shaft showing the approximate location of the fracture near the wheel mounting flange; (b) general view of the failed axle shaft referred for analysis; (c) closer view of the fracture surface of the failed component.

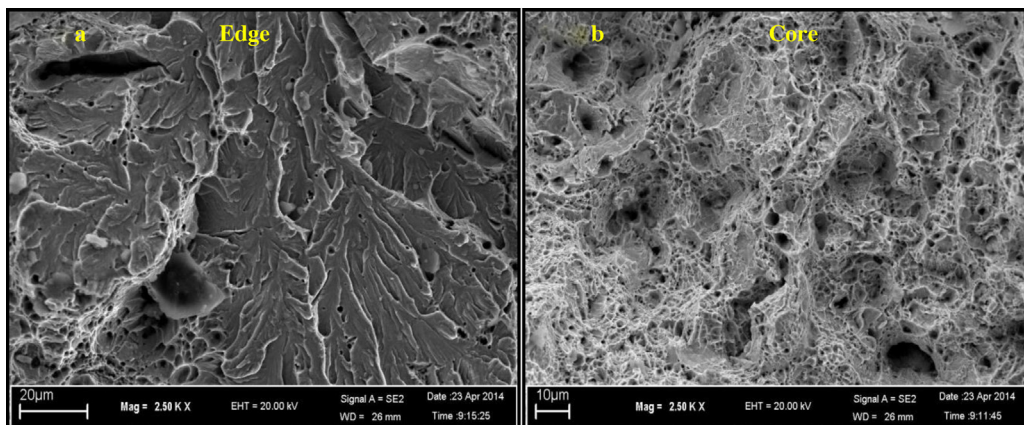
Fractography of the outer surface (region A) revealed cleavage nature of the fracture surface suggesting brittle fracture (Fig. 2a), whereas the fractography of the inner core (region B) revealed dimple nature of the fracture surface suggesting ductile fracture (Fig. 2b).

Fig. 2. (a) Fractography analysis of side A of the failed component; (b) fractography analysis of side B of the failed component.

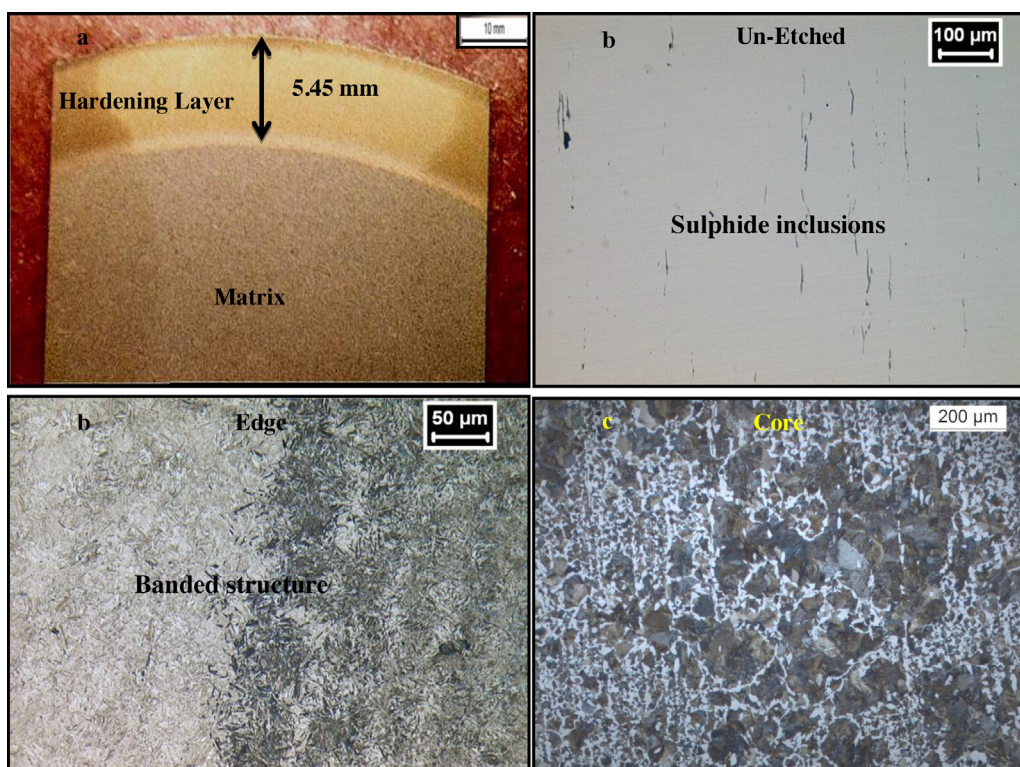
The failed sample was etched with 2% Nital solution. The macrostructure at the cross-section of the rod reveals case hardened layer as the component was subjected to induction hardening treatment (Fig. 3a). The hardening layer was non-uniform along the cross-section and in some location it was found more than the specification ($>2\text{--}3\text{ mm}$). The un-etched microstructure reveals numerous sulphide inclusions throughout the sample which indicates that the steel is not clean (Fig. 3b). The surface of the rod sample reveals in-homogeneous/banded microstructure in martensitic matrix (Fig. 3c), whereas the core reveals ferrite pearlite structure (Figs. 3b). Mixture of coarse and fine pearlite structure was observed in the core of the sample which was resulted due to improper heat treatment process.

Inclusion rating of the failed component was carried out as per ASTM E-45. Un-etched microstructure of shaft shows that thin and thick sulphide (Type A) inclusions are present with a severity of 2.5 and 0.5 respectively. Some inclusions of Type D (oxides) are observed with a severity of 0.5. Such a huge number of inclusions are not desirable as they can act as stress concentration sites and may lead to crack initiation (as shown in Table 2).

Fig. 3. (a) Macrostructure of the cross-section of the failed shaft; (b) un-etched structure of the failed shaft; (c) microstructure of the edge of the component; (d) microstructure of the edge of the component.

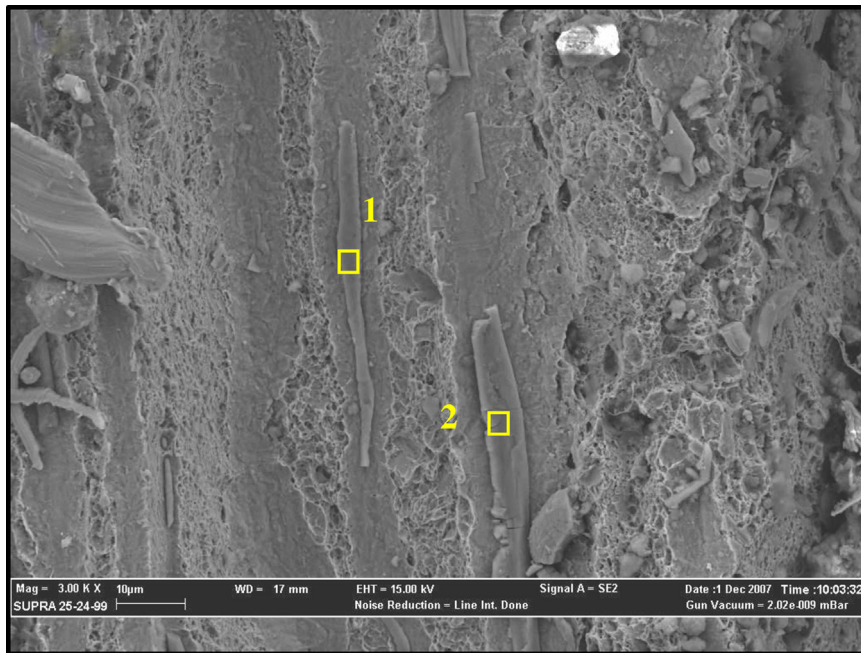
Non-metallic inclusions were observed along the longitudinal axis of the component. Elemental analysis under SEM reveals that the inclusions were found to be rich in Sulphur (S) and Manganese (Mn) indicating them to be manganese sulphide inclusions (as shown in Table 3). The crack in this region has propagated by brittle mode and MnS inclusions could have enhanced the notch sensitivity of the shaft [4–6] (Fig. 4).

Fig. 4. The fracture surface shows multiple sulphide stringers oriented in the direction of crack propagation.

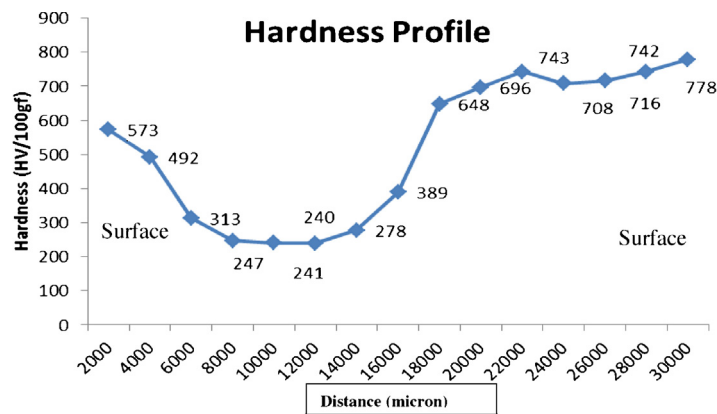
Non-uniform distribution of hardness was observed in the rod sample across the section (Fig. 5). The average hardness of the surface hardened layer is measured to be 735 HV which is very high compared to the core and also for these applications. Such high hardness is not desirable since it imparts brittleness.

Fig.5. The hardness profile of the transverse section of the shaft.
