Analysis of a crankshaft fatigue failure

Wei Li^{*}, Qing Yan, Jianhua Xue*School of Mechanical Engineering, University of Science and Technology Beijing, 30 Xueyuan Road, Haidian District, 100083 Beijing, China*

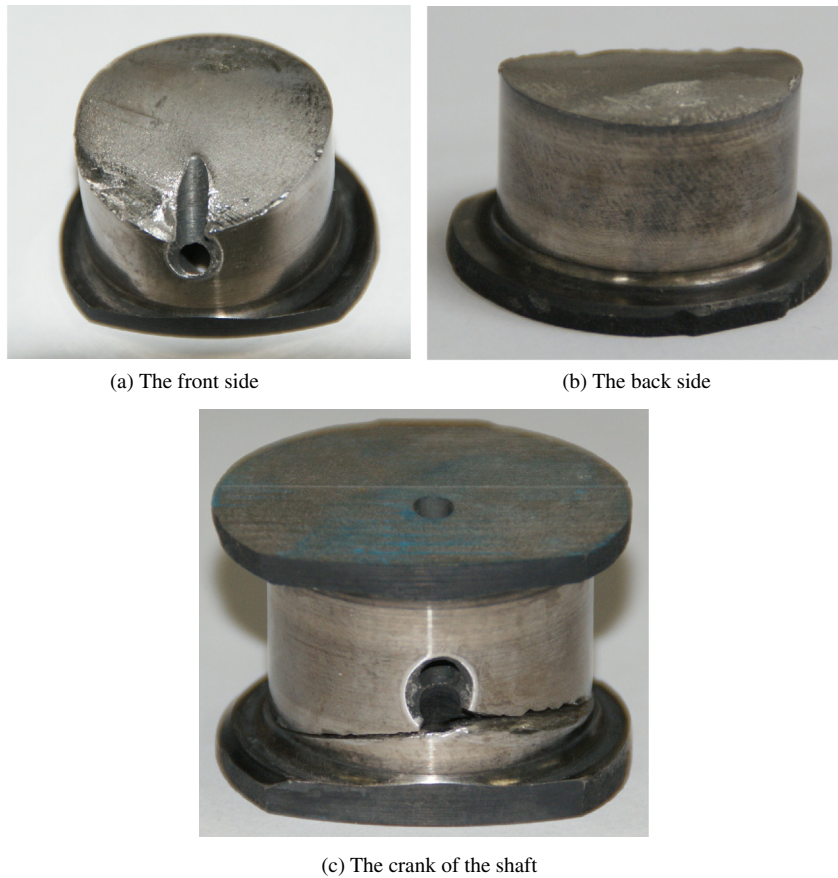
In this paper, the crankshaft is made of 42CrMo steel with forging, heat treatment and nitridation. The crankshaft occurred fracture failure after using a period of time. The fracture position and surface of the crankshaft is shown in Figs. 2 and 3. The region around the lubrication hole is rough by observing Fig. 3.

Fig. 3. The fracture surface of the crankshaft.

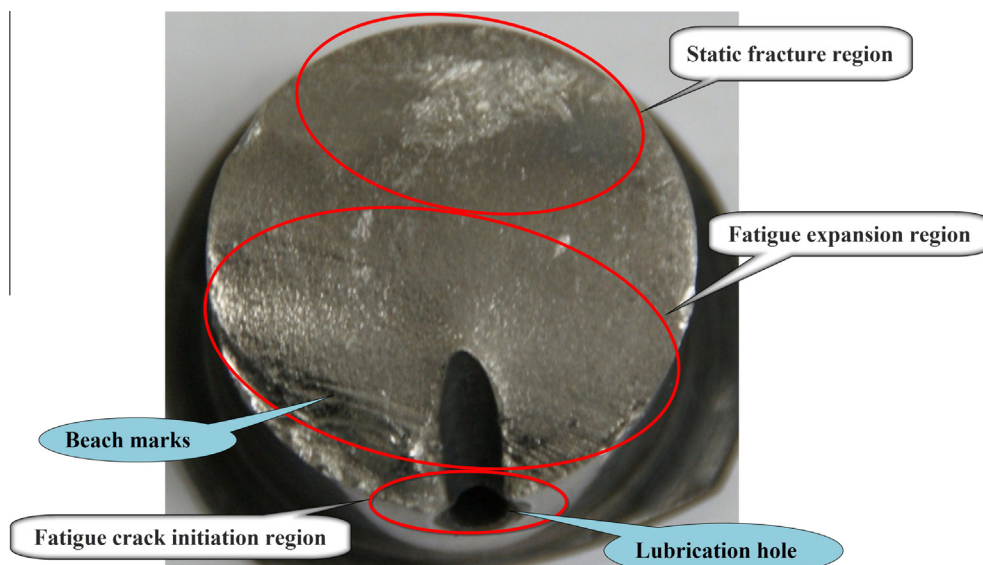
The fracture surface shown in Fig. 4 can be divided into three regions: (1) fatigue crack initiation region, (2) fatigue expansion region and (3) static fracture region.

The catastrophic fracture which shows the fatigue crack growth rate is high seems to be a consequence of a high bending according to the Fig. 4. The reasons why the bending loading is too high is that the misalignment of main journals and the small fillet of the lubrication hole. Under the above two cases which can generate high bending stress concentration, the fatigue crack initiated on the edge of the lubrication hole and finally fractured.

The presence of beach marks with semi-elliptical shape surrounding fatigue crack initiation region indicates its expansion. These beach marks, also named progression marks were extremely important to describe fatigue fractured surfaces,

Fig. 4. Macro-photograph of the fracture surface.

but the beach marks are only the characteristics of the fatigue fracture and some fatigue fracture did not have obvious beach marks. The beach marks are a consequence of small overloads as a result of starting or stopping of compressor. The beach marks are really important to determine the fatigue crack growth rate and also to determine where the focus of the semi-ellipses (the crack initiation site) exists.

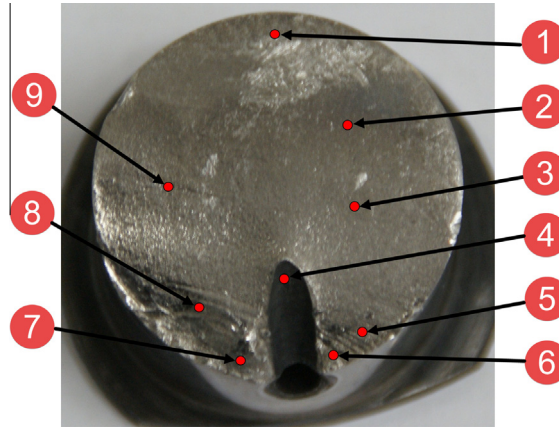
The observation points numbered 1–9 are shown in Fig. 5. However, only display of those critical observation points are shown in Fig. 6, numbered 1, 2, 4, 5, 6 and 9.

Fig. 5. Observation points of the fracture surface under SEM.

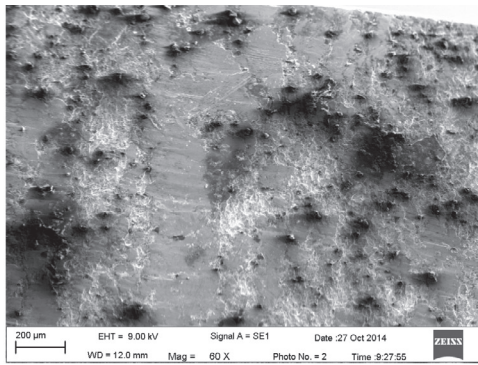
(a) Point 1

Point 1 is located on the edge of the fracture surface which is shown in Fig. 6(a). The display of the rough surface which means the point 1 is located in the static fracture region.

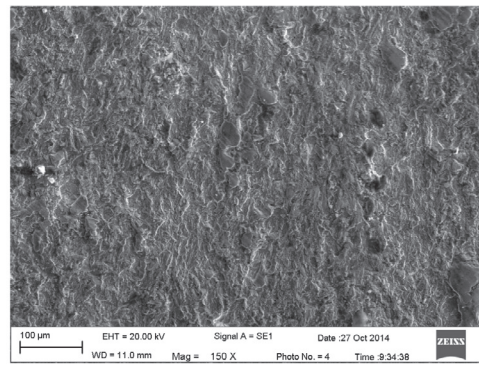
(b) Point 2

Point 2 is located at the static fracture region. The picture shows clearly the typical morphology of fast fracture.

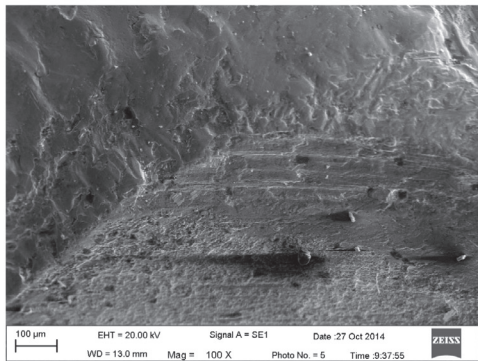
(c) Point 4

Point 4 is located on the surface of the lubrication hole. The relatively smooth surface shown in Fig. 6(c) means there is no stress concentration.

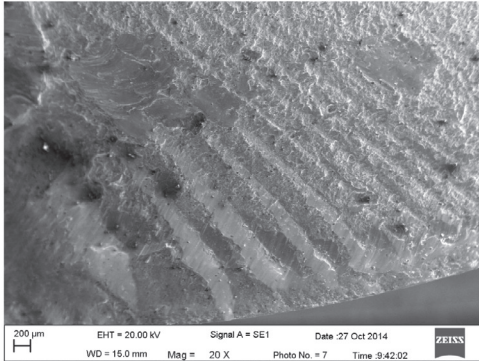
(d) Point 5

Point 5 is on beside of the lubrication hole. The obvious beach marks distributed in Fig. 6(d) meaning that this is a typical fatigue expansion region.

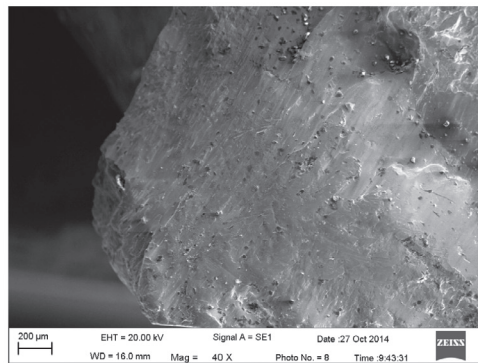
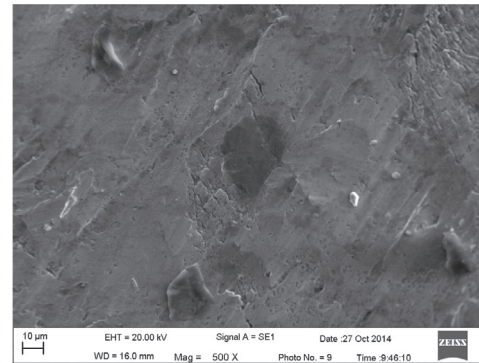
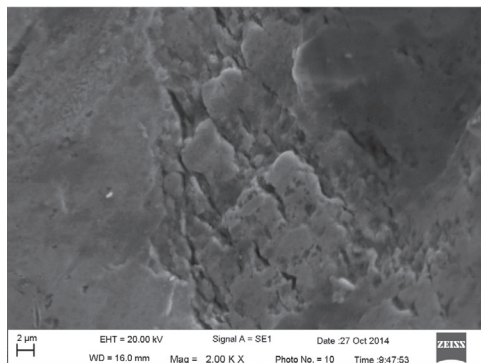
Point 6 is located on the edge of the lubrication hole. There are three pictures in different magnification to understand the morphology of the point 6 clearly. Fig. 6(e) shows a smooth surface and we can make sure the point 6 is on the fatigue source region. We can also find out the fatigue crack initiation site by tracing back the beach marks.

(e) Point 6-1

(f) Point 6-2

(g) Point 6-3

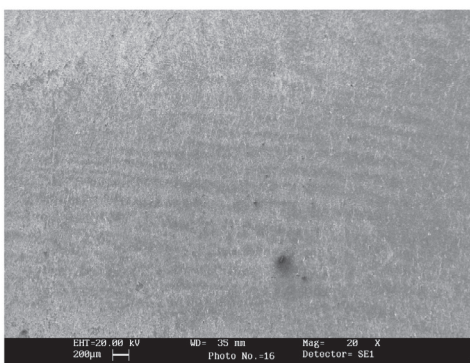
(h) Point 9

Point 9 is located at the fatigue expansion region and the morphology of point 9 seems to show an occasional beach mark.

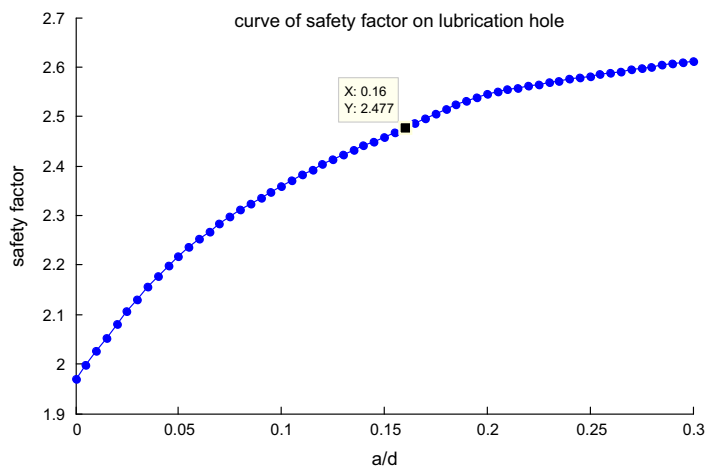
According to the known parameters of the crankshaft, the relationship between the safety factor and the diameter of lubrication hole after fillet has been obtained, which is shown in Fig. 9. The parameter a represents diameter of the lubrication hole after fillet in Fig. 9.

According to the part drawing where $a = \varphi 5$ mm, $d = \varphi 32$ mm, the safety factor $S_{ca} = 2.477$ has been got from Fig. 9, and then we know that the fatigue strength on the lubrication hole is in allowable range which is $[S_{ca}] = 2.0\text{--}3.0$.

Fig. 9. Curve of safety factor on lubrication hole.

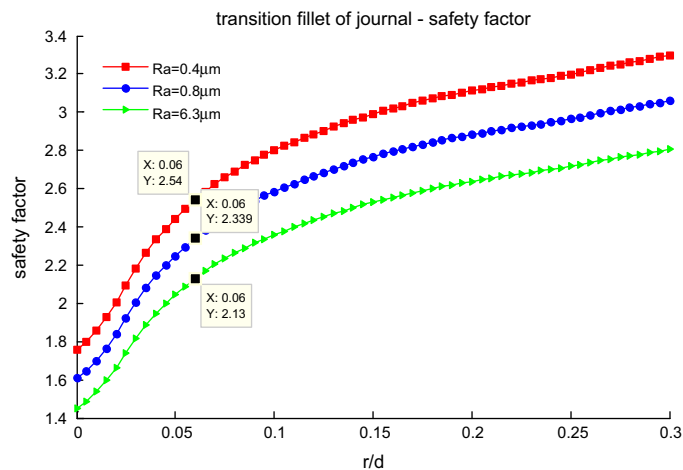
Fig. 11. Curve of safety factor on transition fillet of journal.

Then the relationship between the safety factor, transition fillet of journal and surface roughness is found out and the curve is shown in Fig. 11 where R_a is surface roughness.

According to Table 3, the method to improve safety factor when the transition fillet has been large enough is found out which is reducing the surface roughness. The safety factor and surface roughness have been obtained where $S_{ca} = 2.540$, $R_a = 0.4 \mu\text{m}$ which is shown in part drawing, and the conclusion that fatigue strength on transition fillet of journal is in allowable range which is $[S_{ca}] = 1.5\text{--}2.0$ can be drawn.

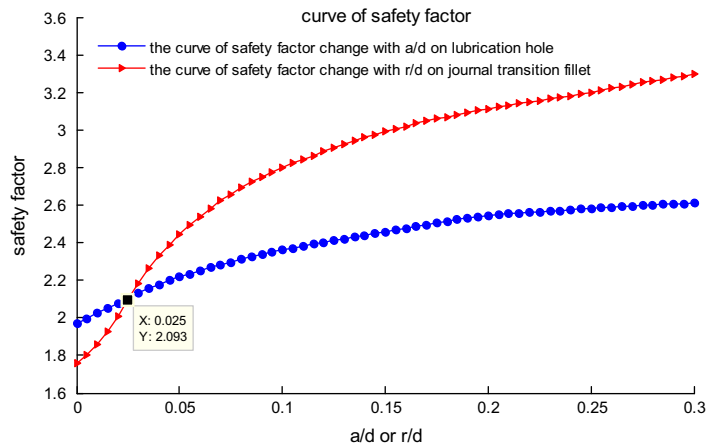
Fig. 12. Curve of safety factory.

Then a comprehensive consideration of safety factor on surface of the lubrication hole and the transition fillet of journal has been taken into which is shown in Fig. 12.

The abscissa value 0.025 is a critical point from Fig. 12. When the abscissa value is greater than 0.025, the safety factor of transition fillet of journal is greater than the one on the lubrication hole and the dangerous section is on the surface of the lubrication hole. Through calculation we obtain that the critical radius is $r = 1$ mm and the critical lubrication hole diameter is $d = 1$ mm.
