## 1. Introduction

The failed fasteners were subjected to detailed metallurgical investigation to understand the cause for failure. This paper brings out the details of investigation carried out.

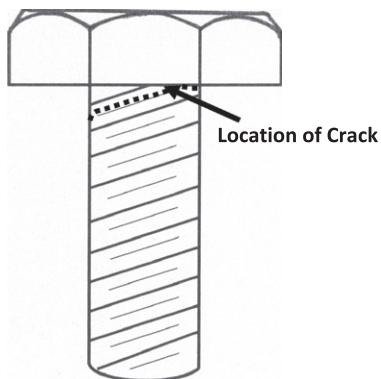
**Fig. 1.** Schematic of fastener showing location of crack.

The location of failure in each one of the three failed fasteners was at head-shank junction. Fig. 1 shows the schematic sketch of fastener and location of crack. Evidence of corrosion was seen at and near the fracture edge. Fracture surface had two distinct regions. One all along the periphery had dark and dull, while the region concentric to centre and irregular in shape was bright in appearance. The parts of failed fasteners were cleaned thoroughly using methanol through ultrasonic means. Threaded region near the fracture edge, under optical microscope with stereographic facility revealed a number of cracks at thread root, very near to the fracture edge. The shank portion was cut across its axis and prepared for optical microscopic observations. Fracture path all along the fracture edge was zig-zag and had a number of secondary cracks with branching along grain boundaries, penetrating into the material (Fig. 2). The crack branching resembled feature of tree root morphology. This was further confirmed when specimens were etched with 3%Nital. Features were indicative of anodic dissolution and even at few locations, grains were detached from the matrix. Thread roots nearby fracture edge too had crack initiation at thread root and their penetration with branching (Fig. 3), typical of tree root morphology.

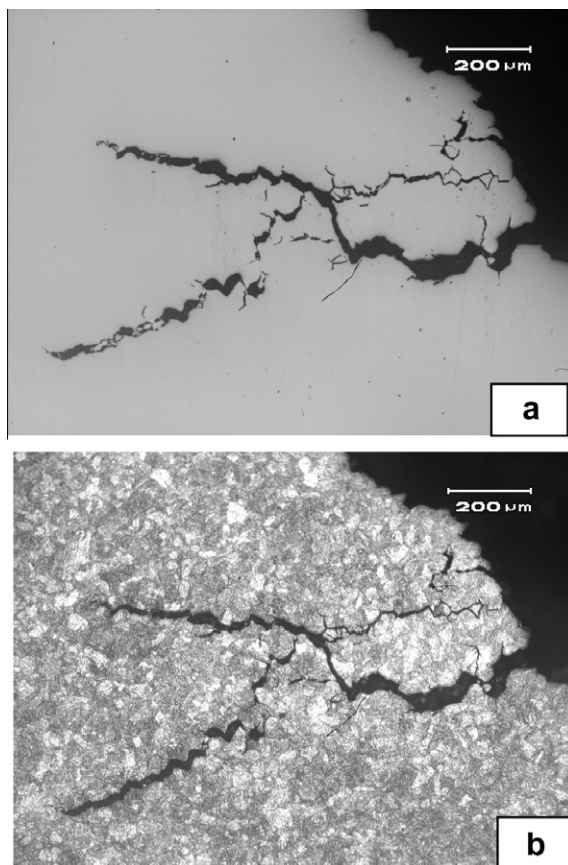
**Fig. 2.** Optical microphotographs showing secondary cracks from primary fracture edge (a) unetched and (b) etched.

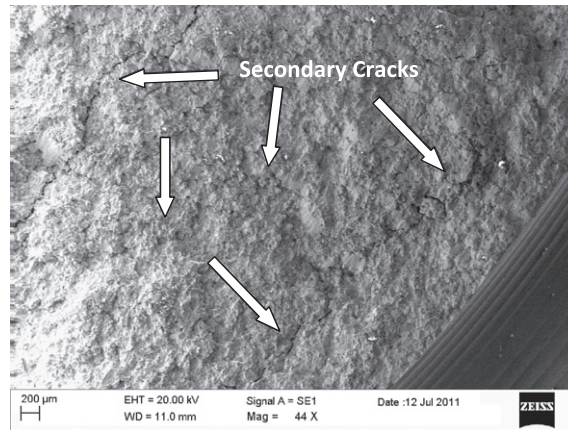
Fracture surface of failed bolt had two distinct regions. Within outer periphery of the fracture surface, multiple secondary cracks penetrating almost perpendicular to the fracture plane were seen (Fig. 4). It was confirmed that crack initiated at and coincided with region of multiple crack at thread root. Fracture surface at the initiation site had predominantly intergranular mode of fracture with presence of secondary cracks (Fig. 5).

**Fig. 4.** Fractograph showing multiple secondary cracks within outer periphery of the fracture surface.

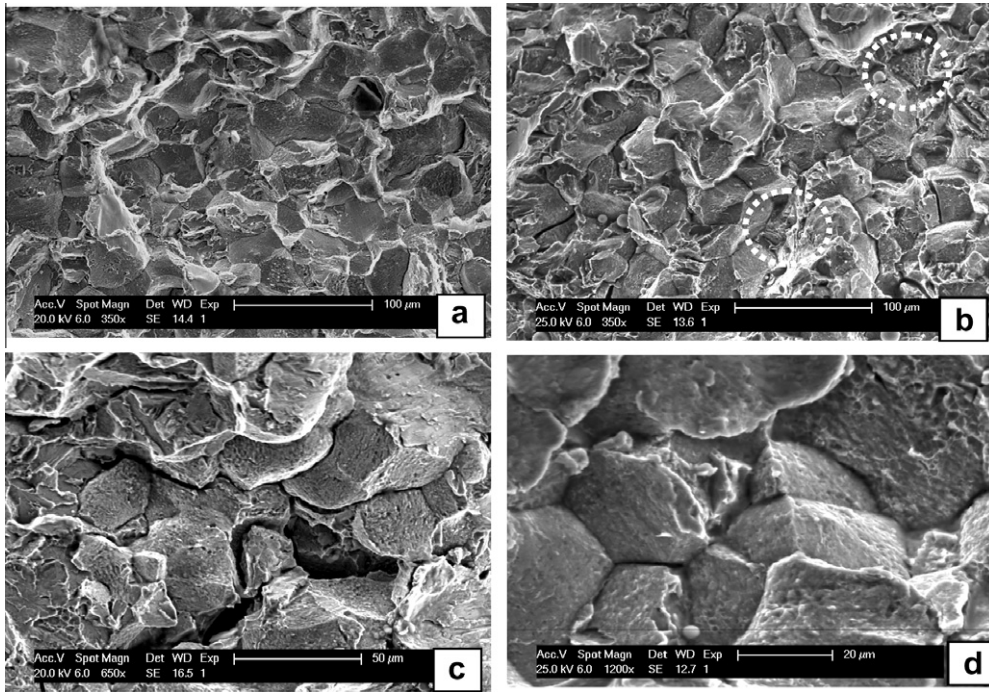
The facets on either side of these grain separation had pits resulted due to local preferential corrosion. at certain locations, grain facets had corrosion product left behind crack advancement (Fig. 6). Central part of the fracture surface had predominantly dimple mode of failure (Fig. 7).

**Fig. 6.** SEM fractographs showing (a) intergranular features, (b) corrosion products and (c and d) pitted facets.

1. There was corrosion within the engaged threads, which caused cracks to initiate at thread roots and propagated under influence of load (assembly).
2. Crack propagation was intergranular.
3. Corrosion products at crack tip as well as within grain separation gap were conclusive evidence of anodic dissolution during crack advancement.

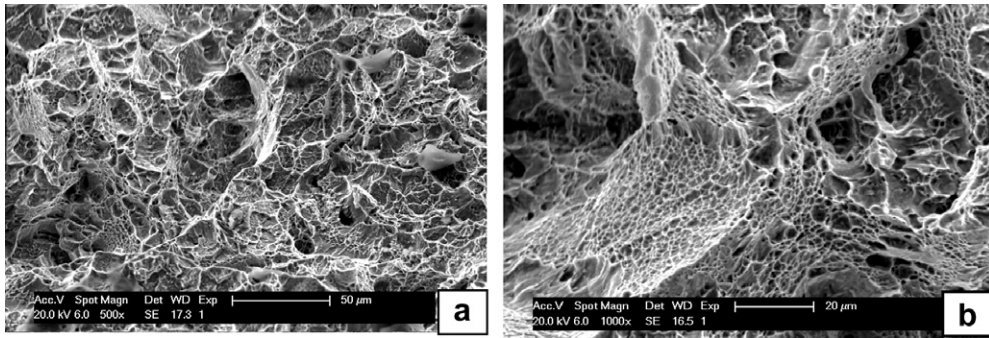
**Fig. 7.** SEM fractographs showing dimple mode of failure within central region of fracture surface.
