Failure analysis of maraging steel fasteners used in nozzle assembly of solid propulsion system

^a Material Processing Division, Vikram Sarabhai Space Centre, Indian Space Research Organization, Trivandrum 695 022, India

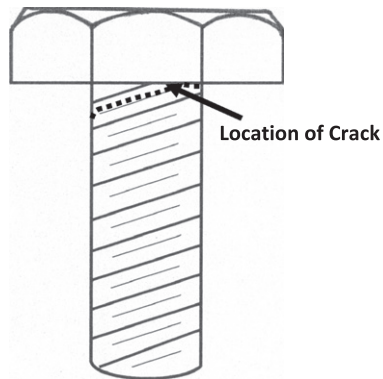
Fig. 1. Schematic of fastener showing location of crack.

The location of failure in each one of the three failed fasteners was at head-shank junction. Fig. 1 shows the schematic sketch of fastener and location of crack. Evidence of corrosion was seen at and near the fracture edge. Fracture surface had two distinct regions. One all along the periphery had dark and dull, while the region concentric to centre and irregular in shape was bright in appearance. The parts of failed fasteners were cleaned thoroughly using methanol through ultrasonic means. Threaded region near the fracture edge, under optical microscope with stereographic facility revealed a number of cracks at thread root, very near to the fracture edge. The shank portion was cut across its axis and prepared for optical microscopic observations. Fracture path all along the fracture edge was zig-zag and had a number of secondary cracks with branching along grain boundaries, penetrating into the material (Fig. 2). The crack branching resembled feature of tree root morphology. This was further confirmed when specimens were etched with 3%Nital. Features were indicative of anodic dissolution and even at few locations, grains were detached from the matrix. Thread roots nearby fracture edge too had crack initiation at thread root and their penetration with branching (Fig. 3), typical of tree root morphology.

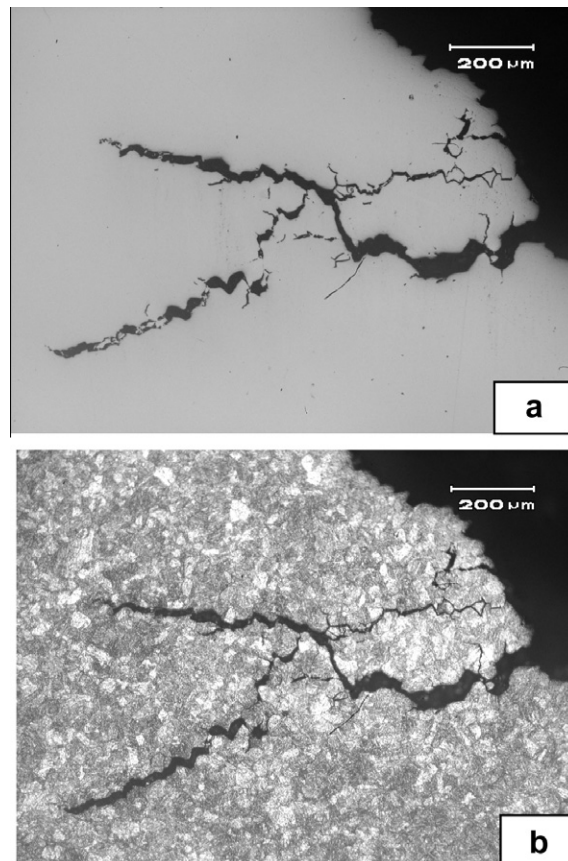
Fig. 2. Optical microphotographs showing secondary cracks from primary fracture edge (a) unetched and (b) etched.

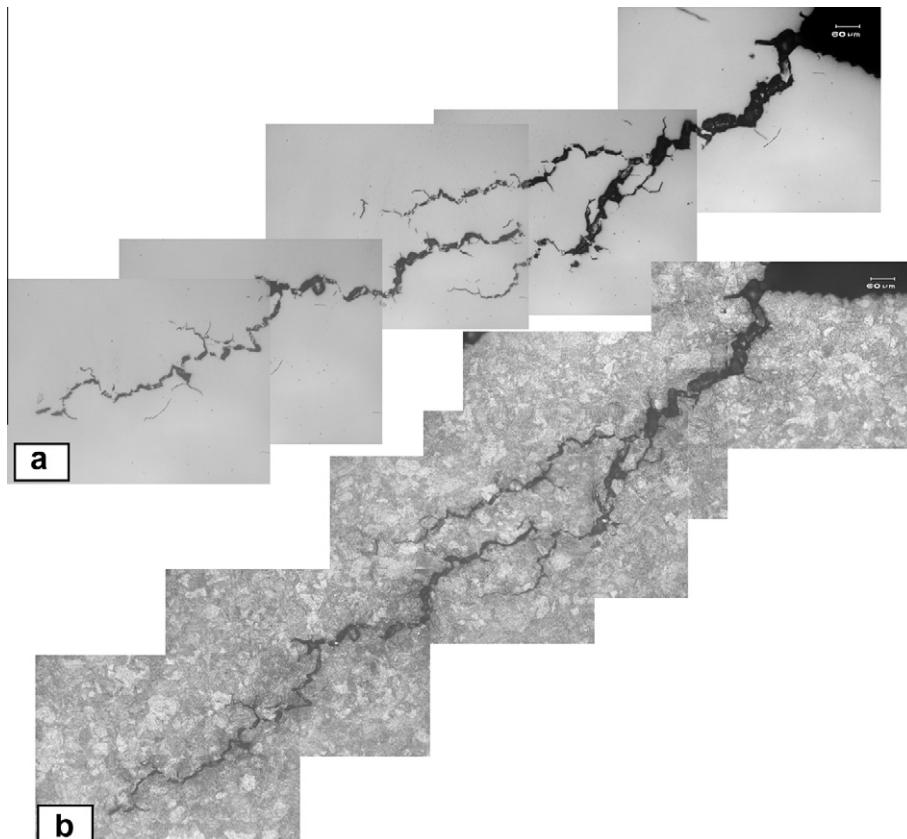
Fig. 3. Optical microphotographs showing the crack branching from the thread root near the fracture edge (a) unetched and (b) etched.

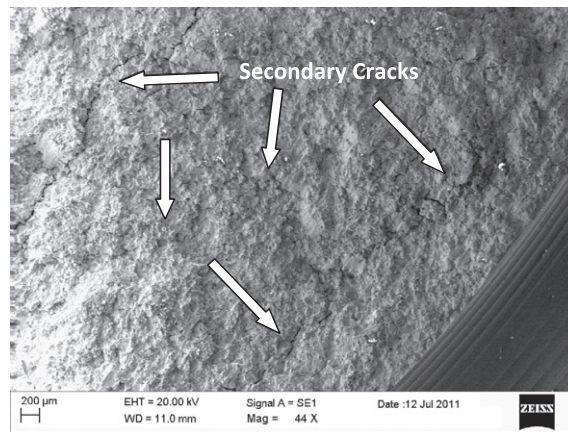
Fracture surface of failed bolt had two distinct regions. Within outer periphery of the fracture surface, multiple secondary cracks penetrating almost perpendicular to the fracture plane were seen (Fig. 4). It was confirmed that crack initiated at and coincided with region of multiple crack at thread root. Fracture surface at the initiation site had predominantly intergranular mode of fracture with presence of secondary cracks (Fig. 5).

Fig. 4. Fractograph showing multiple secondary cracks within outer periphery of the fracture surface.

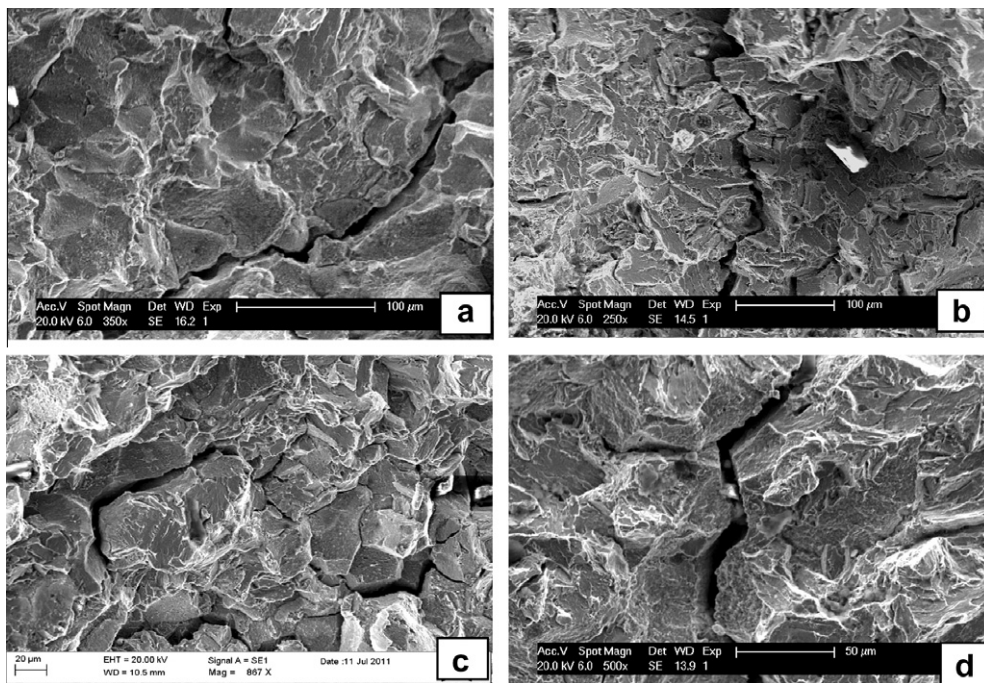
Fig. 5. SEM fractographs showing presence of secondary cracks on fracture surface running along the grain boundaries.

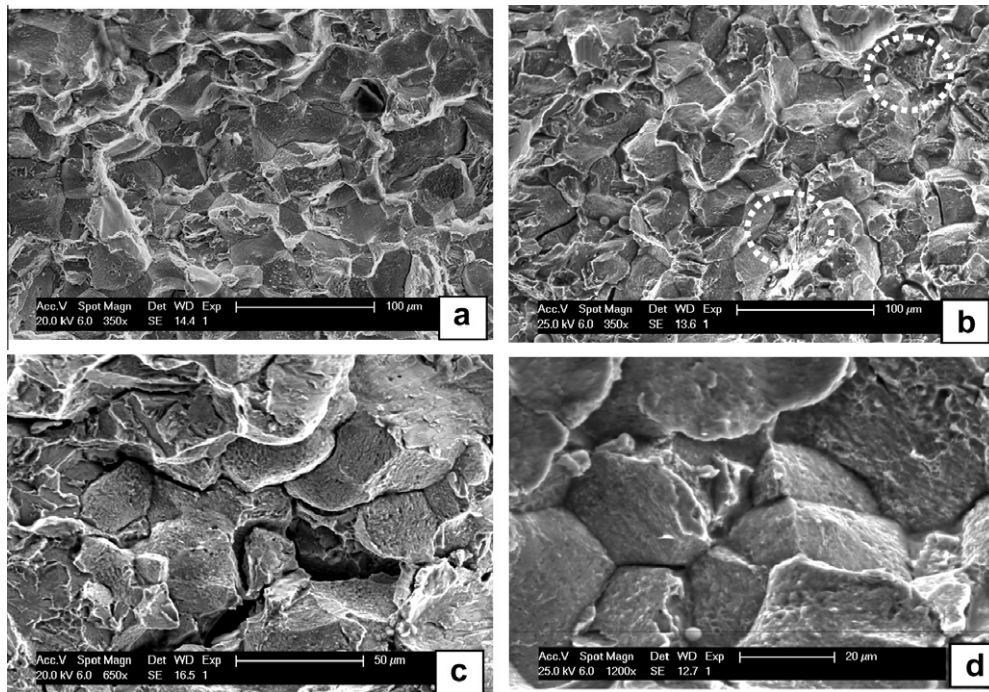
The facets on either side of these grain separation had pits resulted due to local preferential corrosion. at certain locations, grain facets had corrosion product left behind crack advancement (Fig. 6). Central part of the fracture surface had predominantly dimple mode of failure (Fig. 7).

Fig. 6. SEM fractographs showing (a) intergranular features, (b) corrosion products and (c and d) pitted facets.

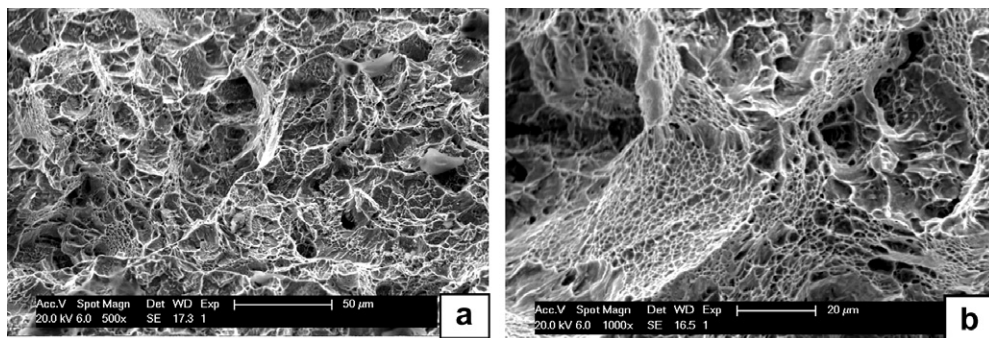
Fig. 7. SEM fractographs showing dimple mode of failure within central region of fracture surface.
