This paper presents the causes and a diagnosis of the corrosion types in a tank used to store warm water in a brewery house. Corrosion of the installation made of austenitic stainless steel in conditions of hot water containing chloride ions can be considered as a very common problem [5]. Detailed researches had been performed in order to solve this problem after it was found that corrosion phenomenon also concerns cold water installations in nuclear power plants [6,7]. It was recognised that it would be demanded to perform a very detailed selection of construction materials on the basis of chemical composition of water and its temperature [8,9]. Corrosion in hot water installations occurs mainly in the form of stress-corrosion cracking or pitting corrosion [10]. Nevertheless, the stress-corrosion cracking process can be initiated by the pitting corrosion, precisely by the increase in stresses in the pits' bottom [11,12]. Data available in scientific literature indicate that appearance of localised corrosion processes in hot water installations (static stresses) does not demand high concentration of chloride ions. Studies carried out by Turnbull et al. [11] point out the critical c

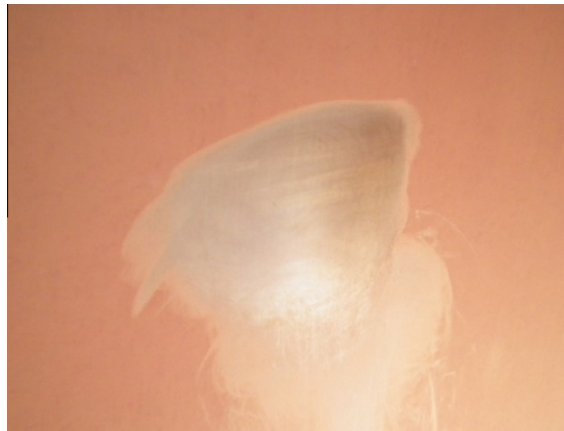
After a downtime and submitting the tank for inspection, the inner stainless steel surface was covered with dark brown deposit consisting mainly of the products of corrosion. The deposit was not very adhesive and could be easily removed with a paper towel. No changes in the steel below the deposit were found, so it can be concluded that the deposit was driven in by the water due to the corrosion in the water supply installation. The condition of the tank surface is shown in Fig. 1.

Fig. 1. View of the inner surface of the container with partially removed deposit.

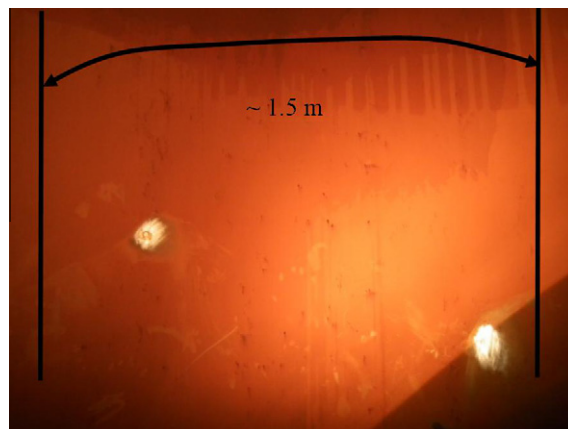
A corroded area was found in an approx. 1.5 m-wide cylindrical fragment of the tank (Fig. 2), located in the zone of mechanical impact of the pipeline outside the tank (See Fig. 3).

Fig. 2. A corroded part of the stainless steel tank.

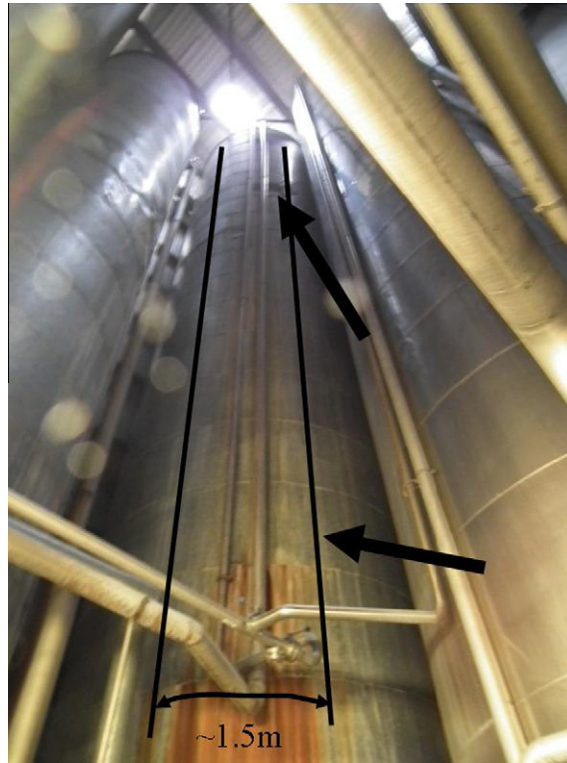
The locations of tank repairs correspond precisely to the zones of intense stress caused by the pipeline. This allows for associating the corrosion with the mechanical and corrosive impact. Corrosion attack visible in the form of branched lines and local centres is shown in Fig. 4.

Fig. 3. Outside view of the tank with the corroded zone inside the tank marked.

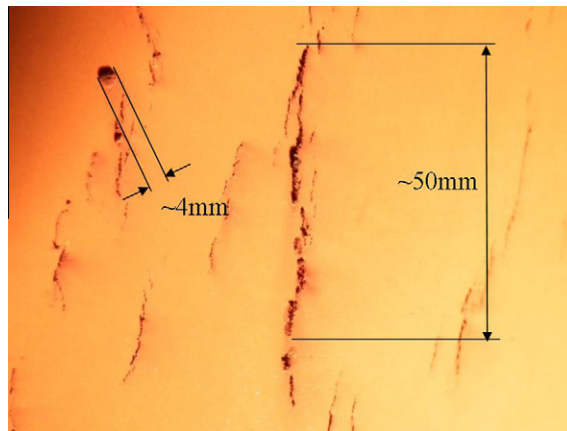
Fig. 4. Examples of corrosive attack of the cylindrical part of the tank.

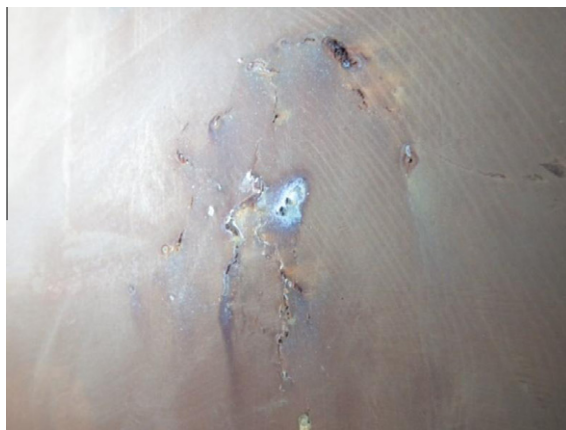
After the products of corrosion were removed, clear corrosive attacks could be seen as cracks, pits and etchings (the result of deposit corrosion) (Fig. 5).

Fig. 5. Corrosive attacks in a stainless steel tank.

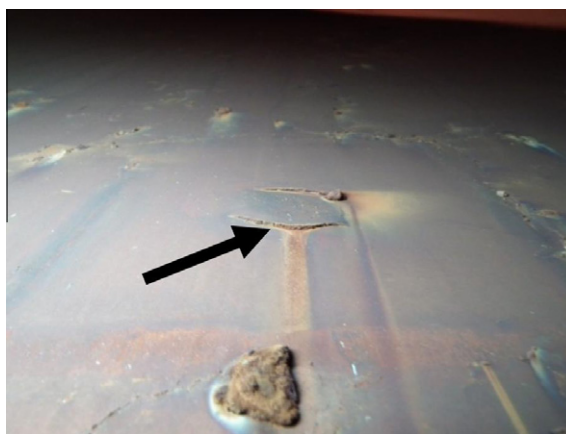
In some places, the cracks extended across the thickness of the tank. Fig. 6 shows the location of the total tank rupture (perforation).

Due to the presence of cracks visible on the tank surface, the stresses resulting from the interactions of hydrostatic pressure were calculated at the levels of 63% and 85% of the permissible tensile stresses for cold and hot water, respectively.

Fig. 6. Corrosion cracking of the mantle as the cause of perforation.

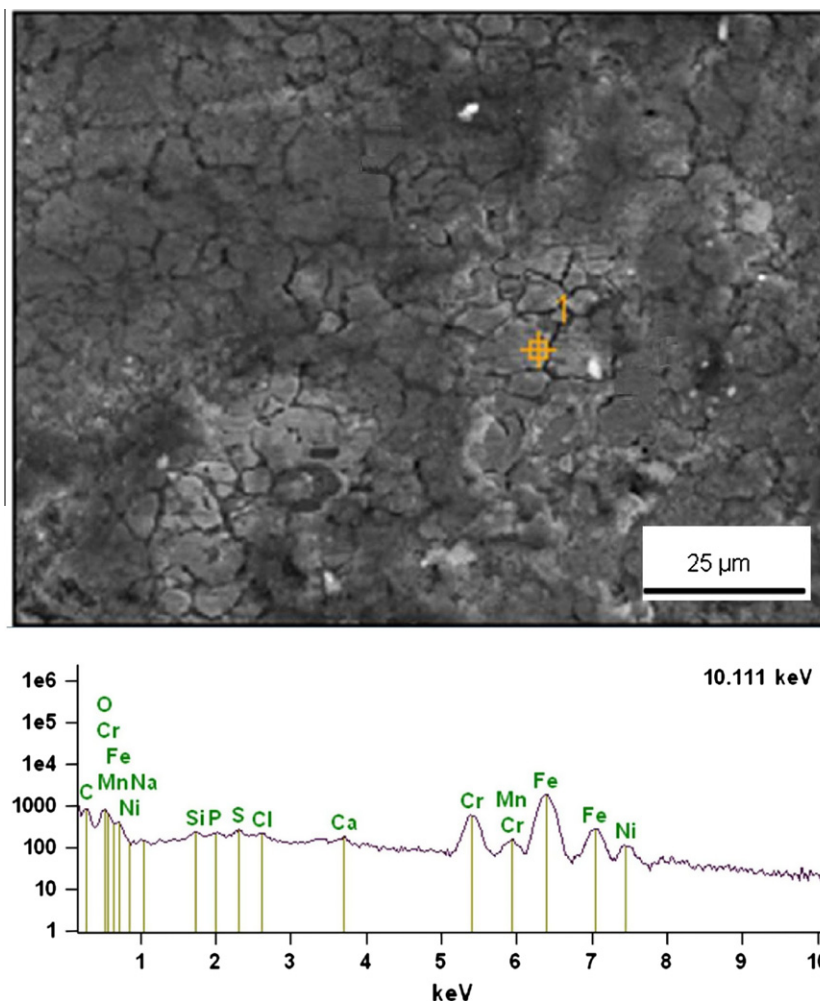
Additionally, SEM research of the examined steel surface was conducted. Steel specimens were taken from the places, where the corrosion products were detected on the tank. SEM images were obtained by using S-3400N Hitachi VP-SEM (with THERMO Scientific EDS unit attached). Results of this analysis are presented in Fig. 7.

Fig. 7. SEM and EDS images of the corroded surface of the tank.

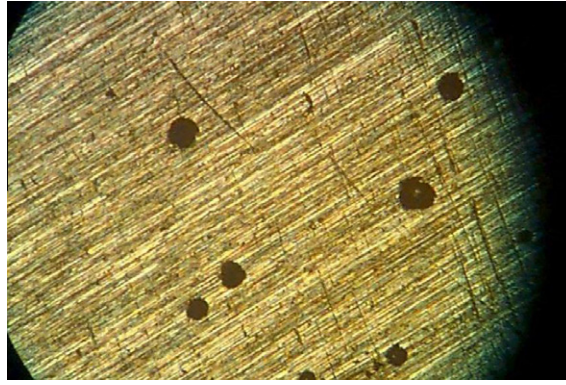
After completing the electrochemical measurements, a photo of a 1.4301 steel sample was taken after studying it in water at 75 °C, which is shown in Fig. 10.

Fig. 10. The surface of a 1.4301 steel sample after cyclical polarisation test in water at 75 °C.
