The present study focuses on the investigation of the systematic short-time failure of a superheater pipeline, part of the main heat exchanger assembly operating with steam, in a power-plant unit in Northern Greece. The multi-curved pipeline was constructed over a lignite combustor, 30 years ago. According to the original design, the whole pipeline consists of an array of individual tubes of outer diameter 38 mm, wall thickness 6 mm and length 4 m. These tubes are properly welded to form a pipeline with a total heat exchange area of 5200 m². The suggested construction materials were the steel grades: 15Mo3, 13MoCr44 and 10CrMo910 (Table 1), commonly proposed for the production of pressure vessels.

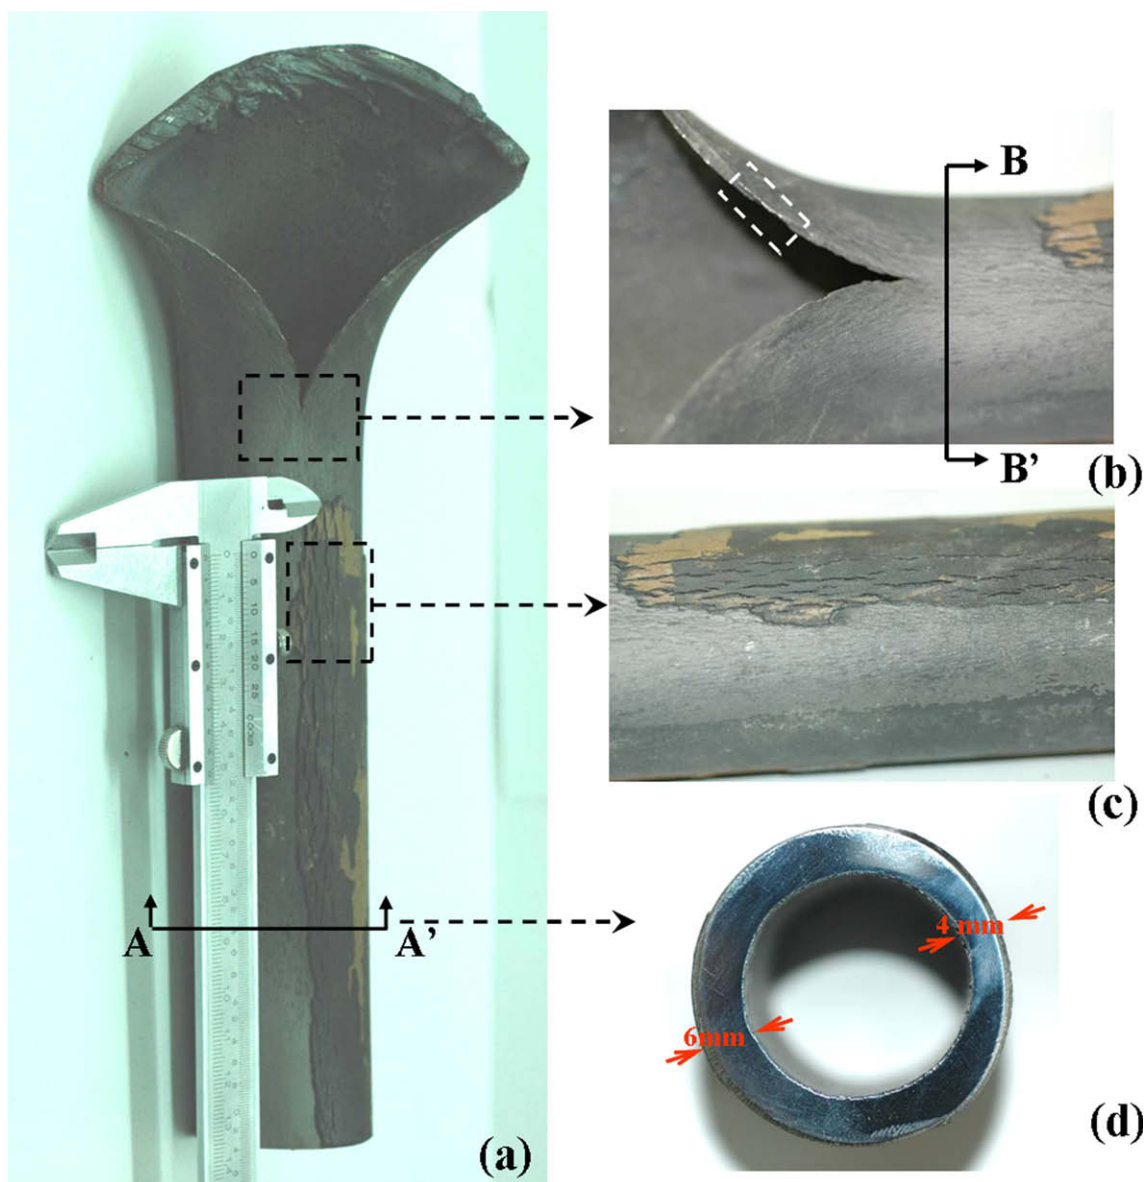
Fig. 1. Macrographs of the failed-tube retrieved from a curved area of the pipeline: (a) total view of the retrieved part, indicating “fish-mouth” rupture; (b) zooming of (a), at the area of the tip of the rupture lip; (c) zooming of (b), at the area of tube swelling and (d) cross-section ring along the line AA' of (a).

The failed parts retrieved from curved pipeline areas exhibit the typical “fish-mouth” thin-lip rupture (Fig. 1a), commonly observed in cases of creep-induced failure of superheater and reformer tubes [3,4].

In the particular case, rupture occurred always at the inner wall of the curved tube. The wall thickness at the tip of the “fish-mouth” was diminished from its original value of 6 mm down to about 1 mm, whilst the typical metal plastic flow striations could also be clearly observed along the tube axis (Fig. 1b). At a distance of about 30 mm from the rupture tip, a bump on

detachment of the cracked oxide layer, most likely caused during the maintenance works. Similar features have been observed in the case of creep failure of turbine blades [5]. Such oxide layers were also present on the diametrically opposite area of the outer wall of the curved tube; however they were much thinner, free of cracks and well adhered to the parent metal. Wall thinning extending to a distance of about 120 mm from the rupture tip was observed; at this location the thickness of the inner wall was measured at 4 mm, corresponding to a 33% reduction of its original dimension (Fig. 1d).

Based on these points, the continuous pipeline review and re-design is suggested taking into account each time the calorific value of lignite that is fed to the combustion chamber of the unit. As this seems to be higher with increasing exploitation depth, the 13Mo3 grade should be rejected and more heat-resistant steel grades should be considered as materials of choice.

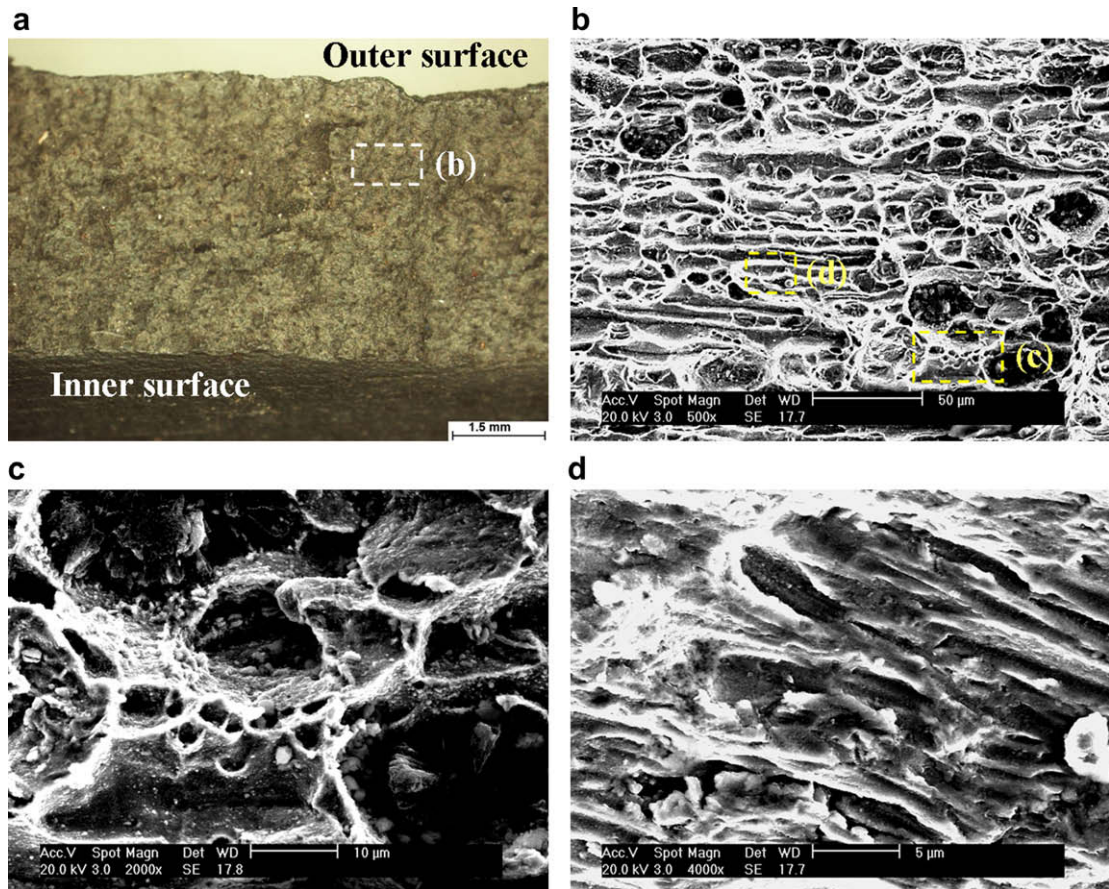
Fig. 2. Fracture surface of the rupture lips, indicated in Fig. 1a with a dashed rectangle: (a) stereo-graph of the dimpled fracture surface; (b) SEM image of the zoomed area indicated in (a); (c) SEM image of micro-voids, present on the fracture surface and (d) SEM image of dimples oriented along the initial direction of the material's grains.

Stereo- and SEM-photographs of the rupture-lips' (Fig. 1b, marked area) are shown in Fig. 2. On the dimpled fracture surface (Fig. 2b), two co-existing features can be clearly distinguished:

- Large equiaxial voids arising from the coalescence of creep voids of smaller dimensions (Fig. 2c).
- Elongated dimples corresponding to the initial orientation of the material's grains due to the unidirectional tube forming process (Fig. 2d).

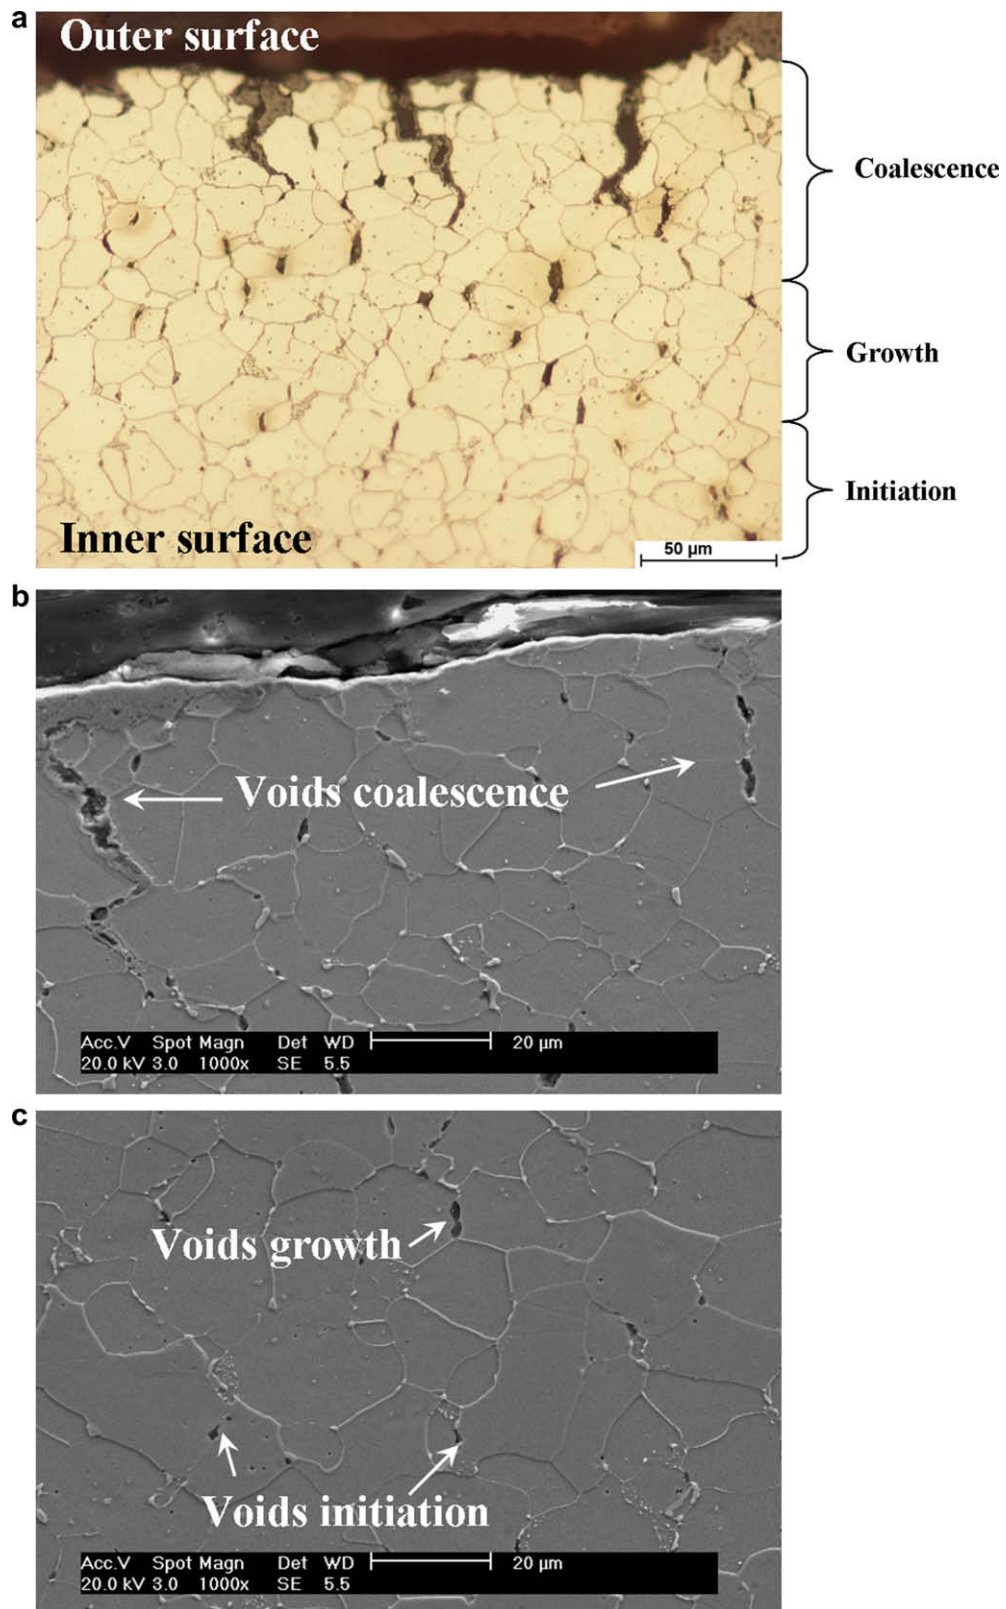
Fig. 3. Cross-sections along the line BB' of Fig. 1b: (a) optical micrograph of the failed-tube wall; (b) SEM image of outer surface of the failed-tube wall and (c) SEM image of inner surface of the failed-tube wall.

The creep void evolution across the tube wall is presented in Fig. 3a. At the outer surface of the tube, void coalescence (Fig. 3b) resulted in intergranular surface cracks of a mean length of 50 μm , filled with oxidation products. Consequently, a second zone of creep void growth can be observed, extending from a depth of about 70 μm to about 130 μm (Fig. 3c); whilst toward the inner surface of the wall, initiation of individual voids appeared along the grain boundaries (Fig. 3c) [6,7]. The co-existence on the same tube cross-section of the three stages in creep void evolution: initiation/growth/coalescence is indicative of a temperature gradient across the wall through which heat exchange is taking place between the hot lignite combustion gases in contact with the outer surface of the tube and the high-pressure steam flow in contact with the inner surface of the tube.

The tube material identification was obtained by applying both metallographic observation and EDAX microanalysis; which showed that it was a low-alloy ferritic steel, probably corresponding to the 15Mo3 grade proposed by the designers of the pipeline. Precipitates observed at the grain boundaries (Fig. 3b and c) indicated cementite spheroidisation, due to the prolonged heating of the material during operation, at a temperature close to A_{C1} .

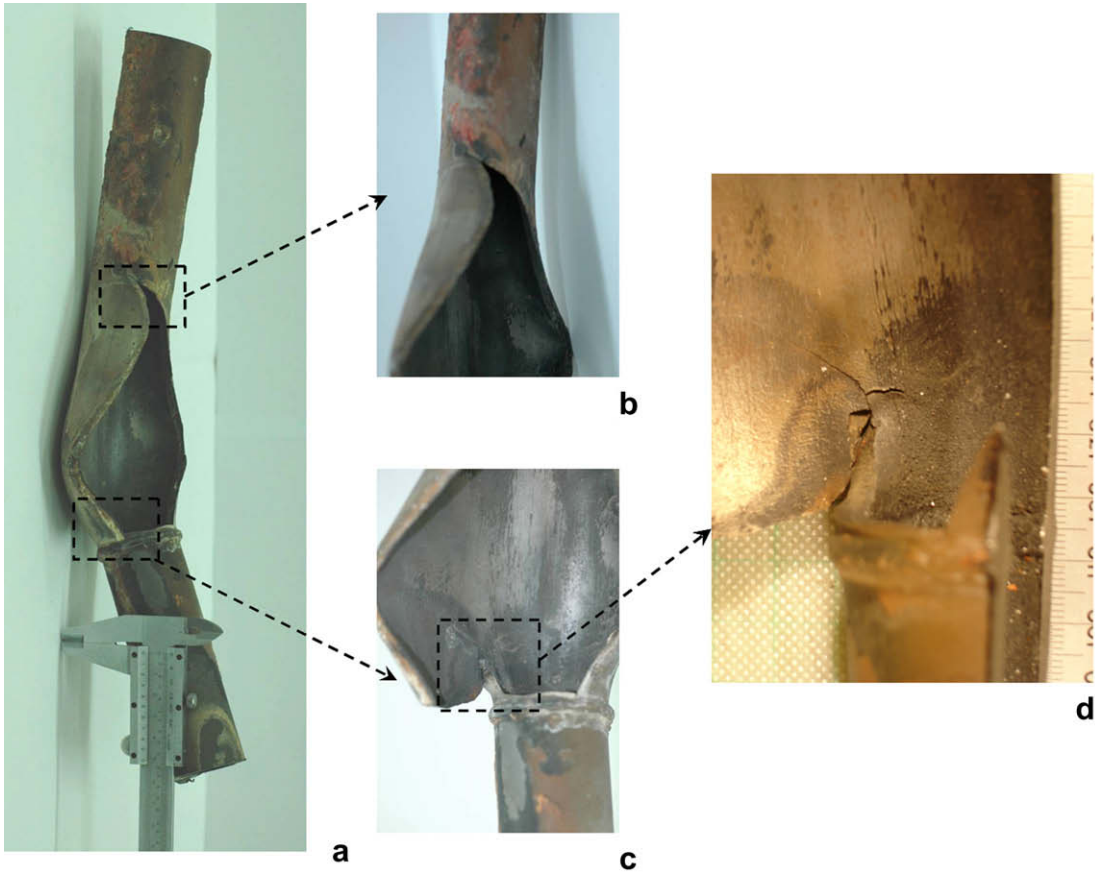
Fig. 4. Macrographs of the failed-tube retrieved from area of the pipeline with circumferential weldment: (a) total view of the retrieved part, exhibiting a “cobra” appearance and (b–d) zooming of characteristic areas, indicated in (a).

The failed parts of the pipeline retrieved from areas near circumferential weldments (Fig. 4) exhibit a “cobra” appearance [3], with fracture cracks initiating near the seam (Fig. 4c) and propagating within one of the joined tubes, in a direction almost parallel to its axis (Fig. 4d).

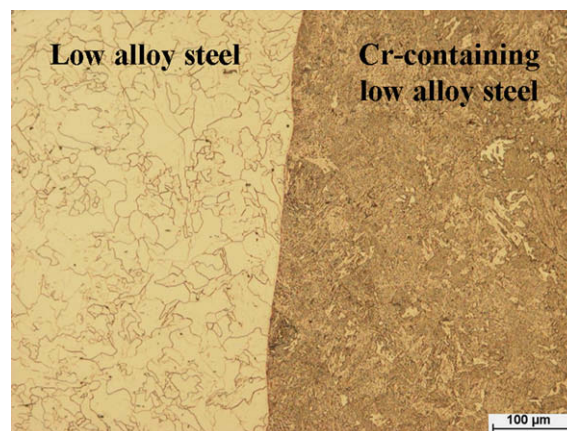
Fig. 5. Optical micrograph of a cross-section perpendicular to the circumferential weldment, revealing solid-state welding of dissimilar steel grades.

Metallographic observations of the weldment's cross-section (Fig. 5) revealed both the materials' dissimilarity of the joined tubes, as well as the absence of fusion zone or filler material, which indicate that a high-temperature solid-state welding technique was applied. EDAX microanalysis indicated that one of the tubes was a Cr-containing steel, probably corresponding to the 13CrMo44 or 10CrMo910 grades also proposed by the designers, whilst the other one, within which fracture cracks had propagated, was a low-alloy ferritic steel, as in the previous case. Although there is a clear boundary between the two welded parts and there is no apparent metallurgical bonding between the two joined surfaces, the seam nevertheless can be characterised as one of excellent quality, since failure initiation was clearly located outside of it.

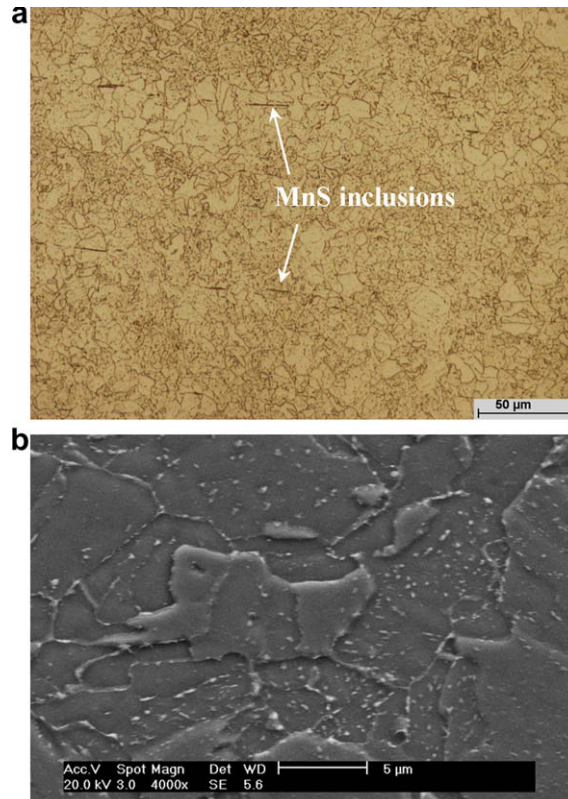
Fig. 8. Optical (a) and SEM (b) images of the Cr-containing steel grade, from cross-sections at an area of intermediate hardness.

In the case of Cr-containing steel grade, the area close to the joint boundary, of 2 mm width, exhibited no re-solidification features, but had the characteristic upper-bainite structure (Fig. 7), with the grain boundaries of prior austenite clearly distinguished. The adjacent area of intermediate hardness of 2.5 mm width, consisted of tempered ferrite with a fine distribution of spheroidised cementite (Fig. 8). Finally, the parent material had a microstructure of ferrite with partially spheroidised pearlite (Fig. 9). Oblong dark features within the base structure correspond to MnS inclusions, entrapped during the material production and shaped during the tube forming process.

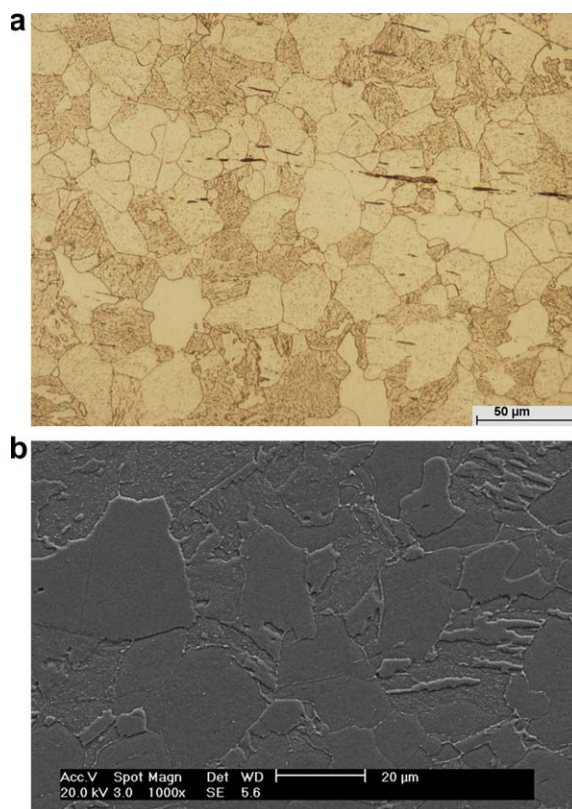
Fig. 9. Optical (a) and SEM (b) images of the Cr-containing steel grade initial structure.

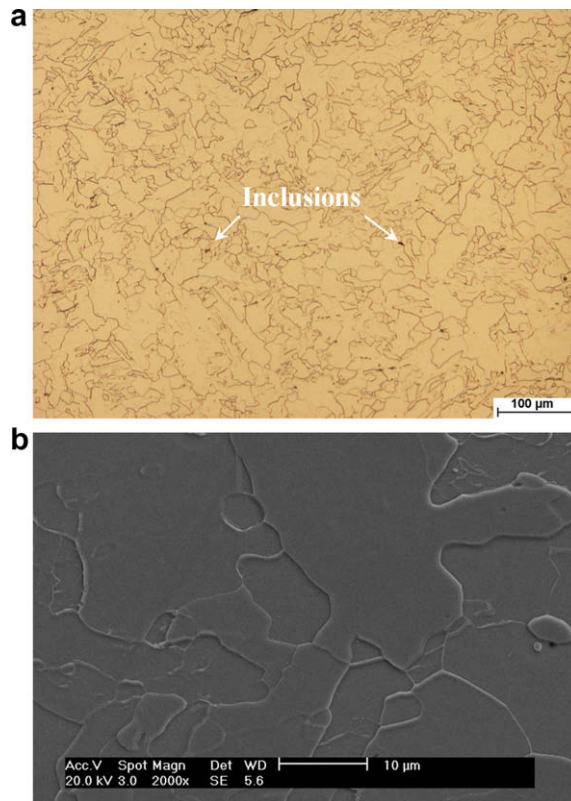
In the case of ferritic steel, the area close to the joint boundary, of 2 mm width, presented irregular ferrite grains (Fig. 10), while dark precipitations distributed within the base microstructure corresponded to residual fluxes (Al_2O_3 and/or CaO) that were entrapped during solidification of the raw material and spheroidised due to their high surface tension. The adjacent

Fig. 10. Optical (a) and SEM (b) images of the ferritic steel, from cross-sections in the neighbourhood of the joint boundary.

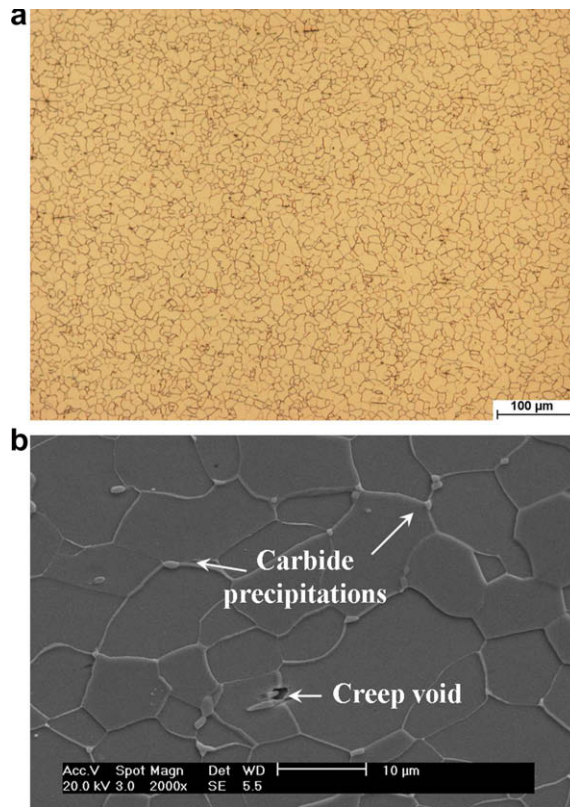
area of 2.5 mm width also consisted of equiaxial ferrite grains, of uniform distribution, which indicates that the material was re-crystallised (Fig. 11). The carbide precipitates found at the grain boundaries probably correspond to spheroidised cementite. In the same area, individual creep voids of small size were scarcely observed. The parent structure was characterised by ferrite grains (normalised ferrite) and a high distribution of creep voids (Fig. 12).

Fig. 11. Optical (a) and SEM (b) images of the ferritic steel, revealing material's re-crystallisation.

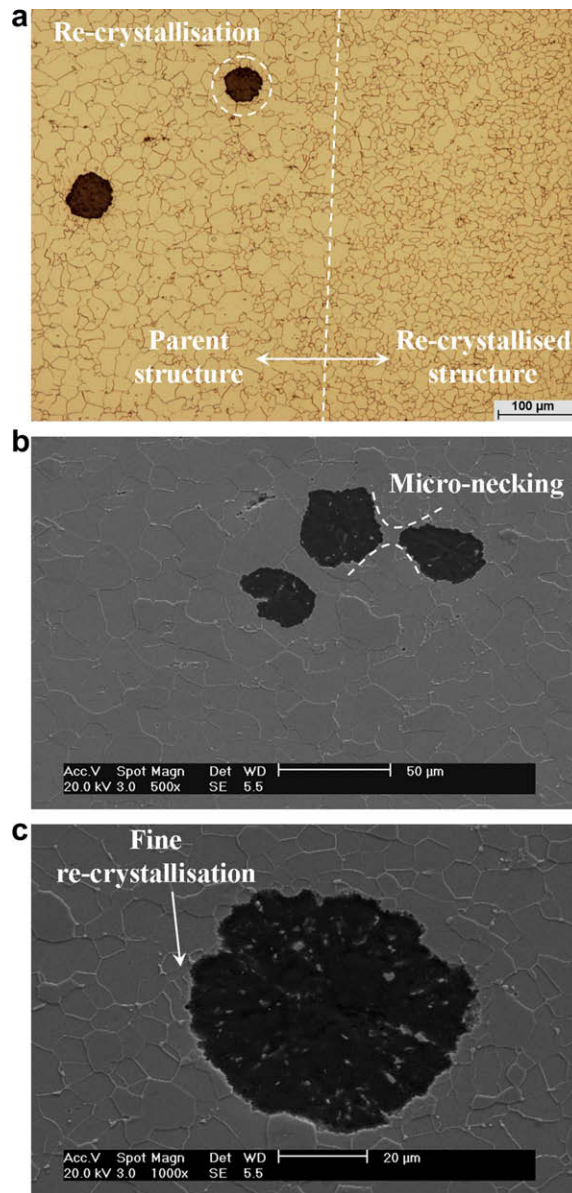
Compared to the area of re-crystallised ferrite, the parent material exhibited large ferrite grains, of almost double the size; and round, trans-granular creep voids with an average diameter of 0.05 mm (Fig. 13a). A close view on this area revealed that the growth and coalescence of creep voids was taking place through micro-necking between two adjacent voids of crucial size (Fig. 13b). Around the voids at this area, a circular zone can be observed with clear evidence of the material dynamic re-crystallisation (Fig. 13a and b), which is attributed to ferrite straining caused during void growth.

Fig. 13. (a) Optical micrograph of the boundary of the re-crystallised/initial structure of the low-alloy steel grade; (b) SEM micrograph of the parent material, indicating micro-necking between adjacent creep void and (c) SEM micrograph of the parent material, indicating fine dynamic re-crystallisation around a creep void.
