# CGRA Architecture

# Innovus - Calibre Mismatch

- There were many issues in recent Tape-out(16nm FinFET) when running Full-Chip DRC
- All these errors couldn't be detected in Innovus
- Examples

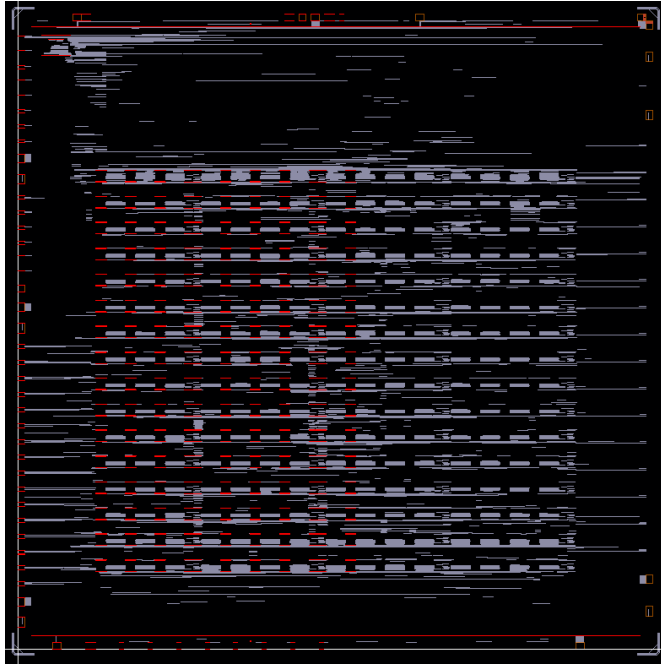
1) *FIN / OD off-grid error ( > # 1M)*

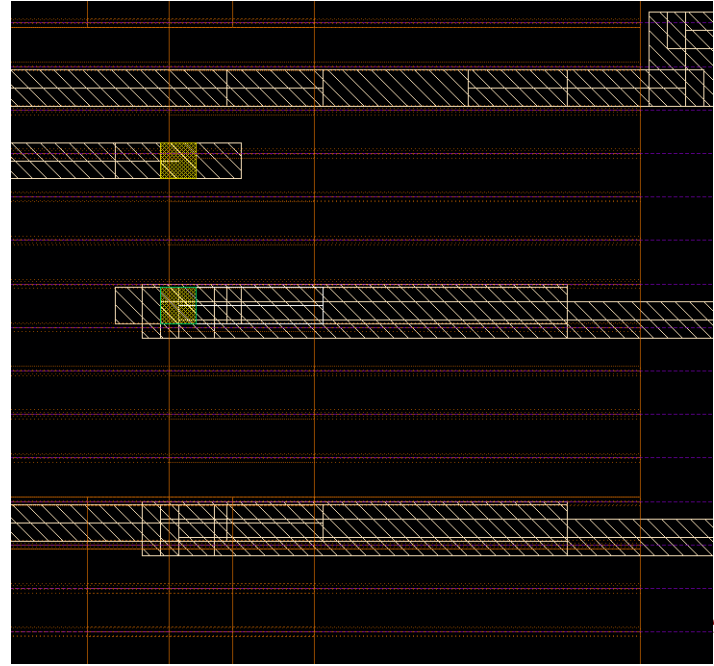
2) *Pin off-grid error ( ~ #100)*

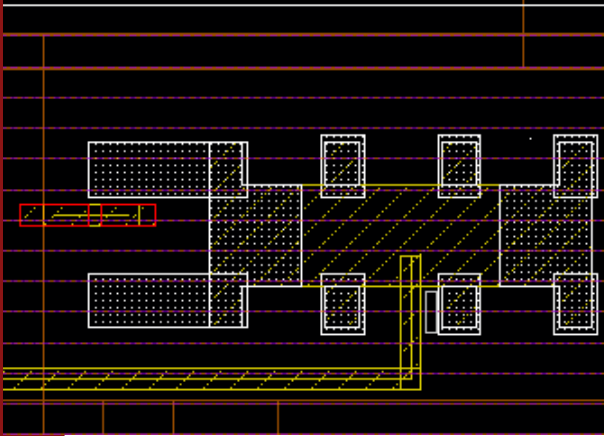
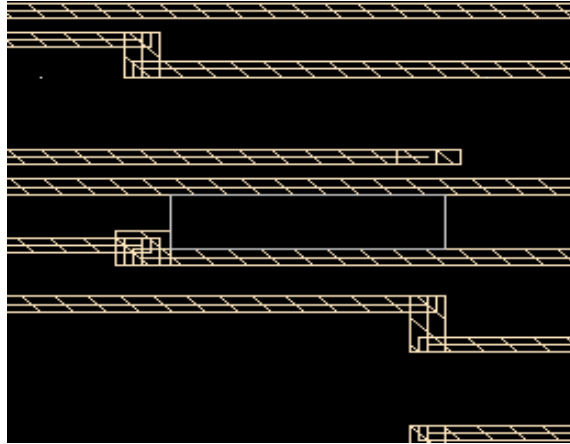
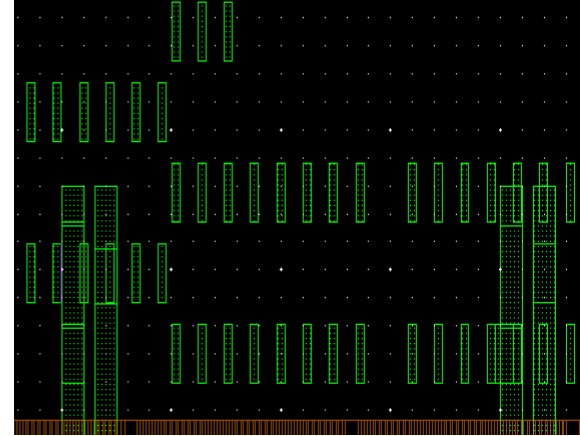
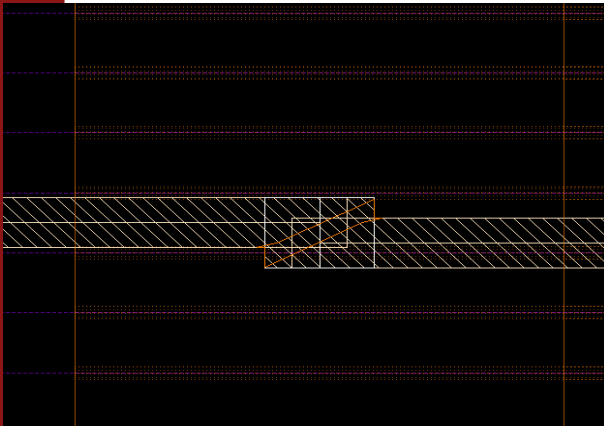
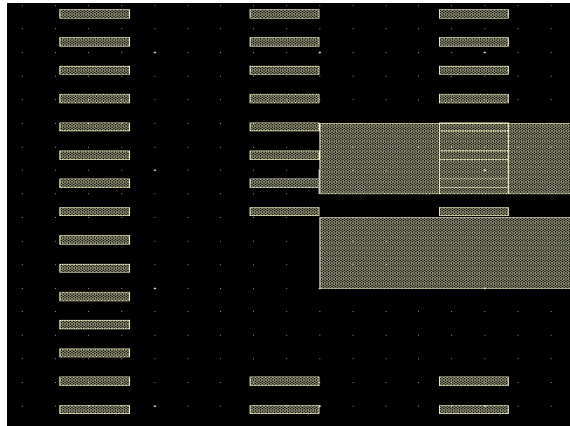
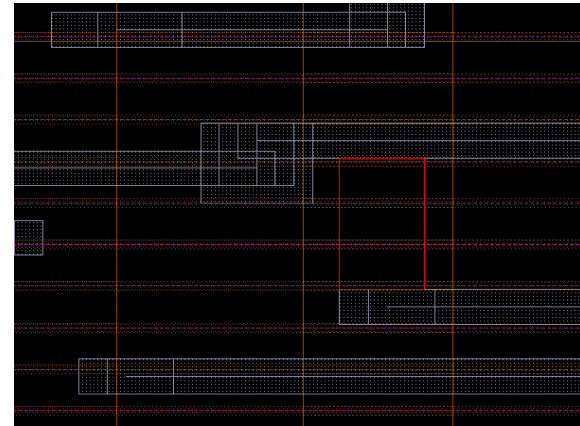
## 3) Metal spacing errors (~ #200)

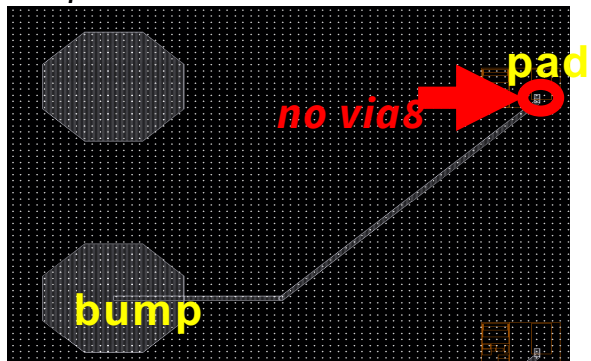
4) Bumps are not connected to PADs (~ #150)

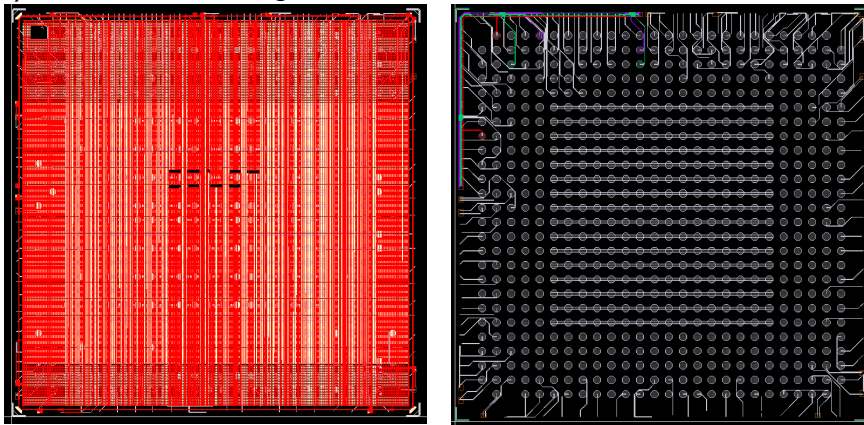
5) Power shortage

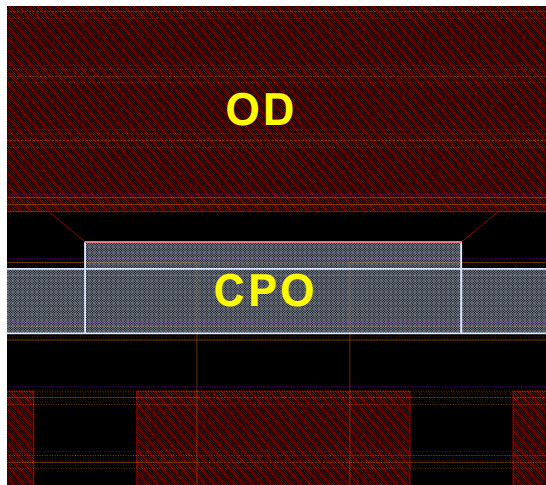
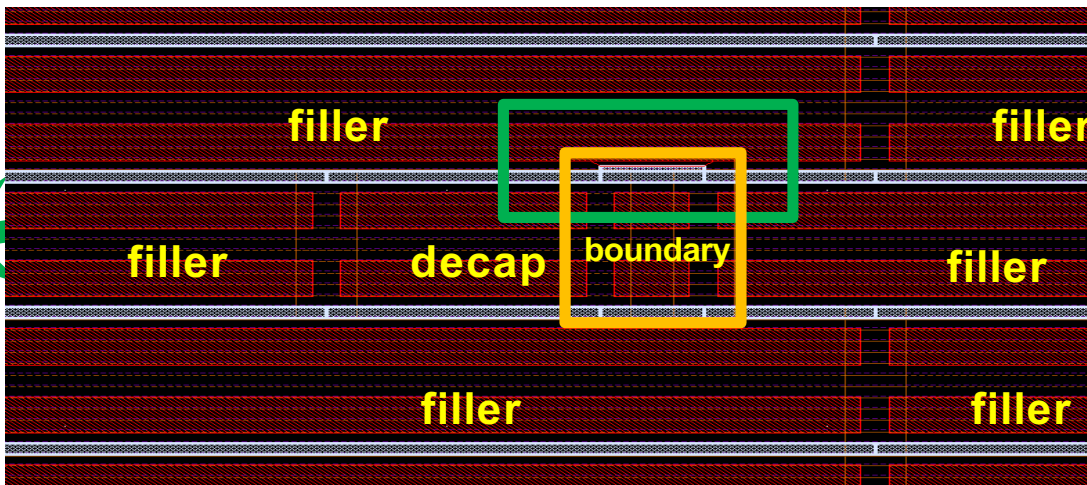
6) Cell misplacements

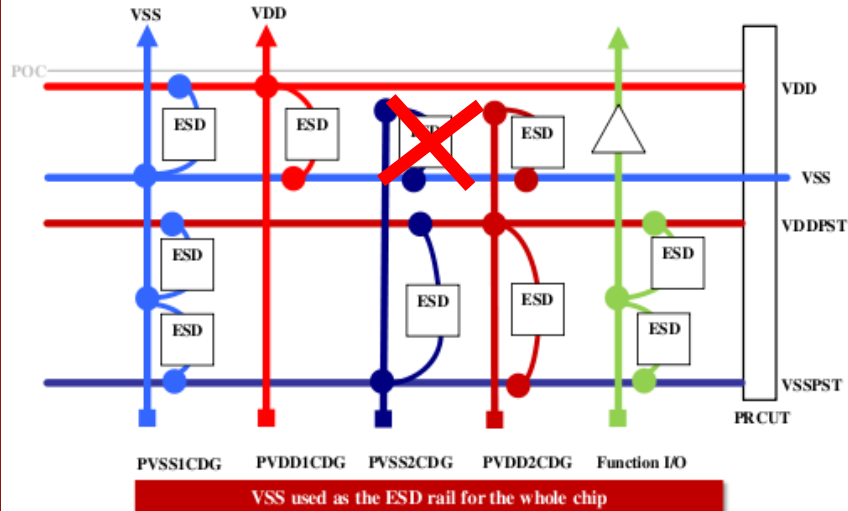
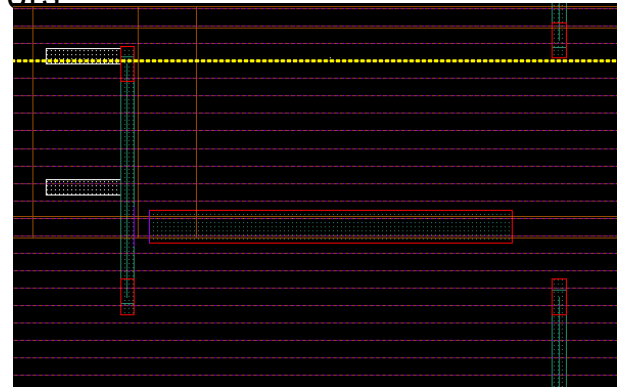
## 7) Voltage dependent metal spacing / ESD (> #300M)

→ Absence of back-to-back diode between two grounds causes **ESD errors** and **voltage dependent metal spacing** errors

- Innovus cannot detect all DRC errors
- More than 3 weeks are taken to fix these errors by manual layout revision
