# Styrofoam™ Brand Insulation: Shrinkage Case Studies

**Analysis of Styrofoam™ Brand Insulation Joint  
Dimensional Stability  
5 Year In-Use Study  
Midland, Michigan Wall Assembly Research Lab**

### Vancouver Housing Complex Vancouver, Canada

### Single-Family Residential Home Midland, Michigan

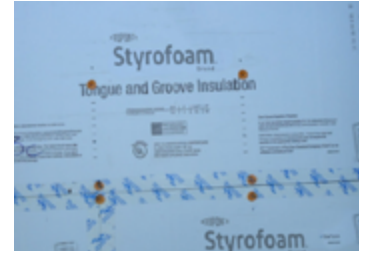
Careful inspection of the before and after assembly photos shows similar spacing. It is clear from these photos that no opening of board joints has occurred during this test exposure period. The construction tape was still strongly adhered to the foam boards with no evidence of loss of adhesion performance through this five year period

Photo 2b  
Aged E Wall Assembly Sept 2015

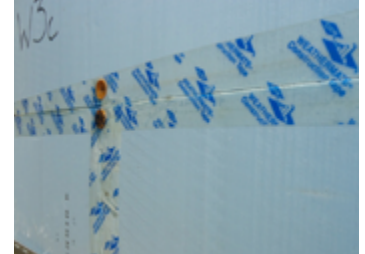
Photo 4b  
Aged W Wall Assembly Sept 2015

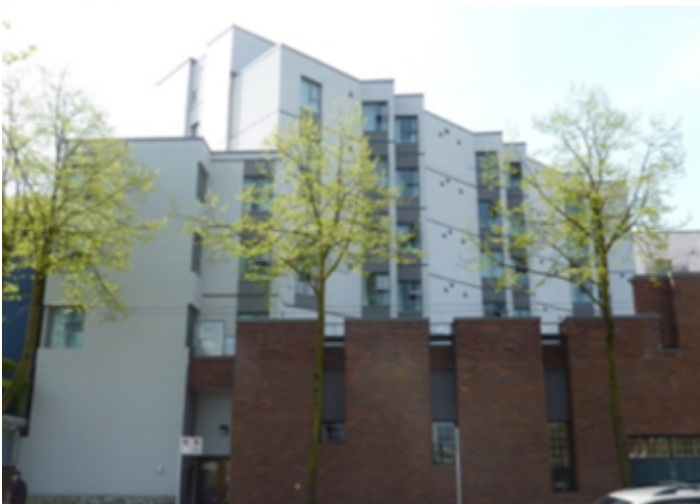
Photo 5a  
North Elevation After Repairs

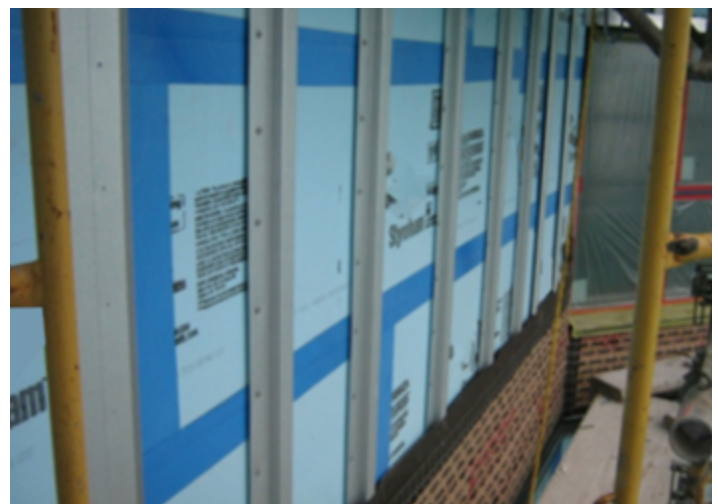
Photo 5b  
Galvalume Z-girts on 3" rigid XPS

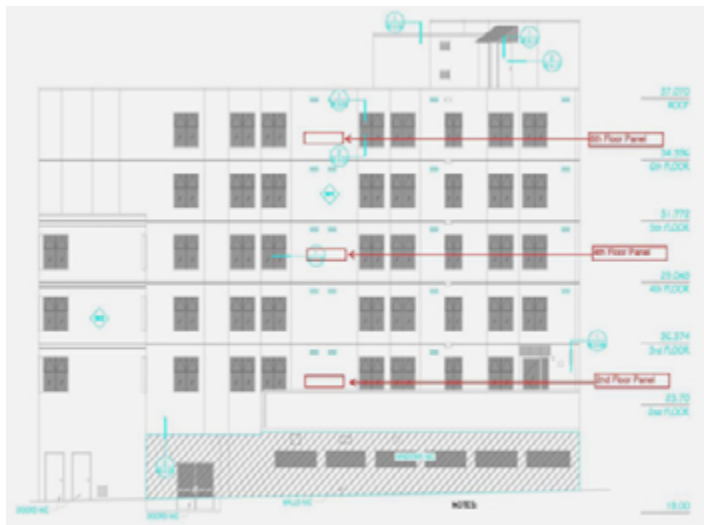
Building position measurements were taken on the south and north façades of the building, with sensors located on the second, fourth and sixth floors. Locations of measurement panels are indicated by the red squares in Figure 1 for the south location. North instruments were similarly located directly across the building.

Figure 1. Measurement Panel Locations (S)

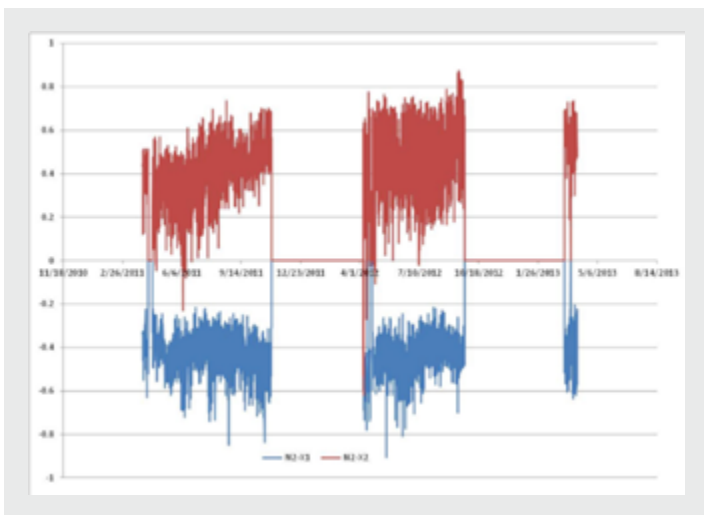
An example of board length movement relative to the building structure reference bracket is shown in Figure 2. Displacement is measured in millimeters. An increasing value for displacement indicates an increase in distance between the sensor and the reference bracket and indicates shrinkage of the board length. Since the X-direction sensors are oriented on opposite ends of the insulation board, both sensor values simultaneously increasing would indicate opposite board ends becoming closer together and the foam insulation board shrinking. These conditions are not observed in the monitored data at any of the six building locations and the maximum movement range is approximately 0.5 mm.

Figure 2. Length move of North elevation 2nd floor foam board

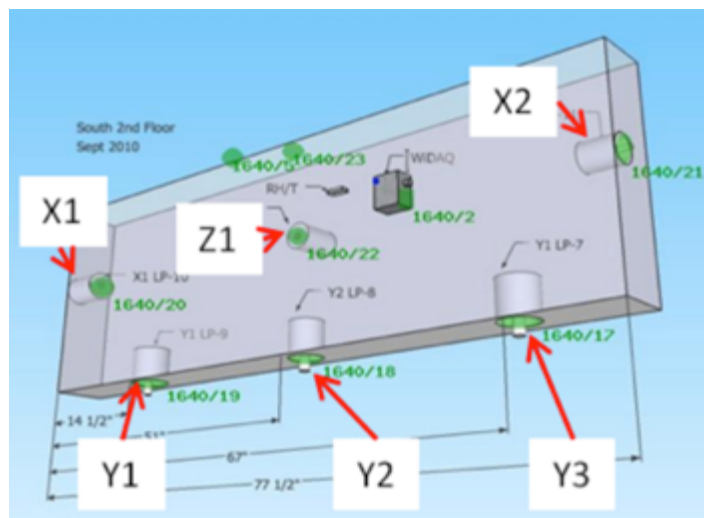
The sensors were installed along foam board joints to monitor foam displacement relative to the structural steel of the building via an external bracket directly attached to the interior steel studs. Sensor locations on an insulation board are shown in Figure 3. This attachment facilitated foam movement relative to the steel structure to be measured. To monitor shrinkage, each panel included two side sensors (X axis). Position data was collected every two hours and transmitted via wireless data acquisition units to the network analysis software.

Figure 3, Sensor locations on foam board

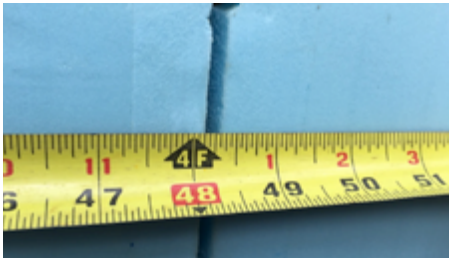
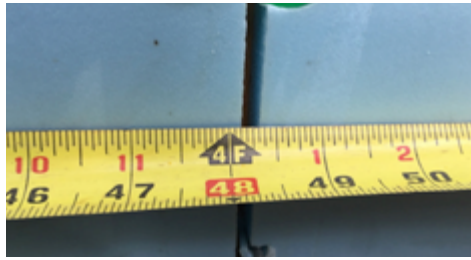
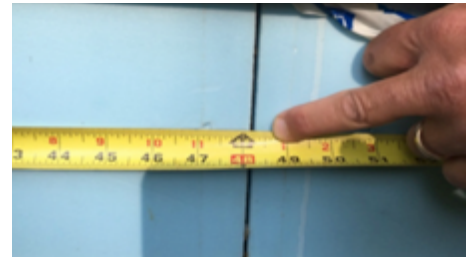
Photos 8 a, b, c show the width dimension of the three exposed boards with intact factory edges. Each measured board is slightly over 48", which indicates that although slight gaps are present that the boards remain at the manufacturing design dimension, in fact slightly wider. The cap nail does not show signs of pull

through or sliding in the foam that could also indicate board movement. Again this is an indication that boards have not shrunk in the width dimension. It can be concluded from the combination of tape condition, lack of fastener drag and current board dimension that board gaps resulted from installation.

Photo 8a, b, c; width dimension measurement of three boards with intact factory edges

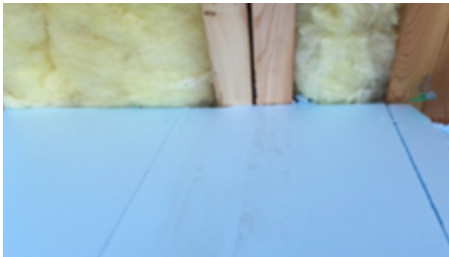
Since no wood sheathing was used in construction of the wall system, it was possible to inspect cavity conditions for signs of deterioration and water intrusion. Photo 9a is of the back side of one removed piece of **Styrofoam™ Brand Insulation** and is found in clean condition with no signs of water anywhere on the board,

Photo 9a, back side of foam

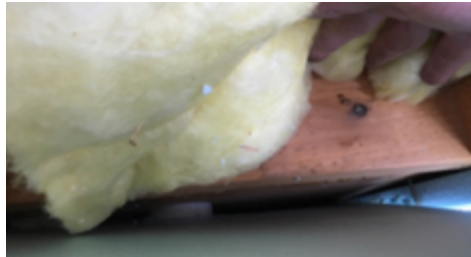
including around fasteners and board edges. Photos 9b and 9c show the conditions within the cavity including the bottom plate and subfloor below the bathtub located at the interior of the inspected cavity. Again, there are no signs of moisture or deterioration in either location.

9b, bottom plate

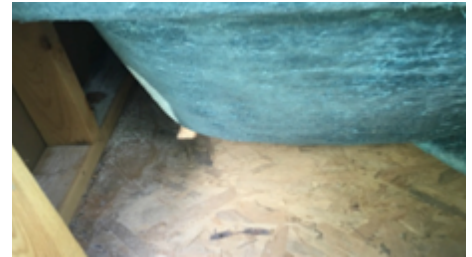
9c, subfloor beyond cavity
