Inspection Report

Order No: #8168127

Date: 23-05-2023

Vehicle State	MH
Vehicle Number	MH05DS2670
Vehicle Make	Maruti suzuki
Vehicle Model	Celerio
Variant	VXI
MFG Year	2018-05-01
REG Year	2018-06-27
Tax Validity	2033-06-26
Colour	Gray
Engine Cubic Capacity	998
Fuel type	Petrol
Owner Serial No	01
Odometer Reading	35382
Accidental Summary	No
Flooded Condition	No
Special Comments	MH05, Actual Colour is Glistening Grey

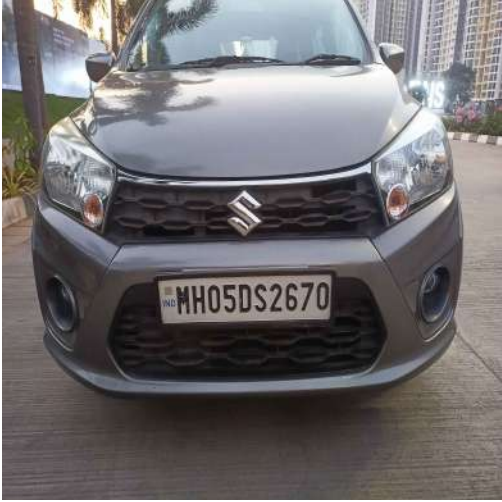
Front Bumper	Bonnet

<p>Original, Minor Scratches</p>

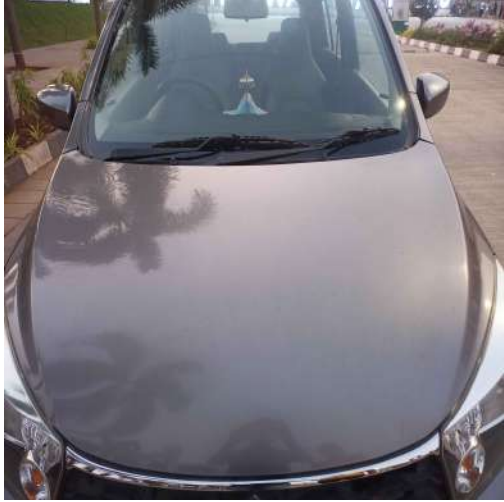
<p>Original, Minor Scratches, Minor Dent</p>
Front Glass	Roof

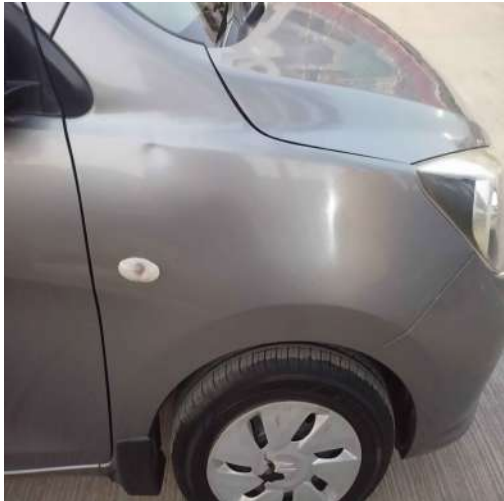
<p>Original, Minor Scratches, Major Dent</p>

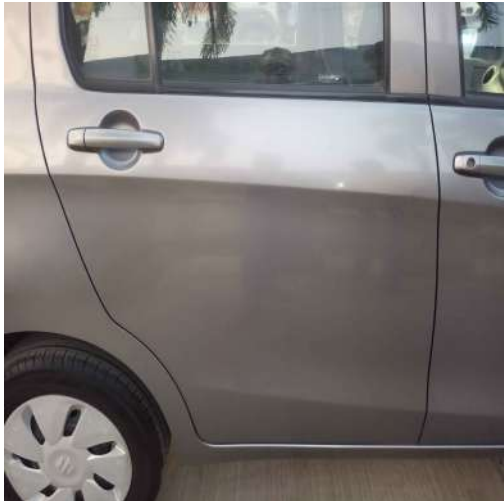
<p>Original, Minor Scratches</p>

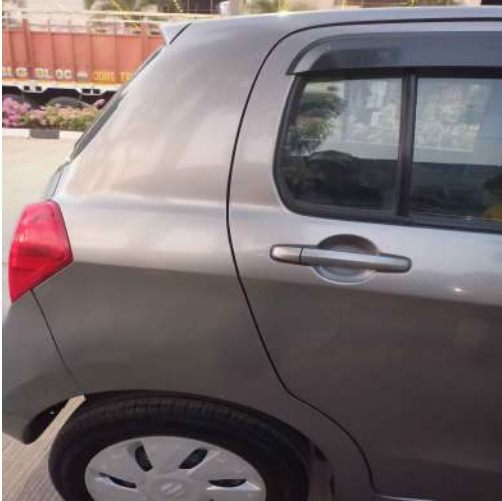
RHS Quater panel

<p>Original, Minor Scratches, Rusted</p>

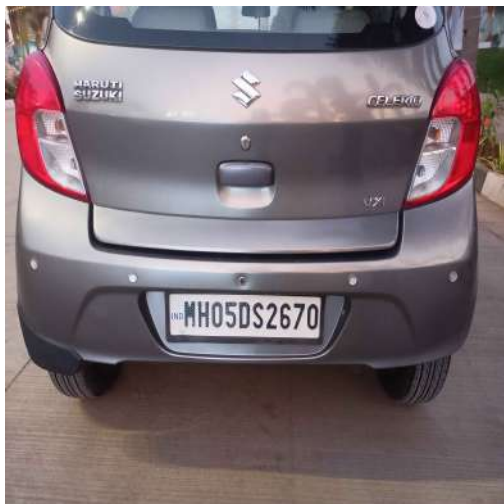
Rear Bumper

Original, Minor Dent, Major Scratches

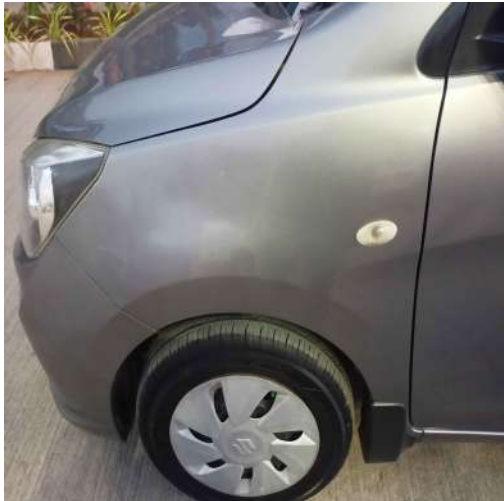
<p>Original, Minor Scratches, Major Dent</p>

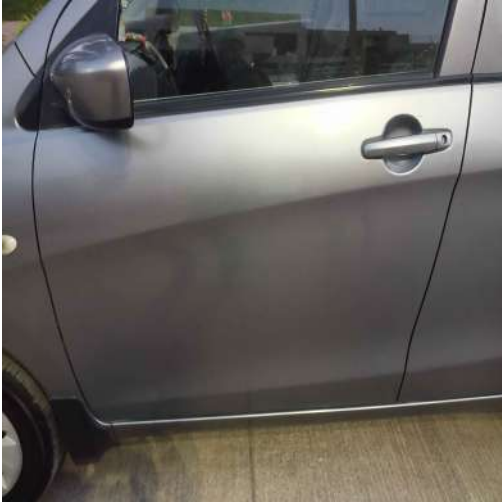
<p data-bbox="164 1612 727 1646">Original, Minor Scratches, Repainted, Rusted</p>

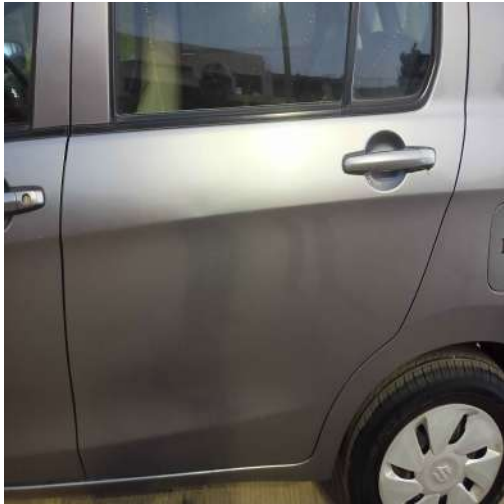
<p data-bbox="914 1628 1382 1662">Original, Minor Scratches, Major Dent</p>

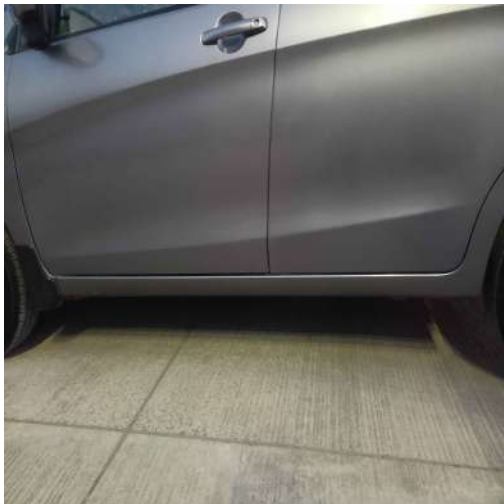
<p>Original, Minor Dent, Major Scratches</p>
C Pillar	Rear LHS Tyre percentage

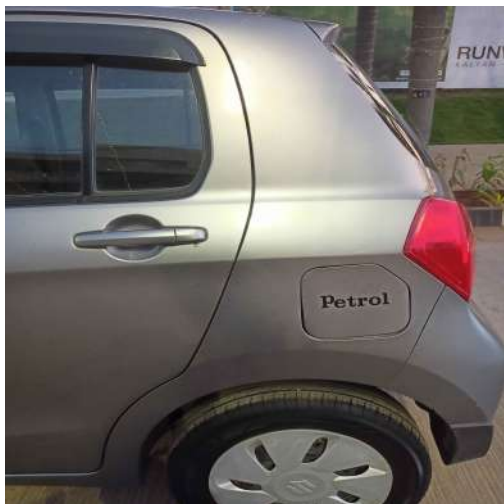
LHS Quater panel

Original, Major Scratches, Major Dent
