# Inspection Report

Order No: #8168127

Date: 18-12-2022

Vehicle State	MH
Vehicle Number	MH05DS2670
Vehicle Make	Maruti suzuki
Vehicle Model	Celerio
Variant	VXI
MFG Year	2018-05-01
REG Year	2018-06-27
Tax Validity	2033-06-26
Colour	Gray
Engine Cubic Capacity	998
Fuel type	Petrol
Owner Serial No	01
Odometer Reading	35382
Accidental Summary	No
Flooded Condition	No
Special Comments	MH05, Actual Colour is Glistening Grey

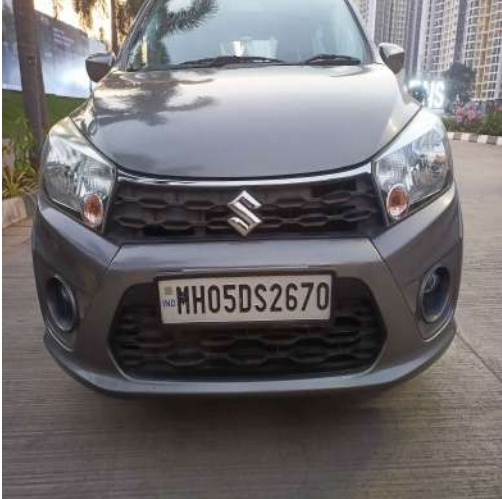
<p>Original, Minor Scratches</p>

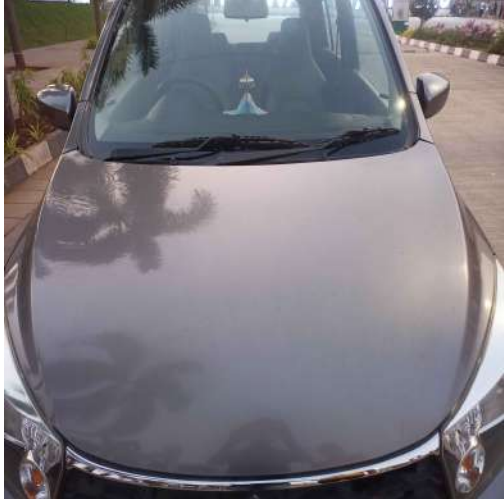
<p>Original, Minor Scratches, Minor Dent</p>
Front Glass	Roof

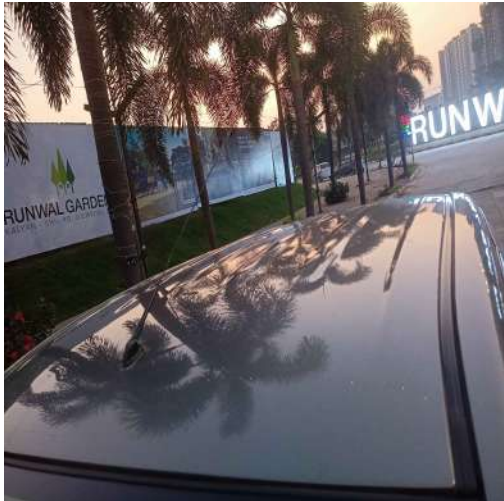
<p>Original, Minor Scratches, Minor Dent</p>

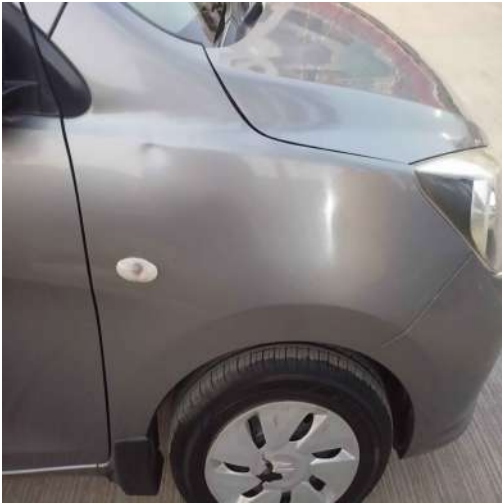
<p>Original, Minor Scratches, Major Dent</p>

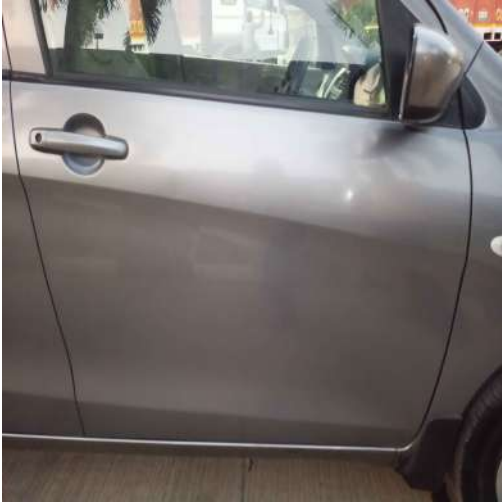
<p data-bbox="284 1612 603 1646">Original, Minor Scratches</p>

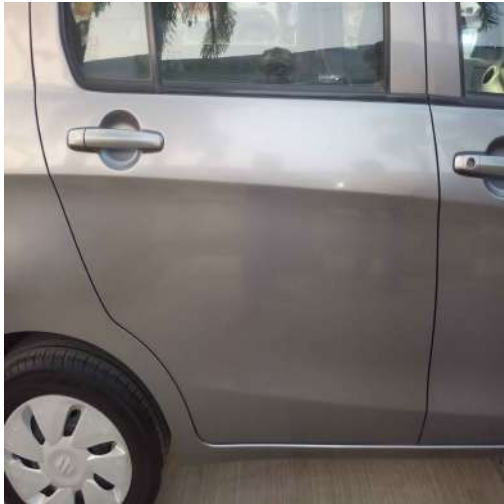
<p data-bbox="987 1628 1307 1662">Original, Minor Scratches</p>

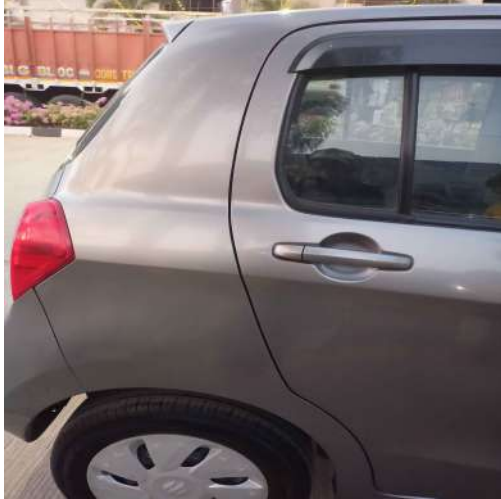
## RHS Quater panel

**Original, Minor Scratches, Rusted**

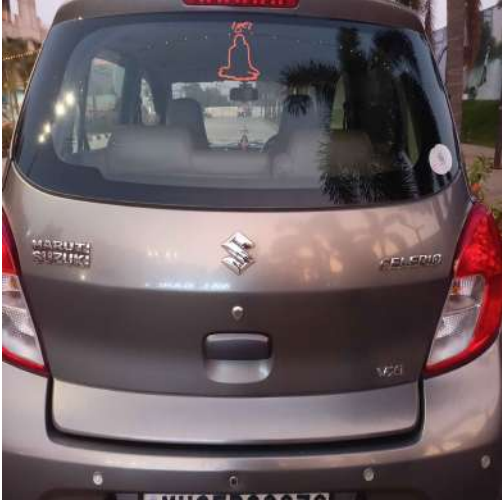
<p>Original, Major Scratches, Minor Dent</p>

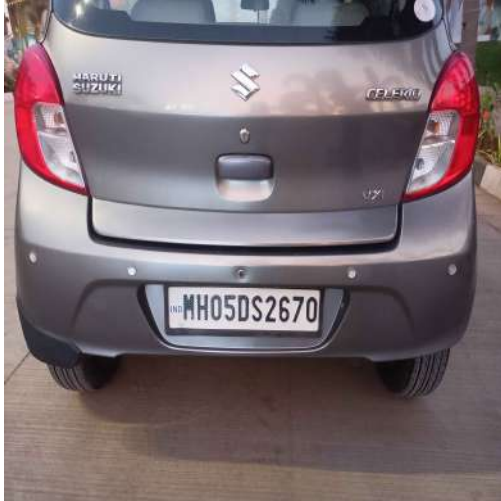
## Rear Bumper

**Original, Minor Dent, Major Scratches**

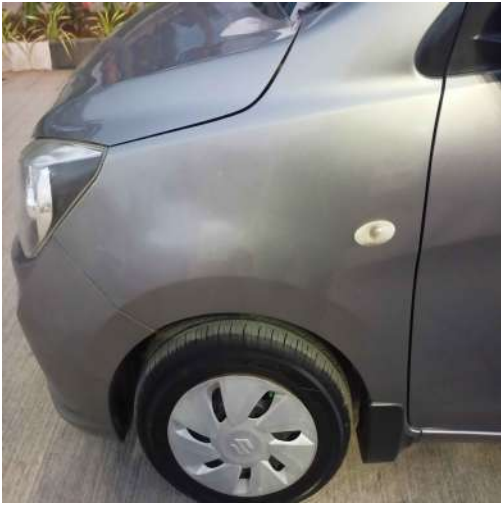
<p>Original, Minor Scratches, Major Dent</p>

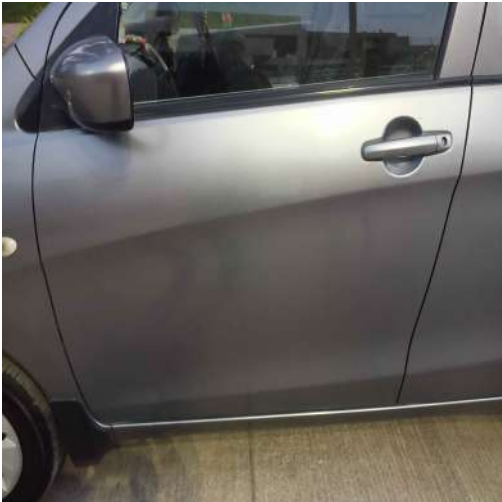
<p data-bbox="164 1612 727 1646">Original, Minor Scratches, Repainted, Rusted</p>

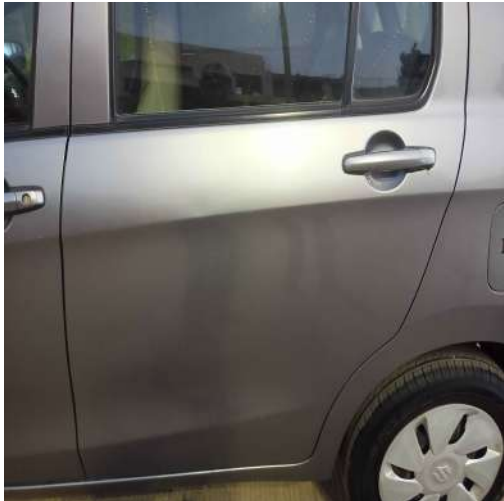
<p data-bbox="914 1628 1382 1662">Original, Minor Scratches, Major Dent</p>

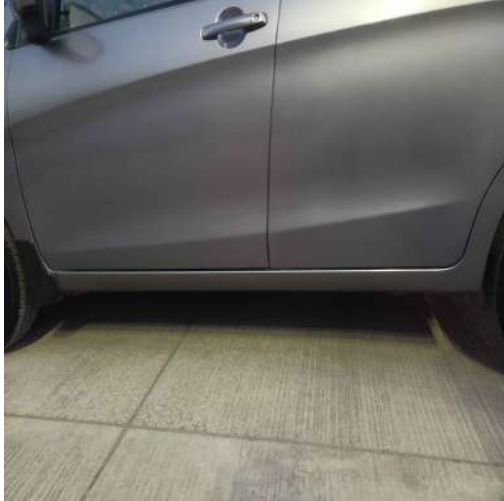
<p>Original, Minor Dent, Major Scratches</p>
C Pillar	Rear LHS Tyre percentage

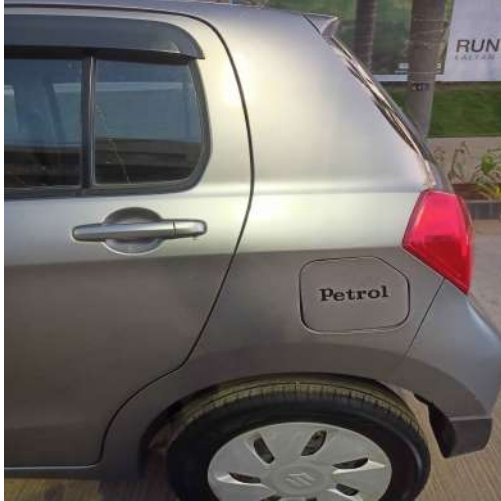
## LHS Quater panel

**Original, Major Scratches, Major Dent**

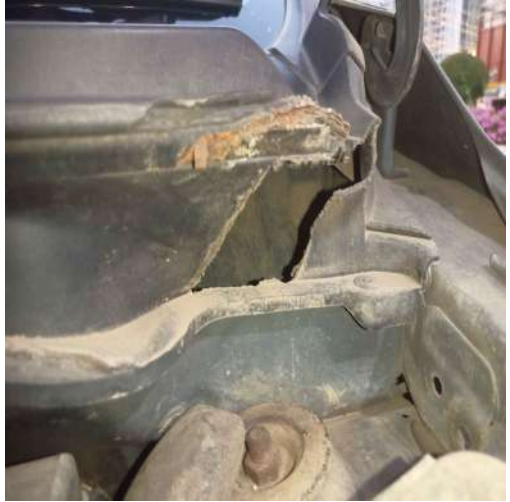
Comment 1	Photo
Cowl panel Grill broken
