# Analysis of Cracking Causes in an Aluminium Alloy Bike Frame

## ABSTRACT

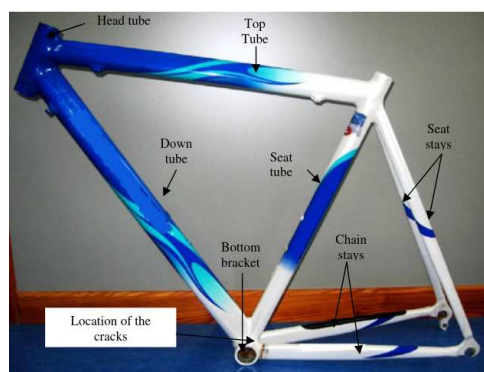
Fig 1. The bicycle being studied

Fig. 1 shows the bike frame and the location of the cracks, while Fig. 2 shows a detail of both cracks. It can be seen how the chain stays, the seat tube and the down tube are welded to the bottom bracket, generating a complex

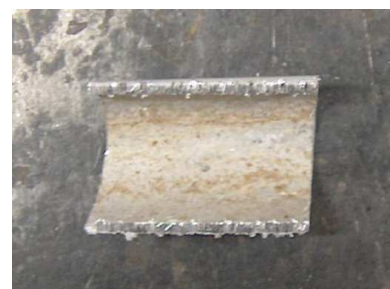
Fig 2. This is a section

In Fig. 2, some indications of corrosion can be noticed in the interior of the bottom bracket and also in the vicinity of the cracks, in which the cyclist had performed a manual sanding, depriving these zones of the paint-layer. Fig. 3 presents the cracked section containing Crack 1,<sup>[3]</sup> which is the largest one. The extension of the crack and its approximate geometry can be observed here.

As mentioned above, Fig. 2 shows indications of corrosion in the interior of the bottom bracket and also in the vicinity of the two detected cracks. In order to establish the extension of the corrosion processes occurring in the bike frame, several cuts were performed on it. Fig. 4 shows the inner part of the joint between the bottom bracket, the seat tube and the downtube, with a widespread, clear and extended corrosion process occurring in the entire internal surface.<sup>[5]</sup>

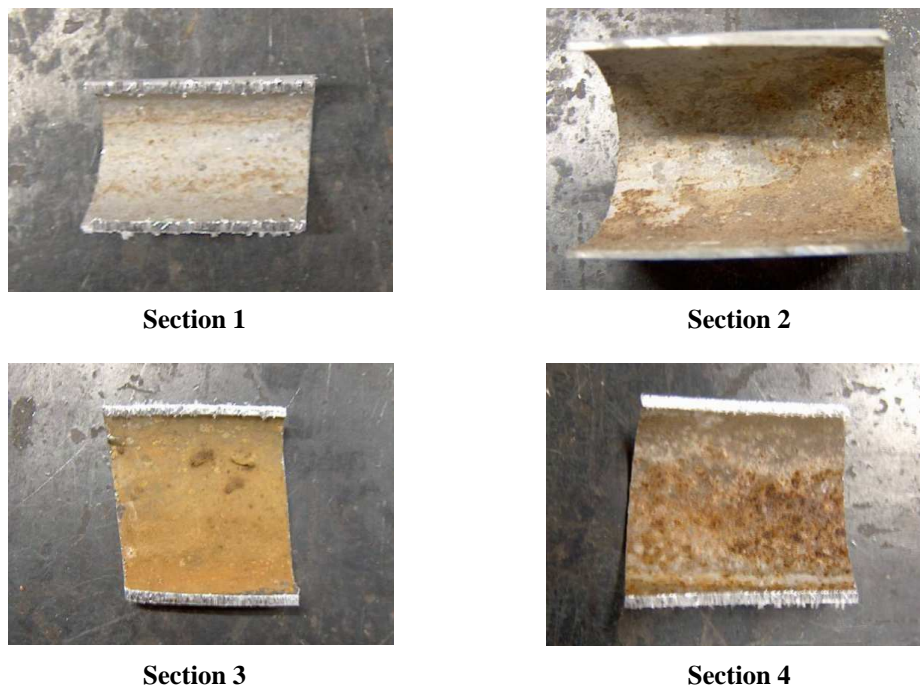
The rest of the cuts performed on the bike frame also revealed corrosion processes occurring all along the interior of the frame, in such a way that the closer to the bottom bracket, the more extended the corrosion process. Fig. 5 shows the corrosion level found in some of the locations. Likewise, Fig. 6 shows a hole found in the lower part of the bottom bracket. This hole provides an immediate access for the air, the water and the dirt to the interior of the tubes which, as shown in Fig. 4, were connected through additional internal holes. The hole shown in Fig. 6 explains the images shown in Fig. 5, given that the extension of the corrosion processes occurring on the different tubes depends on their corresponding proximity to the hole (that is, to the external environment).

**Fig. 3** Corrosion levels found in different tubes
