Analysis of Cracking Causes in an Aluminium Alloy Bike Frame

The contents of this paper are only used as a demonstration of the GNU troff typesetting system. Two cracks were detected in the bike frame of an amateur cyclist, before the final failure of the component and after using it for around 35,000 km. The cracks were located in the joint between the bottom bracket, the chain stays, the seat tube and the down tube.^[1]

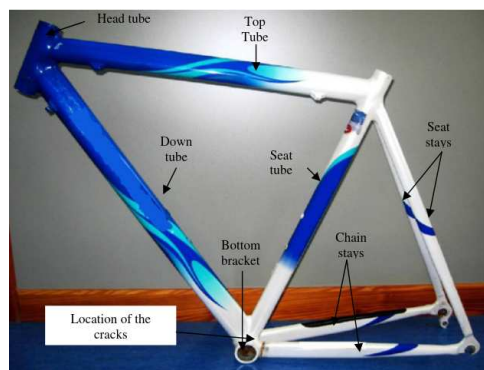
Fig 1. The bicycle being studied

Fig. 1 shows the bike frame and the location of the cracks, while Fig. 2 shows a detail of both cracks. It can be seen how the chain stays, the seat tube and the down tube are welded to the bottom bracket, generating a complex

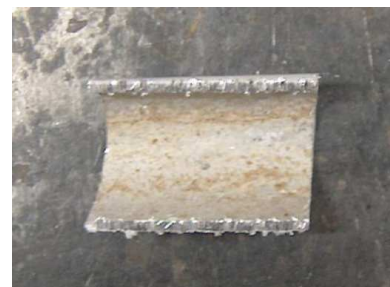
Fig 2. This is a section

In Fig. 2, some indications of corrosion can be noticed in the interior of the bottom bracket and also in the vicinity of the cracks, in which the cyclist had performed a manual sanding, depriving these zones of the paint layer. Fig. 3 presents the cracked section containing Crack 1,^[3] which is the largest one. The extension of the crack and its approximate geometry can be observed here.

As mentioned above, Fig. 2 shows indications of corrosion in the interior of the bottom bracket and also in the vicinity of the two detected cracks. In order to establish the extension of the corrosion processes occurring in the bike frame, several cuts were performed on it. Fig. 4 shows the inner part of the joint between the bottom bracket, the seat tube and the downtube, with a widespread, clear and extended corrosion process occurring in the entire internal surface.^[5]
