**BOILER TUBE FAILURE ANALYSIS IN
210MW SUBCRITICAL BOILER**

AT MTPS 1

A PROJECT REPORT

MARCH 2020

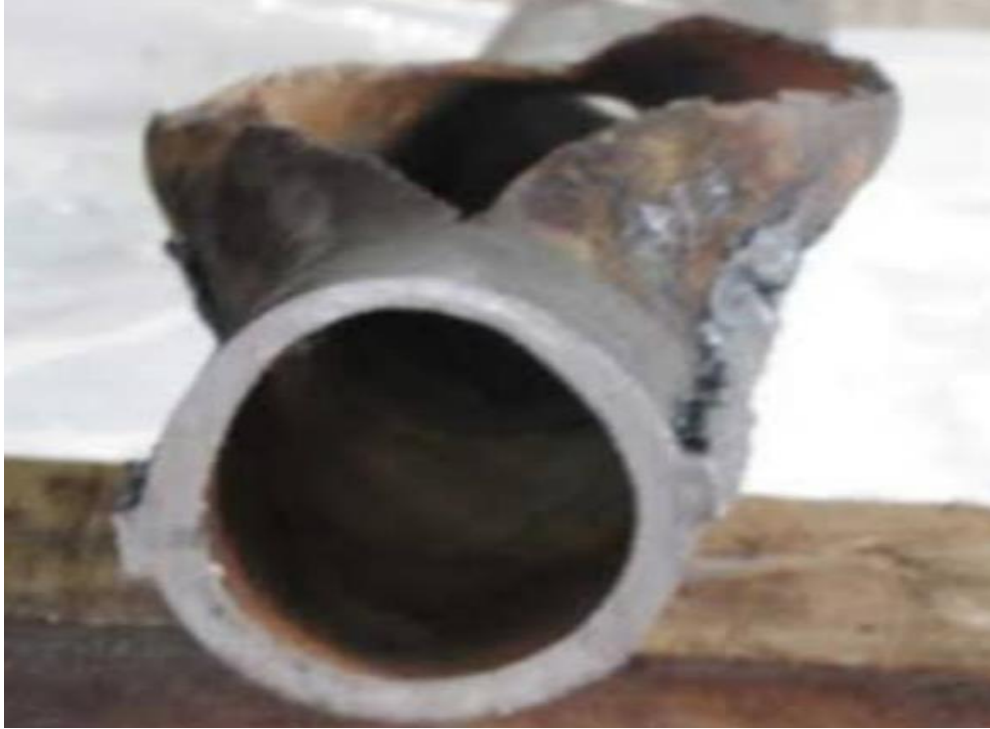
Fig 6.1 short term over heating

Short term overheating can occur if temperature of pressure part (tube, drum, pipe and header) increases rapidly in short period exceeding limitation of design temperature. It can occur at the pressure part which has high operating temperature such as superheated, water wall, roof wall, boiler bank, screen tubes and down comes and rarely occur in low operating temperature of pressure part such as air heater and economizer. When the tubes have insufficient cooling from inside and excessive heat input from combustion process will lead to short term overheating. Figure 6.1 shows the failure of boilers due to short term overheating.

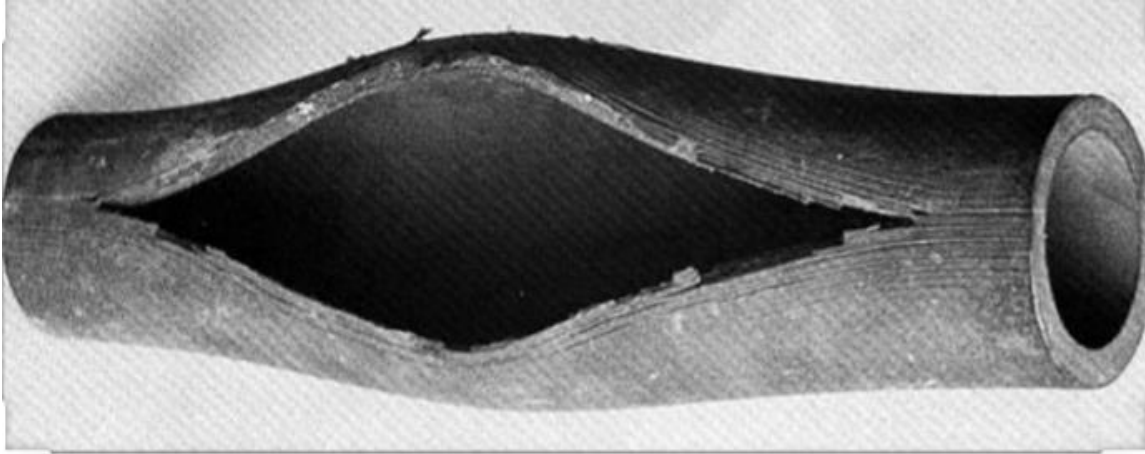
Figure 6.2 long term over heating

Long term overheating tube failures are due to operating metal temperature of the boiler tubes going above the allowable limit. These types of failure are soon in steam cooled tubes like super heater and re-heater and in water tubes of water wall. While selecting the tube there is requirement to select the correct material for withstanding the metal temperature. Normally the water cooled areas likes economizer and water walls are made of carbon steel of boiler quality. Super heaters and re-heater will have combination of low alloy tubes to stainless steel tubes selected to withstand the metal temperature. Figure 6.2 show the failure of boilers tube due to long term overheating.

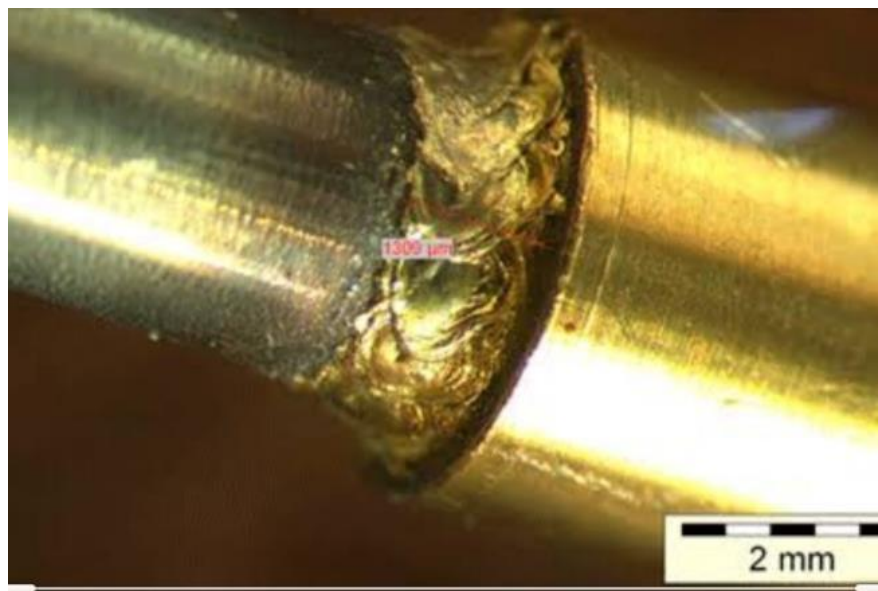
Figure 6.3 Dissimilar metal welding

In the mettur thermal plant station, dissimilar metals welds (DMWS) are used join ferrite low-alloy steels to austenitic stainless steel. Unfortunately, these welds can fail prematurely from austenitic steel to ferrite could replace the one dissimilar weld with two similar welds. Figure 6.3 show the dissimilar welding metals.

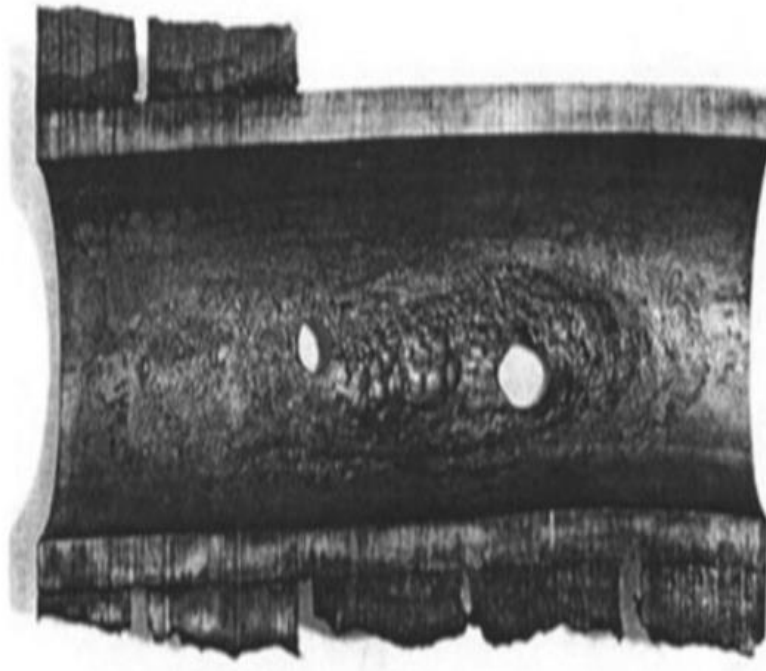
Figure 6.4 Caustic corrosion

Caustic corrosion, a specific form of stress corrosion, results in the inter crystalline cracking of steel. Inter crystalline cracking result only when all of them following are present: specific condition stress, a mechanism for concentration such as leakage, and free NaOH(sodium hydroxide) in the boiler water. There, boiler tubes usually fail, from caustic embrittlement at point where tubes are into sheets, drum or header. Figure 6.4 refers the caustic corrosion in boiler tube.

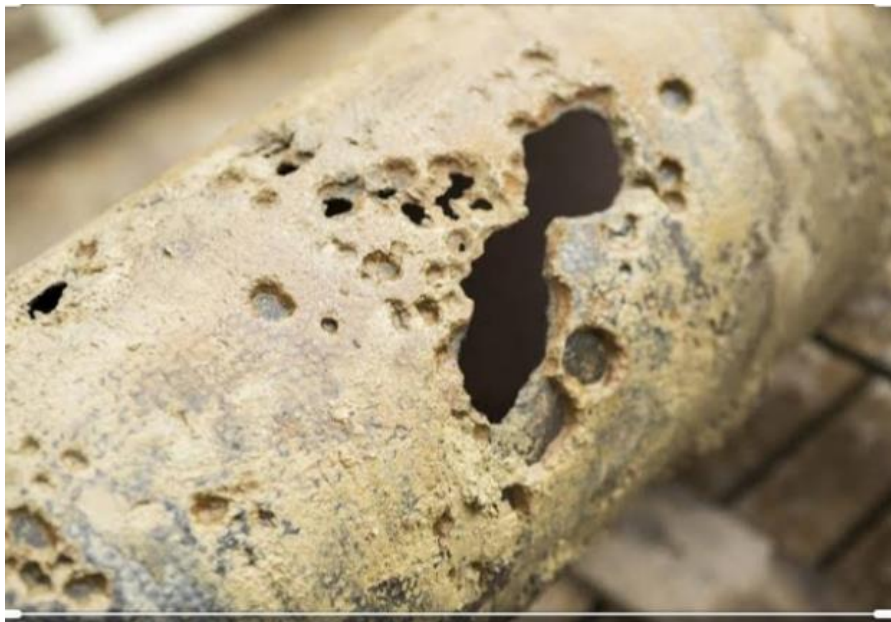
Figure 6.5 Pitting corrosion

Pitting corrosion is a form of extremely localized corrosion that leads to the creation of small holes in the metal. The driving power for pitting corrosion is the depassivation of a small area, which becomes anodic while an unknown but potentially vast area becomes cathode; leading to very localized galvanic corrosion. The corrosion penetrates of the metal, with limited diffusion of ions. Figure 6.5 refers the pitting corrosion made in boiler tubes.

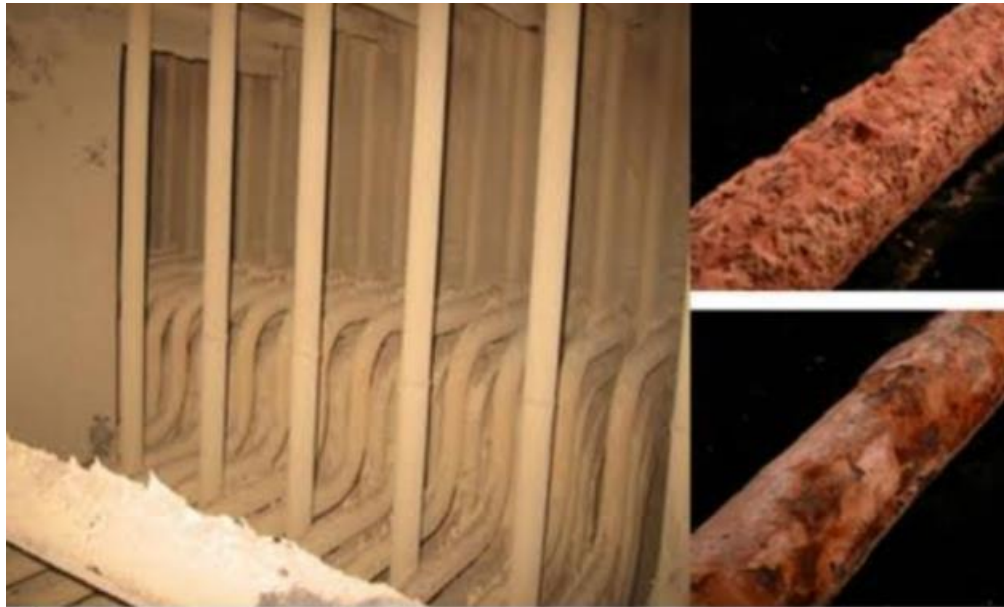
Fig 6.6 High temperature corrosion

High temperature corrosion is a mechanism of corrosion taking place in boiler tube coming in contact with hot gas containing contaminations. Flue contains sometime vanadium compounds or sulfur which can form compounds during combustion having a low melting point.

These liquid melted salt are strongly corrosive for stainless steel and other normally inert against the corrosion and high temperature. Other high temperature

corrosion includes high temperature oxidation, and carbonization. Figure 6.6 refers the high temperature corrosion.
