Service Bulletin

Revised Information: Release of DX-D 100 / DX-D 100 Wireless System Version 4.3.10

DD+DIS184.13E

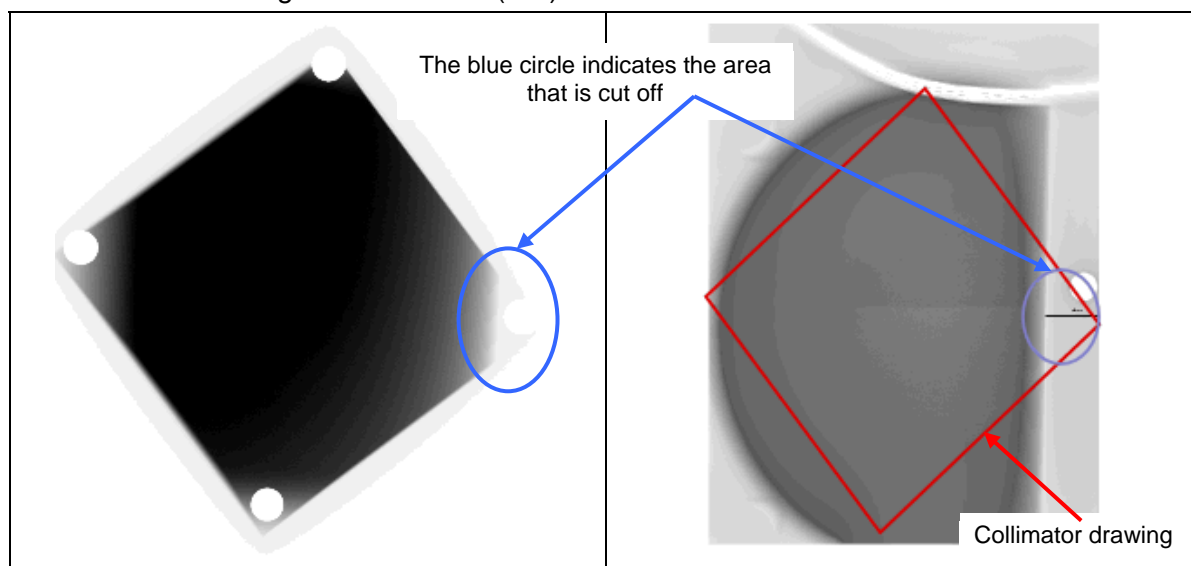
Figure 1

Symptom When Source Image Distance (SID) is short and collimator rotated by approx. 45° the light field does not match up with X-ray field. Part of Field of View (FOV) is not exposed (see Figure 1).

The issue appears when the user wants to use SID smaller than 100 cm.
The reason is the angle of the anode (12°).

Cause This is due to the limitations, specifications and performances of the X-ray tube.

Solution It is not possible to solve the issue when using the same tube with SID 100 cm.
Advice the user to use an SID higher than 100 cm.

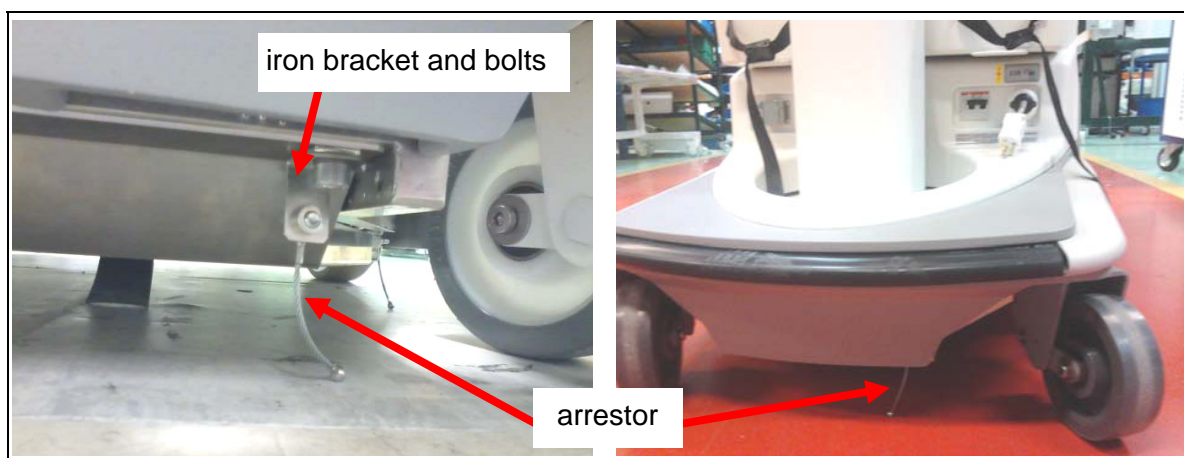
Figure 3

To improve the electrostatic discharge the current strap for discharging the equipment can be replaced by a metallic arrestor, fixed with an iron bracket and bolts.

- (1) Order the Arrestor Strap Kit. Refer to section 2.
- (2) Mount the arrestor at the front side by the means of the iron bracket and bolts.

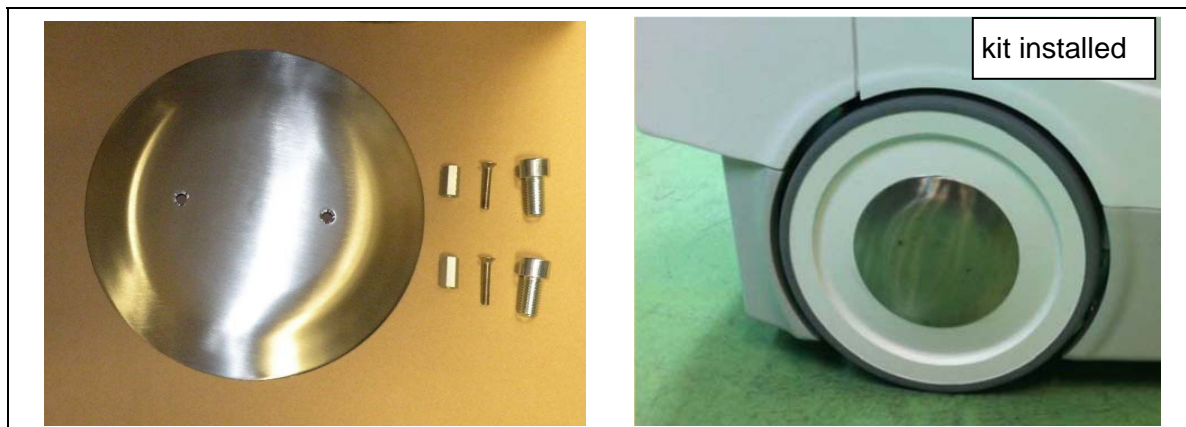
Figure 4

FR1302280012	Paint coming off the wheels. Solved in production by installing stainless steel hubs at the wheels. A service kit for retrofitting is available.

- (1) Order Hubcap kit(s). Refer to section 2.
One kit consists of **one** hubcap and the hardware needed for installing.
- (2) Mount the stainless steel hubs at the rear wheels. The installation instruction is part of the delivery.

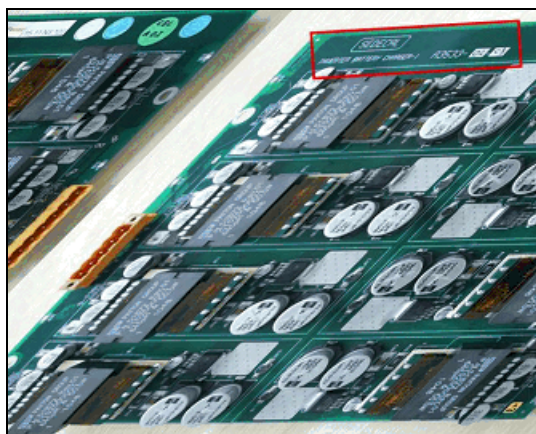
- Issues like short circuit or smoke at the boards during charging the batteries.
- DX-D 100 wireless with serial number lower than A5411000302
- Boards serial number revision is below E. The revision of the charger boards can be identified on the boards itself (see figures below).

Figure 5: Old revision Inverter Battery Charger 1
A3533-04

Replacing battery charger boards is described in the DX-D 100 / DX-D 100 Wireless - Mobile X-Ray Unit - Service Manual in section “Troubleshooting”, chapter “Batteries and Chargers”. The document is available in the Agfa Healthcare Library:

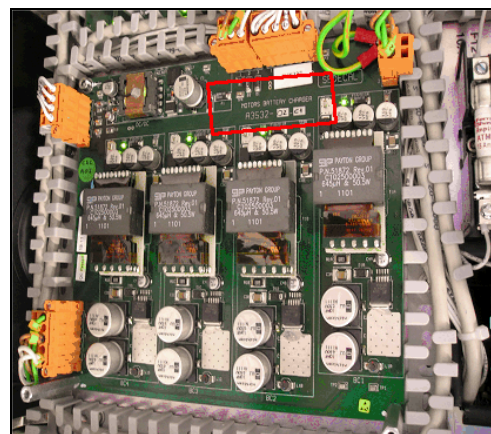
Figure 6: Old revision Inverter Motor Battery Charger
A3532-04

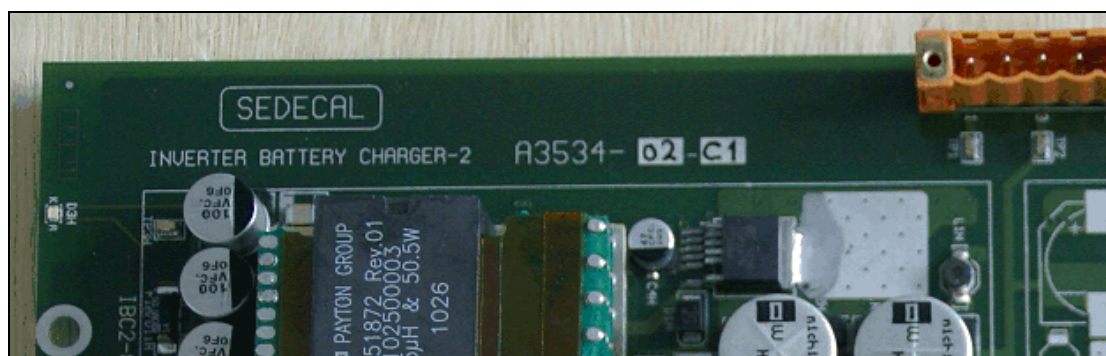
Figure 7: Old revision Inverter Battery Charger 2 A3534-04
