## Service Bulletin

### Introduction of new Generator ATP Software v7R1b78

<b>Title:</b>	DX-D 100 - Service Bulletin No. 63 - Introduction of new Generator ATP Software v7R1b78
<b>Livelink ID:</b>	47923613
<b>Version#:</b>	6
<b>Version Date:</b>	2014-12-17 04:40 PM CET
<b>Status:</b>	Approved on 2015-02-10 12:32 PM CET
<b>Owner:</b>	Annette Peters (awtso)
<b>Created By:</b>	Annette Peters (awtso)
<b>Created Date:</b>	2014-12-04 04:09 PM CET
<b>PDF Creation Date:</b>	2015-02-10 12:32 PM CET

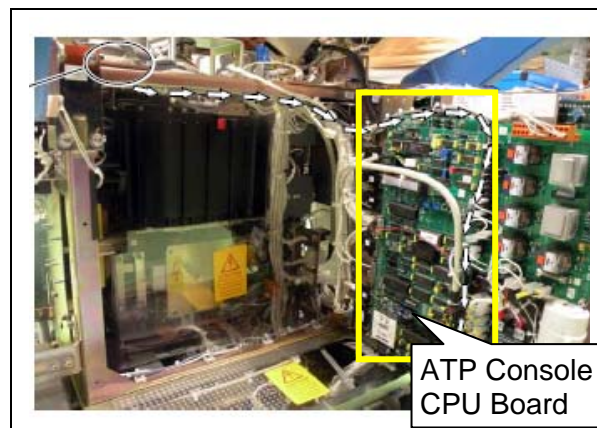
Figure 6

*Cause* This issue is related to the generator firmware. This problem occurs during communication between the HT Controller and the ATP Console.

- (1) Remove the front cover.
- (2) Open the generator module front door by removing the two Allen screws. The ATP console CPU board is placed at the generator module front door.
- (3) Remove the U24 EPROM on the ATP Console CPU with a chip extractor.
- (4) Mount the new U24 EPROM with software version v7R1b78.
