## Service Bulletin

### Improved fixation of telescopic arm introduced with DX-D 100 / 100 Wireless system version 4.6.05

DX-D 100 / DX-D 100 Wireless

Type 5410 / 5411

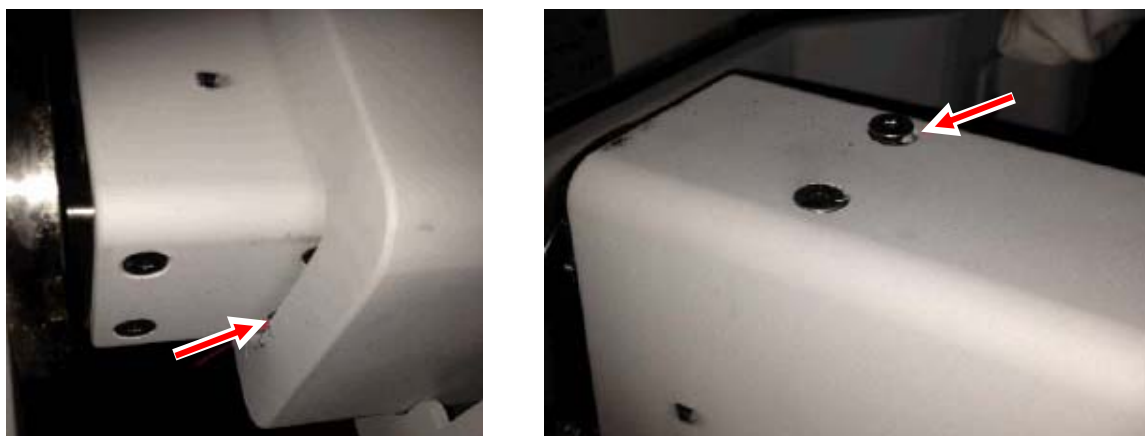
Figure 1

Telescopic arm getting stuck close to the tube head.

*Cause* Loose bolt in telescopic arm close to the tube head.

*Solution* As of production the quality of the screws has been improved. Also, the angle of the countersink holes in the arm was already modified in order to have a bigger contact surface between the screw head and the hole.
