DR 400	Type 5520	SB No. 55
DR 600	Type 5530	SB No. 70
DX-D 100	Type 5410	SB No. 98
DX-D 300	Type 8207	SB No. 102
DX-D 400	Type 5420	SB No. 72
DX-D 500	Type 8206	SB No. 57
DX-D 600	Type 5430	SB No. 113
DR Retrofit	Type 5400	SB No. 63

Service Bulletin

**2nd revised version: Update instructions moved to Detector Service Manual
DX-D 10/20/Fixed detector software VRN 7.5 and Intel I210-T1
network card introduced**

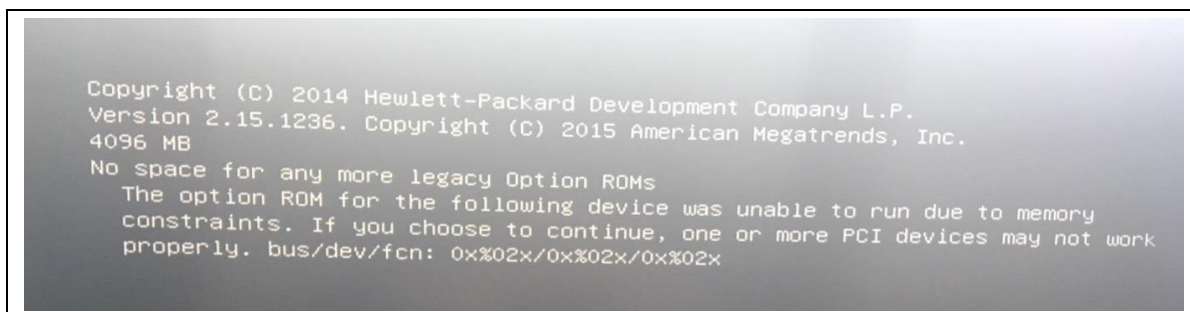
Figure 1

BIOS issue When plugging multiple Intel® I210-T1 network cards in a HP rp5810, the following BIOS message appears.

Solution This can be solved by a BIOS settings adaptation. For details refer to DX-D 10 / DX-D 20 / DX-D Fixed Detector - Service Manual, Document ID [41222172](#), section *Troubleshooting*.
