Document ID: 79985325

## Service Bulletin

### NX 23.00 SU2 available to solve XD Detector grid line issues

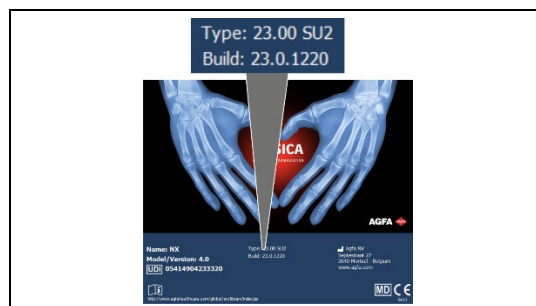
Figure 1

After the NX 23.00 SU2 update, the NX shows **Type 23.00 SU2** and **Build 23.0.1220**.
