## Service Bulletin

### Announcement of Update to System Version 9.0 (bug fixes)

Release date: 02-2017

DX-D 100 / DX-D 100 Wireless

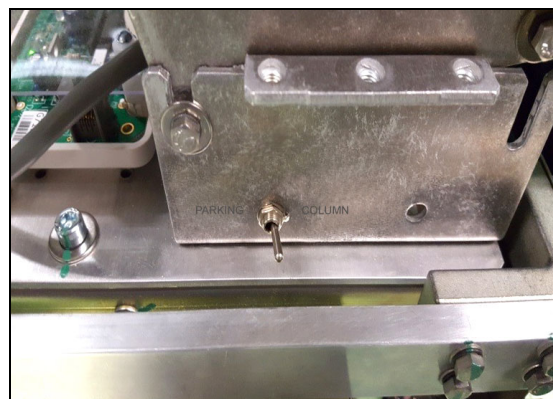
Figure 1

In hospitals with very narrow rooms it might be needed to make exposures with the arm at 0°.

The micro-switch already present at the parking latch is going to be also used to allow making exposures with the arm at 0°, when the arm is out of parking position.

This switch is called X-Ray inhibition switch (SW8) and is implemented ex factory as from DX-D 100 / 100 Wireless V 9.0. It is not possible to upgrade the switch in the field.

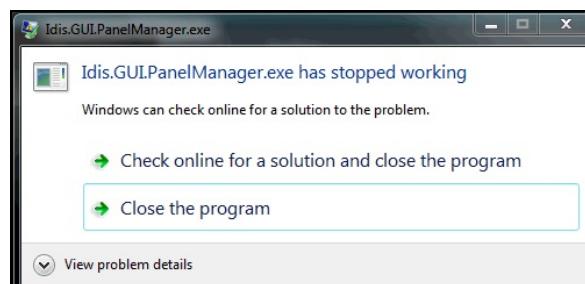
Figure 2

*Symptom* Very sporadically following error message appears in the NX user interface: “Idis.GUI.PanelManager.exe has stopped working”.  
The issue may appear with any XRDl version where the detector switch (“Multi Panel GUI”) is available.  
When clicking “Close the program” the user can continue working.

*Cause* Software issue in all XRDl version where the detector switch (“Multi Panel GUI”) is available (MPG introduced with XRDl 14).

*Solution* In XRDl 18.1 the issue is solved.
