DX-D 100	Type 5410	SB No. 90
DX-D 100 Wireless	Type 5411	SB No. 94
DX-D 300	Type 8207	SB No. 83
DX-D 400	Type 5420	SB No. 54
DX-D 600	Type 5430	SB No. 92
DX-D 800	Type 5440	SB No. 25

DD+DIS178.16E

Service Bulletin

Increasing the lifetime of Power LED on RALCO Collimators and avoiding stripes in Collimator light

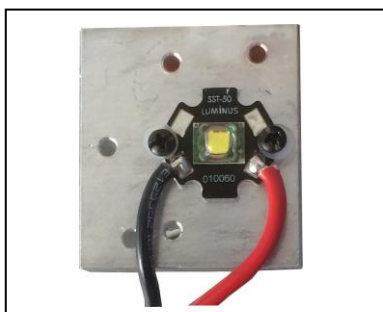
Symptom High spare part consumption of Power LED components.

Cause Overheating due to low thermal dissipation characteristics.

Figure 1: Current Power LED (A525157-01)

- A) To avoid an unplanned machine-down situation it is recommended to replace during next maintenance activity the current Power LED by the improved one.
For exchange instructions refer to section 3.1.
For affected sites refer to the list of affected systems below.
- B) Adjusting current to approximately 3.4 A (+/- 5%) will increase LED lifetime without a significant loss of luminosity.
Always adapt the power consumption of the LED:
- in case the Power LED is exchanged or
 - the timer PCB is exchanged.
- For adjustment instructions refer to section 3.2.
The LED current adjustment additionally avoids regular stripes in the collimator light (details see section 1.2).

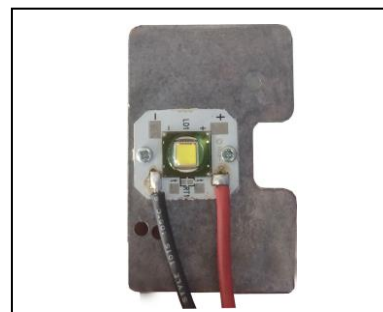
Solution In order to increase the lifetime for the RALCO collimator Power LED components, the current design has been improved. The improved LED components have been introduced in production. The Power LED is compatible to previous version.

Figure 2: Improved Power LED (A525343-01)

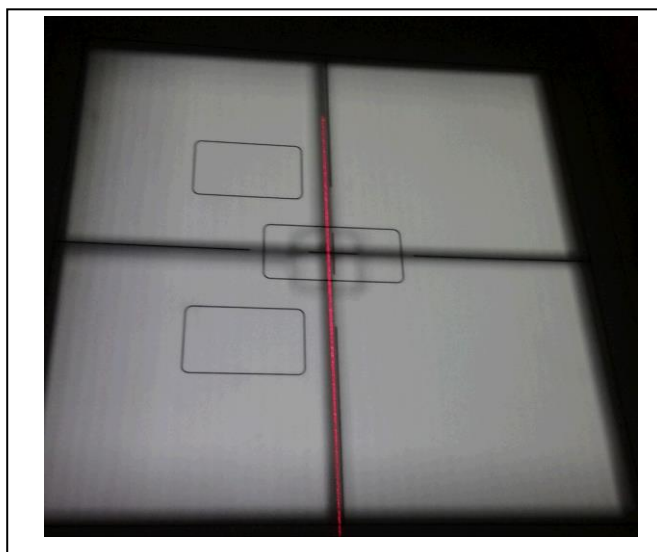
Figure 3

Symptom Collimator light shows shadow / black stripes that look like moiré stripes on FLFS images.

Cause Power LED current settings needs to be adjusted after replacement of the Power LED.

Solution Adjust the LED current to approximately 3.4 A (+/- 5%). For details refer to section 3.2.

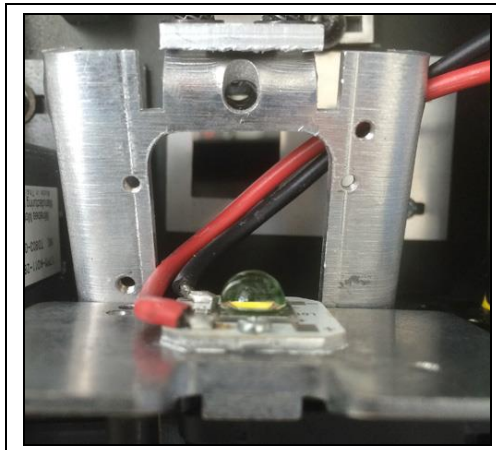
Figure 4: Power LED (Example)

Make sure that the cables do not cover the LED light and that they are routed in a way that the LED light can freely enter the collimator.

- (1) Disconnect power supply.
- (2) Remove the cover. Refer to chapter - COVER REMOVAL in the appropriate collimator manual. See "Referenced Documents" in section 2.
- (3) Exchange the Power LED as described in the appropriate collimator manual.

- (4) After exchange of a Power LED adjust the output current intensity as described in section 3.2 Adjustment of LED output current.
