Service Bulletin

Release of NX 3.0.8950, XRDI 18.0, ASC 4.1 and VDI 3.1

DX-D 100 / DX-D 100 Wireless

Title:	DX-D 100 - Service Bulletin No. 82 - REVISED - Release of NX 8950_XRDI 18.0_ASC 4.1_VDI 3.1
Livelihood ID:	54614702
Version#:	22
Version Date:	2016-10-20 03:52 PM CET
Status:	Approved on 2016-10-27 09:40 AM CET
Owner:	Carsten Bockel (awyuq)
Created By:	Carsten Bockel (awyuq)
Created Date:	2016-04-27 10:18 AM CET
PDF Creation Date:	2016-10-27 09:40 AM CET

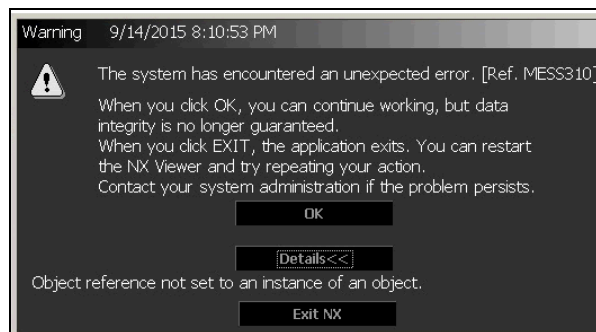
Figure 1

Symptom Error MESS310 when leaving the Viewing and Editing screen. The following preconditions must be fulfilled so that the symptom appears:

- System has NX 2.0.8900 / 3.0.8900 (SU1 / SU2) installed and is configured for touch mode (for DX-D 100 touch mode is always activated).
- Collimation Tool is deactivated (activated by default).

Cause Software bug introduced in NX 2.0.8900 / 3.0.8900 as part of the introduction of Touch Mode buttons in the Viewing and Editing environment: When leaving the Viewing and Editing environment, the software wants to close the Collimation Tool combo box. If this is not available MESS310 is shown.

Solution In NX 3.0.8950 the issue is solved.

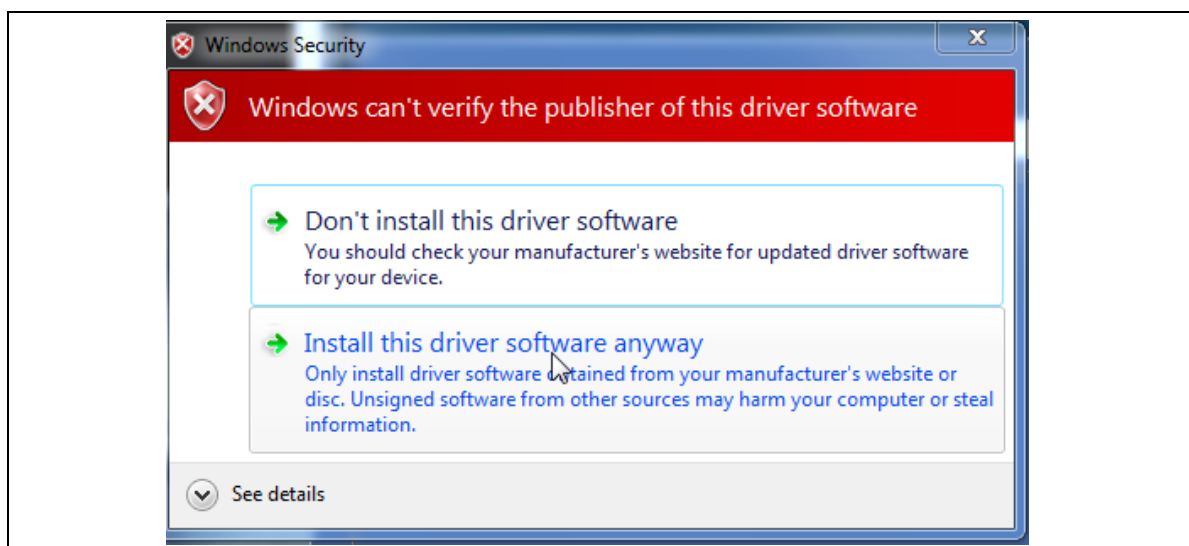
Figure 2

Symptom During installation, Windows security triggers a pop-up message

Solution Workaround solution: Select “Install this driver software anyway”.
