Service Bulletin

Introduction of new power cords in the US

Release date: 10-2016

DX-D 100 / DX-D 100 Wireless

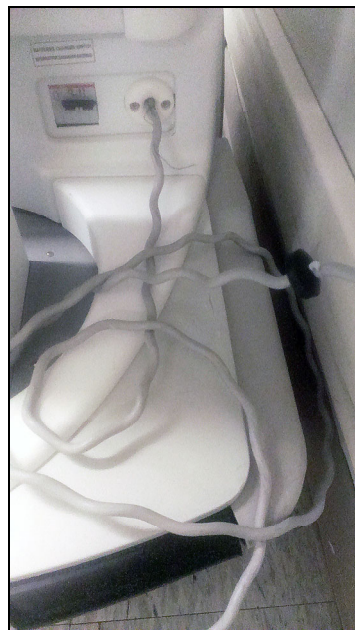
Figure 1

Symptom In some DX-D 100 / DX-D 100 wireless systems in the US the power cord is twisted and kinked during regular use. No issues with the functionality.

Solution A revised power cord with optimized material is introduced as a spare part. Replace the power cord with the new power cord.

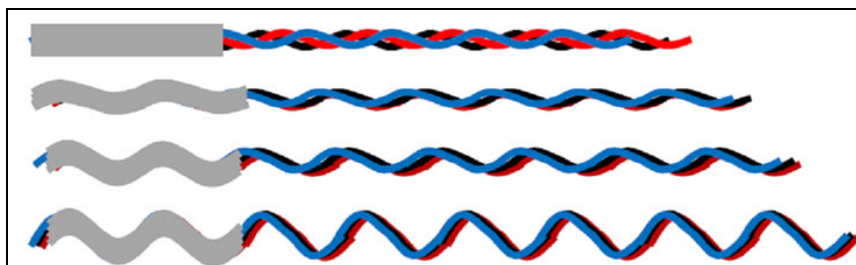
Cause The twisted wires in the power cord come loose and flatten out during regular use due to defect in the material. This creates the curled look. There is no influence on the functionality of the power cord.

Figure 2 - Transition from straight to curled cable.
