## Service Bulletin

### Generator firmware ATP Console updated and fixation of the skid plate guard improved

<b>Title:</b>	DX-D 100 - SB108 - Generator firmware ATP Console updated and fixation of the skid plate guard improved
<b>Livelink ID:</b>	65365640
<b>Version#:</b>	6
<b>Version Date:</b>	2018-07-18 04:54 PM CET
<b>Status:</b>	Approved on 2018-07-24 03:31 PM CET
<b>Owner:</b>	Stephan Schneider (erzhf)
<b>Created By:</b>	Stephan Schneider (erzhf)
<b>Created Date:</b>	2018-07-04 04:14 PM CET
<b>PDF Creation Date:</b>	2018-07-24 03:32 PM CET

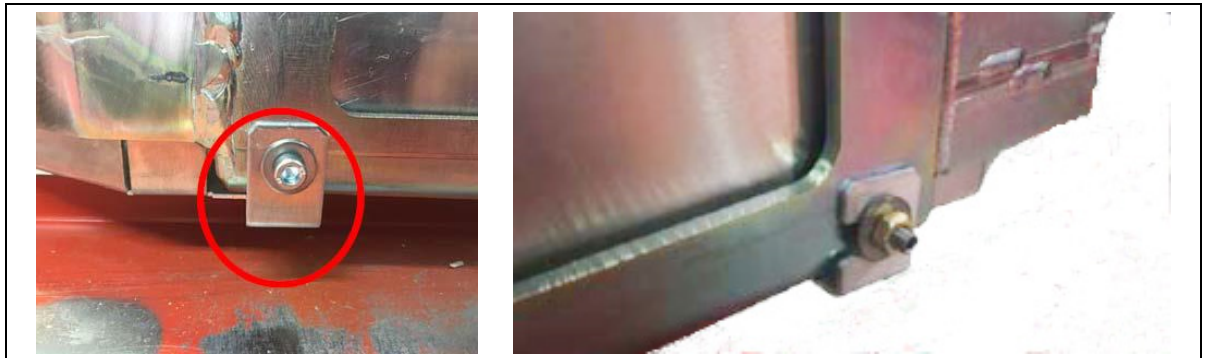
Figure 1: Previous design (left) and new design (right)

*Symptom* A damaged battery tray and metal fragments inside the unit have been found. This poses a safety risk, because a short circuit might be caused by the metal fragments inside the unit.

*Cause* For mobile systems with fix and telescopic column the skid plate guard is fixed to the frame by screws. If one of the screws has to be replaced because it is lost or damaged, the Field Service Engineer has to use the right screw length.  
If it is too short, the skid plate guard can't be fixed properly. If it is too long, the battery tray will be damaged.

*Solution* The current fixation of the skid plate guard to the frame will be changed from screw to nut ex-factory (no field upgrades are foreseen).  
A threaded rod with specific Loctite glue and a nut with washers will be used. The skid plate guard will also be modified by changing the hole drilled to open slots.  
For systems in the field the Field Service Engineer has to pay attention that a new screw has exactly the right length (M6x10) in case of replacement.
