## Service Bulletin

### Revised Version: Announcement of DX-D 100 / 100 Wireless System Version 4.4

DD+DIS005.14E

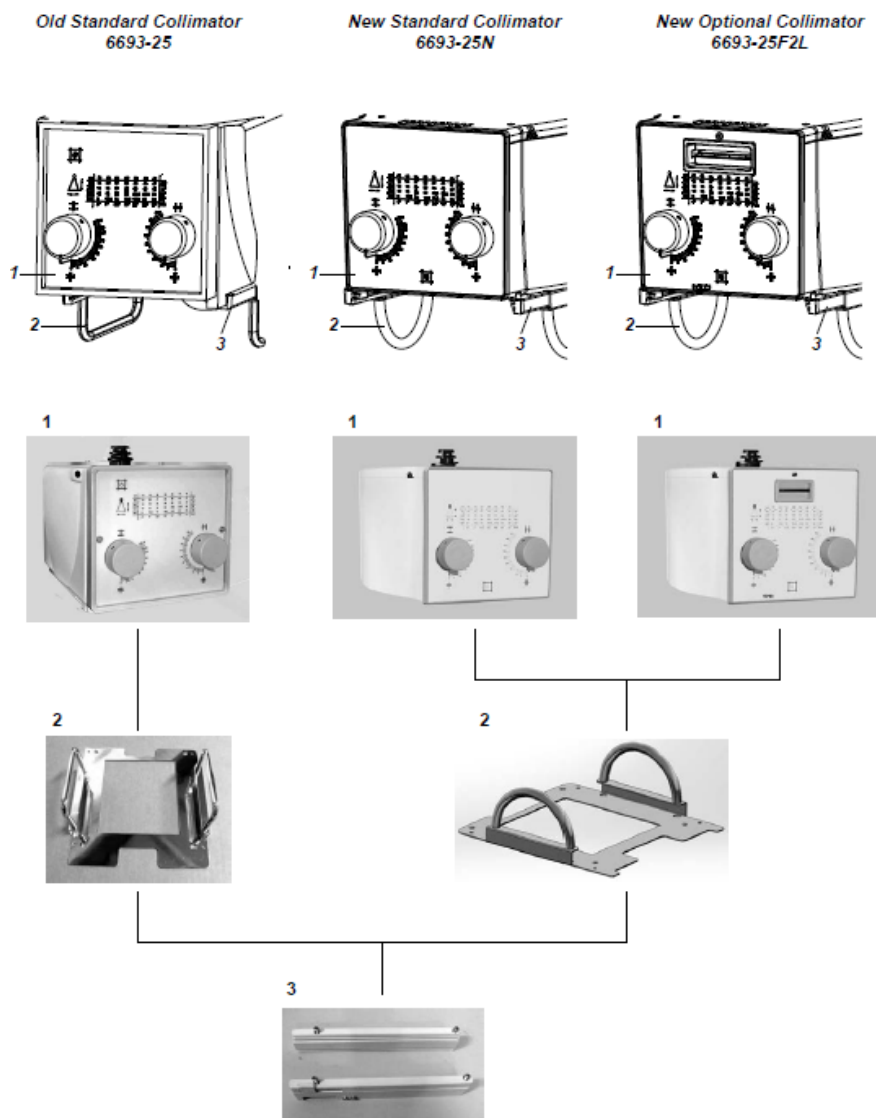
Figure 1

## 1.2 PR1308120002: Additional information about the improved collimator handle design

See below for the different collimators and the improved handle designs:
