Mandatory Service Bulletin

Mandatory upgrade to DMC board Rev. H with firmware V11R3b4

- DX-D 100, Type 5410, with SN < A5410000134
- DX-D 100 Wireless, Type 5411, with SN < A5411000408

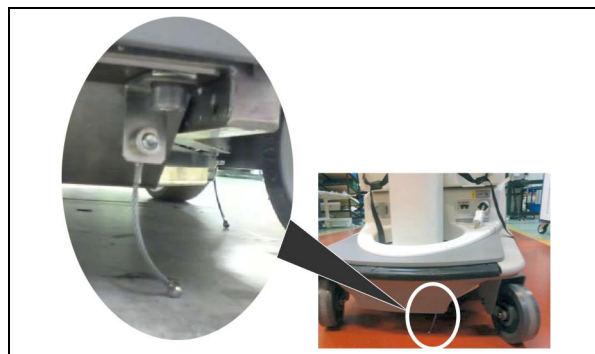
Figure 1: Arrestor

Cause If an ESD discharge occurs via the arrestor of the unit, there is a possibility that the DMC board is affected resulting in a possible unintended movement.

Solution Fix the DMC board with 4 plastic screws and isolate the board from the metallic mounting plate by 4 plastic spacers. For details refer to section 3.

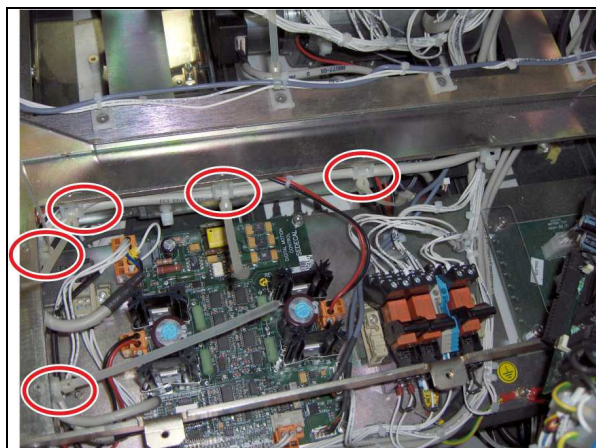
Figure 6

- (1) Check the encoder cable condition.
If there is stress on the encoder cables, continue with the next steps in this section.
If there is no stress on the encoder cables, continue with section 3.1.3.
- (2) Untie the tie wraps of the encoder cables.

- (3) Fix the rerouted cable on the right-hand side motor encoder. Ensure, that there is no stress on the encoder wires.

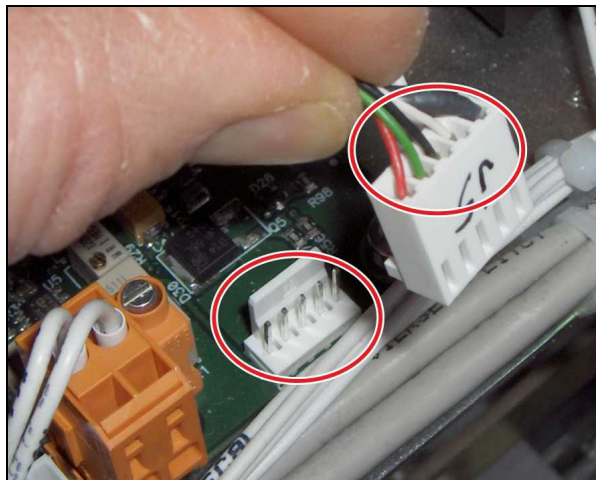
Figure 10

- (1) On the DMC Board, check the wires and the crimping of the wires around the J5 connector pins.
- (2) Check the pins of the J5 connector counterpart.

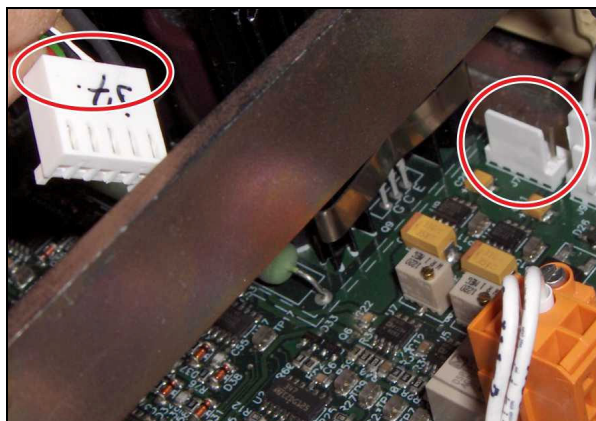
Figure 11

- (3) On the DMC Board, check the wires and the crimping of the wires around the J7 connector pins.
- (4) Check the pins of the J7 connector counterpart.

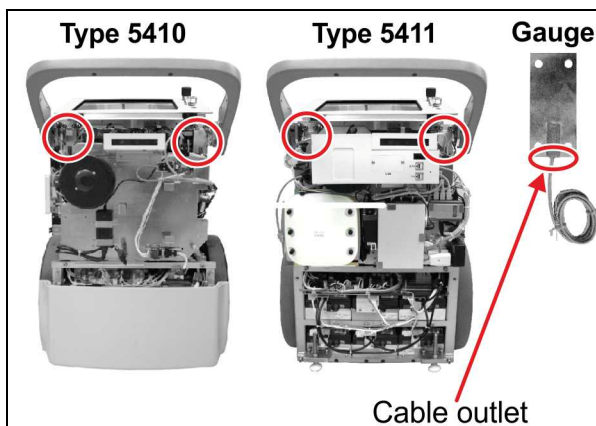
Figure 12

- (5) Carefully check the cable outlet of the two gauges for damages.
