Service Bulletin

Revised Information: Announcement of DX-D 100, version 3.0

DD+DIS227.12E

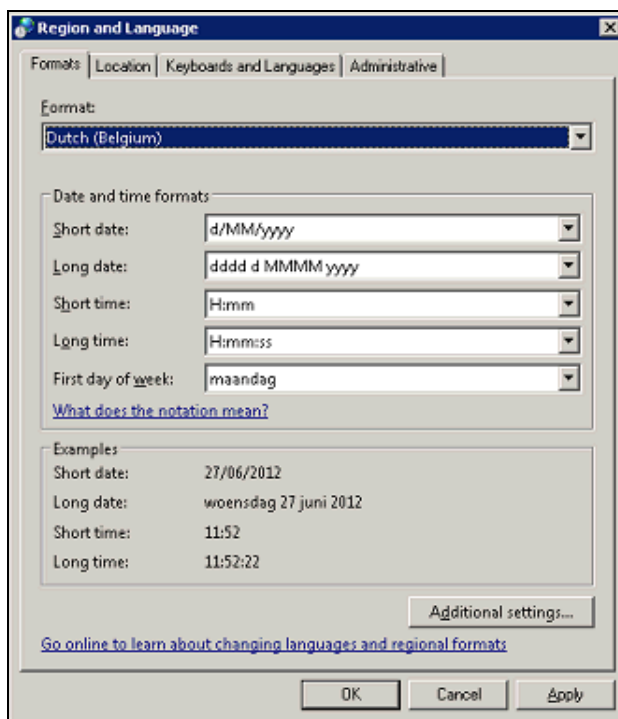
Figure 1

Symptom When the language and regional settings on the Softconsole are set to Dutch (Belgium) in Windows 7, and the user tries to change the mAs value, strange 'jumps' are seen in the values.

Cause: There is no way of correcting this issue when sticking to the Dutch (Belgium) regional settings.

Solution: Possible Workaround:
Setting the regional settings to English (US) as illustrated in the workflow below:

- (1) Make sure the NX viewer is not running.
- (2) In the <Start> menu, select <Control Panel>
- (3) In the <Control Panel>, select <Region and Language>
- (4) Select the <Formats> tab in the <Region and Language> option.

- (8) Return to the **<Region and Language>** window.
- (9) Click the **<Additional Settings>** button, see Figure 1.
- (10) In the **<Numbers>** tab of the **<Customize Format>** window, change the decimal symbol if required: type a comma (",") or period ("."), depending on the language you are working in.
