Document ID 66055531

## Service Bulletin

### DX-D 10/20/Fixed detector software VRN 8.0 released

DR 400 / DR 600 / DX-D 100 / DX-D 300 /

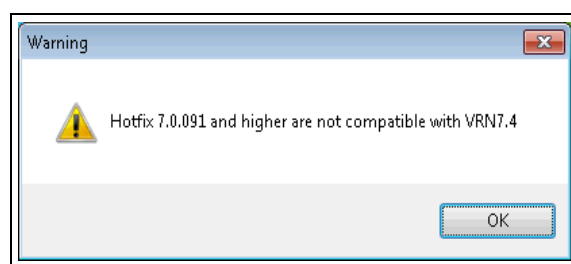
Figure 1

**Symptom** After upgrade to NX hotfix 7.0.091 (and higher):  
Very frequently (up to every second exposure) the communication to a Varian Detector fails and an error message is shown.

**Cause** Software bug (systems with VRN 7.X installed)

- When using FUSE as normal user, FUSE will check if the Pleora drivers are installed. If yes, hotfix 90 will be the latest one. A Message is shown that hotfix 7.0.091 and higher are not compatible with VRN 7.4

**Solution** Solved with upgrade to VRN 8.0 (installed network card remains).  
From VRN 8.0 on, the Intel® PRO/1000 cards will be controlled with the manufacturer drivers instead of Pleora drivers.

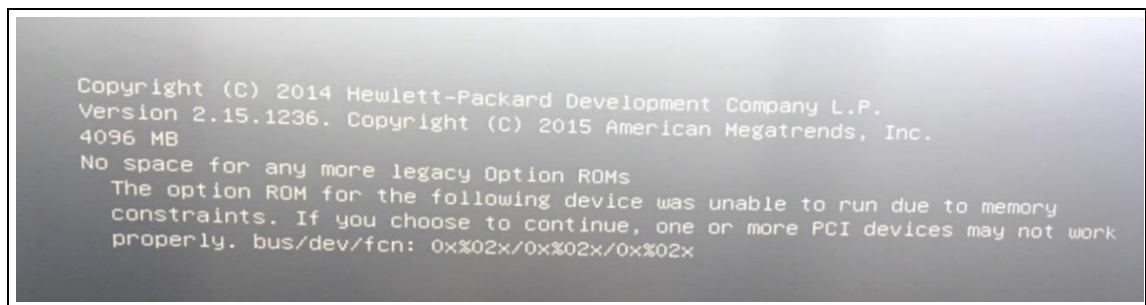
Figure 2

**BIOS issue** When plugging multiple Intel® I210-T1 network cards in a HP 5810, the following BIOS message appears.

- Solution**
- (1) Press F10 during boot to enter setup.  
The Hewlett Packard Setup Utility opens.
  - (2) Set OPTION ROM LAUNCH POLICY as shown in the screenshot below.
  - (3) Press F10 to accept.
