Service Bulletin

Release of NX 3.0.21.00 with XRDl 20.0 and ASC 6.0

Title:	DX-D 100 - SB112 - Release of NX 21.00
Livelihood ID:	66086365
Version#:	6
Version Date:	2018-09-18 10:48 AM CET
Status:	Approved on 2018-09-25 12:58 PM CET
Owner:	Stephan Schneider (erzhf)
Created By:	Stephan Schneider (erzhf)
Created Date:	2018-09-07 04:02 PM CET
PDF Creation Date:	2018-09-25 12:58 PM CET

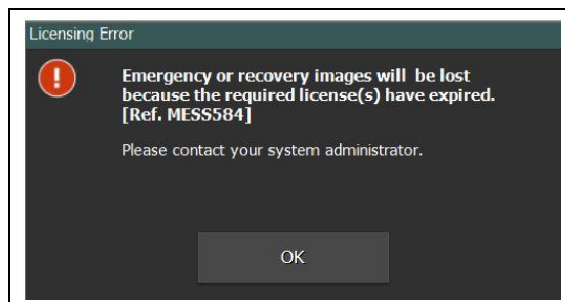
Figure 1

1.1.3 Licensing error after each NX restart in CR only configuration [PRB2000084]

Symptom At DR systems with a CR only configuration, a Licensing Error is displayed with each restart of NX. Contents of the error message (displayed in user language): **Emergency or recovery images will be lost because the required license(s) have been expired [Ref. MESS584]**.

When clicking OK, NX operates normal. This error has no influence on emergency or recovery images.

Cause Software issue in NX 20.00 (SU1).

Workaround Click OK to close the window. Message can be ignored.

Solution The issue is solved in NX 21.00.
