## Service Bulletin

### Improved power cord reel introduced

### 1.1 Low quality of power plug of DX-D 100 [PRB0061042]

<b>Title:</b>	DX-D 100 Wireless - SB110 - Improved power cord reel introduced
<b>Livelink ID:</b>	60520705
<b>Version#:</b>	8
<b>Version Date:</b>	2017-11-07 09:09 AM CET
<b>Status:</b>	Approved on 2017-11-10 11:26 AM CET
<b>Owner:</b>	Annette Peters (awtso)
<b>Created By:</b>	Annette Peters (awtso)
<b>Created Date:</b>	2017-07-21 02:54 PM CET
<b>PDF Creation Date:</b>	2017-11-10 11:26 AM CET

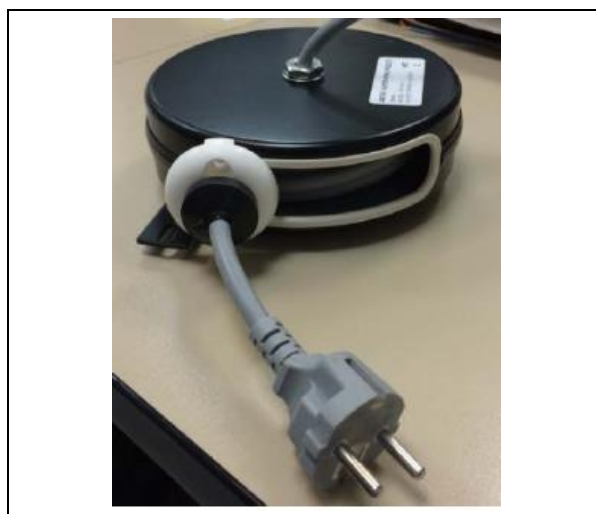
- Symptom* Damaged power plug (90 degrees type)/broken pins, caused
- by incorrect removing of the plug out of the wall socket (pulling at the cable) and/or
  - when the cable is not retracted properly in the cable reel, the plug lies on the floor and the user steps on the plug or runs over it with the unit.

*Cause* This is caused by the design and quality of the power plug / power cord reel.

Figure 1: New straight European plug

*Solution* The plug shape of the European reel changed from 90 degrees type to straight type. A new spare part for Europe is available.

- (1) Replace a defect cable reel with the new cable reel.  
For replacement instructions refer to document  
DX-D 100 / DX-D 100 Wireless Mobile X-Ray Unit - Service Manual, Chapter  
Troubleshooting, Section 2.4.2 REPLACEMENT OF THE POWER LINE CABLE,  
Document ID [41600560](#).

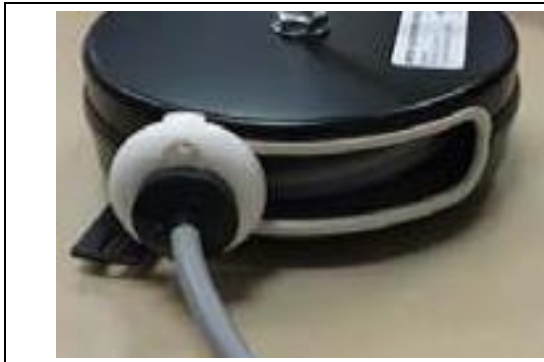
The window for the cable is larger and a plastic support avoids damage to cable and reel.

Figure 2: New: big window and cable support

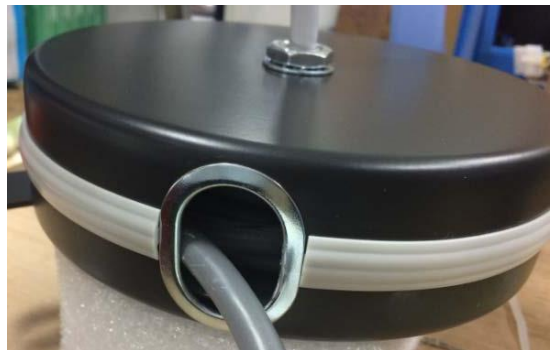
Figure 3: Old: small window

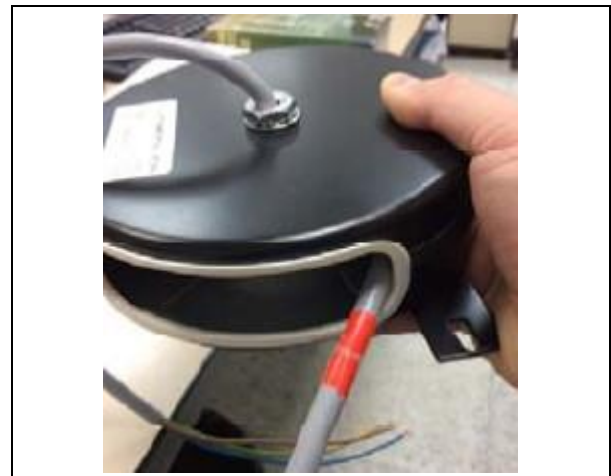
A color mark is added close to the cable extension limit.

It warns the user that the cable should not be pulled out further.

This avoids excessive pulling stress.

Figure 4: Color mark

Inform the customer about the meaning of the red mark at the power cable:  
If the red mark appears the user should stop pulling out the cable.
