## Service Bulletin

## Announcement of System Version 8.0

DX-D 100 / DX-D 100 Wireless

Agfa HealthCare Company Confidential Type 5410/050 / 5411/050/300/400

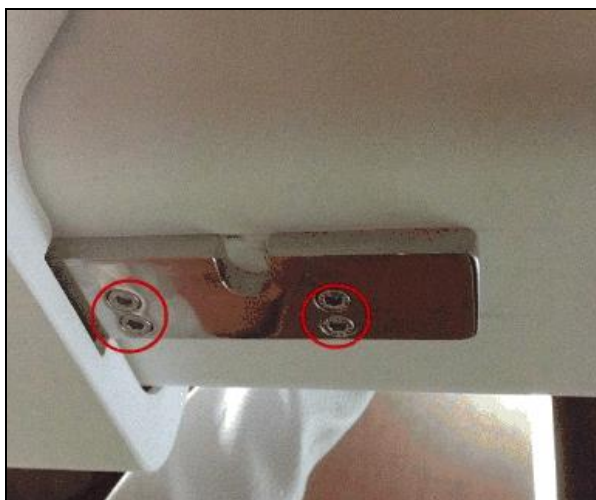
Figure 2

### 1.4.1 Screws of parking block loosened (PRB0048935)

*Symptom* Parking block mounting screws loosened.

*Cause* Quality issue of some fixation screws at the DX-D100 telescopic arm.  
The lock pin bracket fixation screws kit come loose.

*Solution* Quality of the fixation screws improved. The AET washers are changed to Nord-lock washers in order to make the fixation stronger. Also the head of the screws is marked in order to ensure that the final tightening according to the torque defined (4,6 Nm) has been applied.

No need for replacement in the field, change was implemented in production as of:

- DX-D 100 Type 5410 / 050 (DX-D 10/20) from SN A5410001006
- DX-D 100 wireless Type 5411 / 050 (DX-D 30/35) from SN A5411001170
- DX-D 100 wireless Type 5411 / 300 (DX-D 40/45) from SN A5411002043

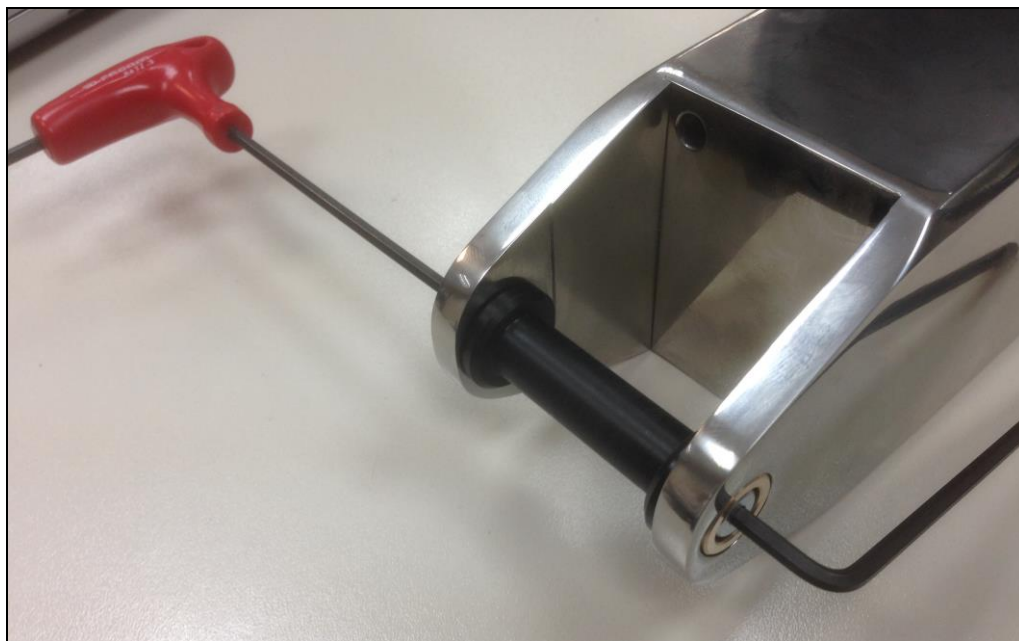
Figure 3

### 1.4.2 Telescopic arm locked (PRB0049986)

*Symptom* Telescopic arm locked in park position due to loosen screws.

*Cause* The loosen screws of the pin locks the arm in the park position.

*Solution* Attachment of the pin with 2 Allen wrench's instead of only one.
