## Service Bulletin

## Solutions for movements caused by disinfection liquids on the collimator hand-grips

Copyright © 2021 Agfa NV | Document ID: 74741907

| <b>Title:</b> | DX-D 100 Wireless - SB162 - Solutions for movements - REMOVED until further notice |

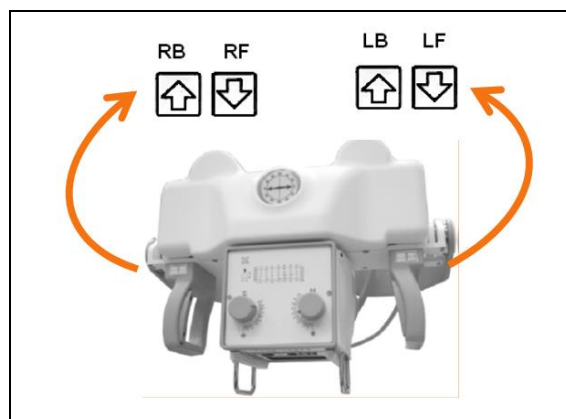
Figure 1: Fine Positioning Controls

*Cause* When disinfecting by pouring or spraying liquids on the collimator hand-grips, a short-circuit in the fine positioning controls can occur.

These are the four buttons on the hand-grips, which control the (low speed) motion of each driving wheel forwards or backwards:

RB = Right Back; RF = Right Front

LF = Left Front; LB = Left Back

The system is not able to distinguish a button pressed by a user or a short-circuit.

The result is that the unit moves on its own in a very slow motion and normally in circles as if just one button would be pressed. Note that the motion is at very low speed; the motion control does not allow high speeds for these controls.

A film (sticker) to cover the four buttons as protection against liquid is available:

With DMC firmware version V11R3b8 (or later), an improvement is introduced to stop the mobile unit after 8 seconds. The unit stops regardless of whether the movement has been caused by a mechanical blocked fine positioning button or by a short-circuit. Install DMC firmware version V11R3b9, which is the replacement of V11R3b8 (see section 1.2).
