Underwing Fuelling of Airbus A320 Family Aircraft

Bulletin 78**Jul 2015**

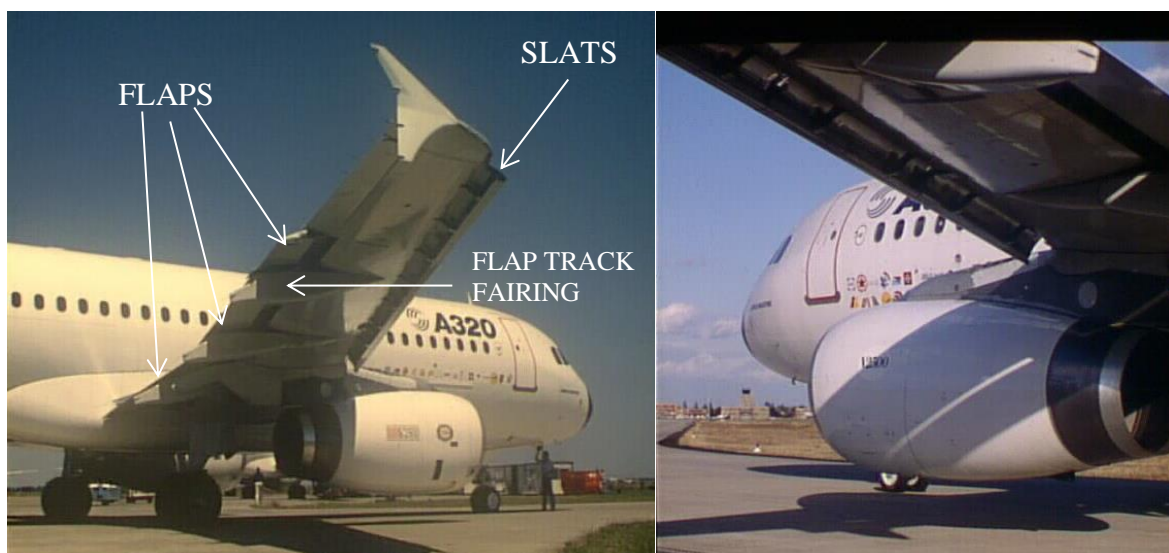
With the flaps extended there is reduced ground clearance under the flaps, and more importantly under the flap track fairings, which are significantly lower than the flaps themselves (as shown in the picture above).

This has resulted in incidents and near misses involving A320 family aircraft, and particularly with the A321, whose flap track fairings are larger and, when deployed, are significantly lower than those of A318, A319, or A320 aircraft. However, the risk of impact exists for all A320 family aircraft due to the reduced ground clearance under the flaps when extended.

In the event that the aircraft crew extend the flaps during fuelling operations without warning, and where the fuelling vehicle is positioned underwing, the Operator shall immediately stop fuelling and shall:

- 1) contact the aircraft ground staff to inform them that the fuelling has been suspended for safety reasons, and
- 2) inform the aircraft ground staff that the fuelling vehicle cannot be moved until the flaps have been retracted and the aircraft crew give the 'all clear'.

Fuelling operations may continue when the flaps have been retracted and the aircraft crew confirm that they are aware of the position of the fuelling vehicle.

Fuelling procedures should avoid the need for fuelling vehicles to be positioned underwing of Airbus A318/A319/ A320/A321 series aircraft with the flaps extended. However, where underwing fuelling with the flaps extended is unavoidable because of aircraft operating procedures that require the flaps to be extended in high ambient temperature conditions, and where local fuel supplier and airline procedures permit this, the fuelling vehicle may be marshalled into position under the direction of airline staff or by a competent guide person authorised by the airline. When positioning underwing, the guide person shall ensure that there is adequate clearance between the aircraft and the fuelling vehicle to allow for aircraft settlement during loading.
