## Hydrant Pit Coupler Incidents and EI 1584 Third Edition

**EI 1584 Third Edition - Hydrant Pit Valves and Couplers**

### **HYDRANT COUPLER KNOCK-OFF INCIDENT SUMMARY** **SHARING LESSONS**

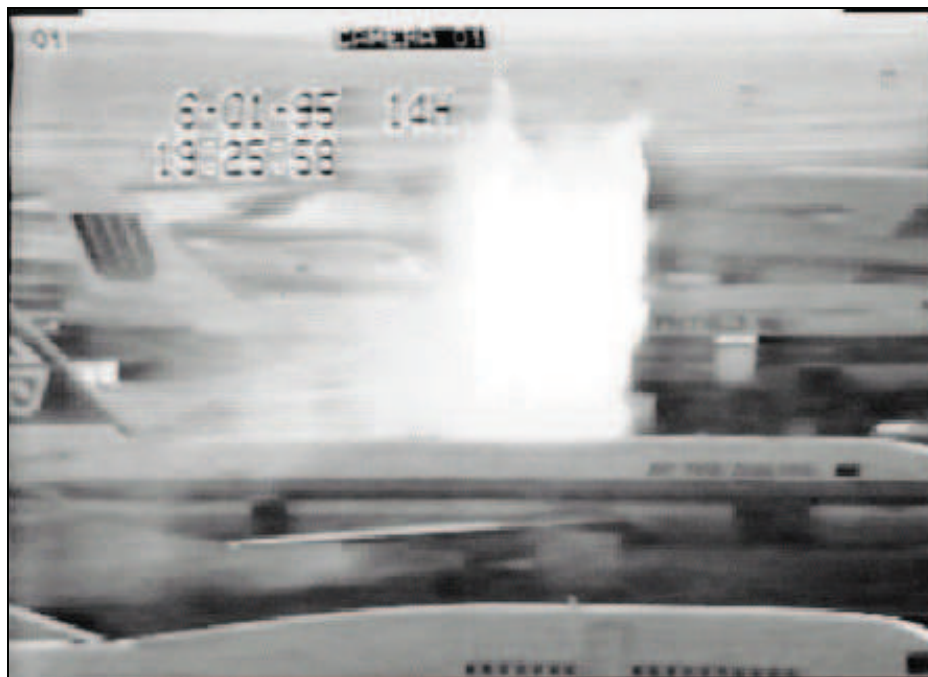
Most of us have seen the graphic images of the Auckland incident in 1995 when a pit coupler became detached from a hydrant pit valve during fuelling, resulting in a release of fuel under full hydrant pressure. Had this spray come into contact with a source of ignition such as a hot aircraft engine or the exhaust system of a nearby vehicle, the outcome could have been an ignition of explosive force with the possibility of multiple fatalities. The event was captured on a CCTV security camera and the image below clearly shows the spray which engulfed several neighbouring aircraft.

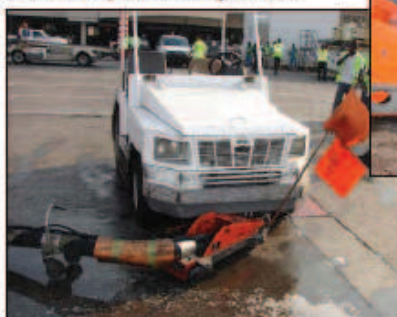
The Airport Fire Department attended, sprayed foam over the area and cleared the spill then continued to stand-by. The tug was towing one dolly loaded with baggage. The tug had stopped directly over the hydrant pit and pit valve, with the hydrant intake coupler and 4" intake hose (fitted with a "Crocodile" unit) lodged under the front of the tug.

The intake coupler and 'Crocodile' unit were damaged. The air-line was severed and the fuel sense line had a small cut. No damage was found on the intake hose. The hydrant intake coupler poppet o-ring was found on the ground, but the pit valve showed no external signs of damage.

All pit valves and couplers had been upgraded to API/IP 1584 Third Edition<sup>(1)</sup> in 2006. The pit valve was fitted with an air-operated pilot. The coupler performed in accordance with the designed "break-away" characteristics and allowed the pit valve to close; 13 of the 16 coupler lugs sheared as a result of the impact.

The tug was lifted from the hydrant pit using a forklift. The hydrant was isolated, depressurised and the hydrant pit valve removed and quarantined. The riser, base flange and pit box (an "environmental" type) were examined and no movement or damage was evident. A tested hydrant pit

valve was fitted and the hydrant system slowly repressurised, vented and inspected to bring the hydrant back into full service.
