MAINTENANCE SAFETY BULLETIN

APPLICABILITY : All Engineering & Maintenance
MSB NUMBER : MSB 2022-003
DATE : 1 August 2022

SUBJECT: BELLY FAIRING SLIDING PANEL DISLODGED FROM GROOVE

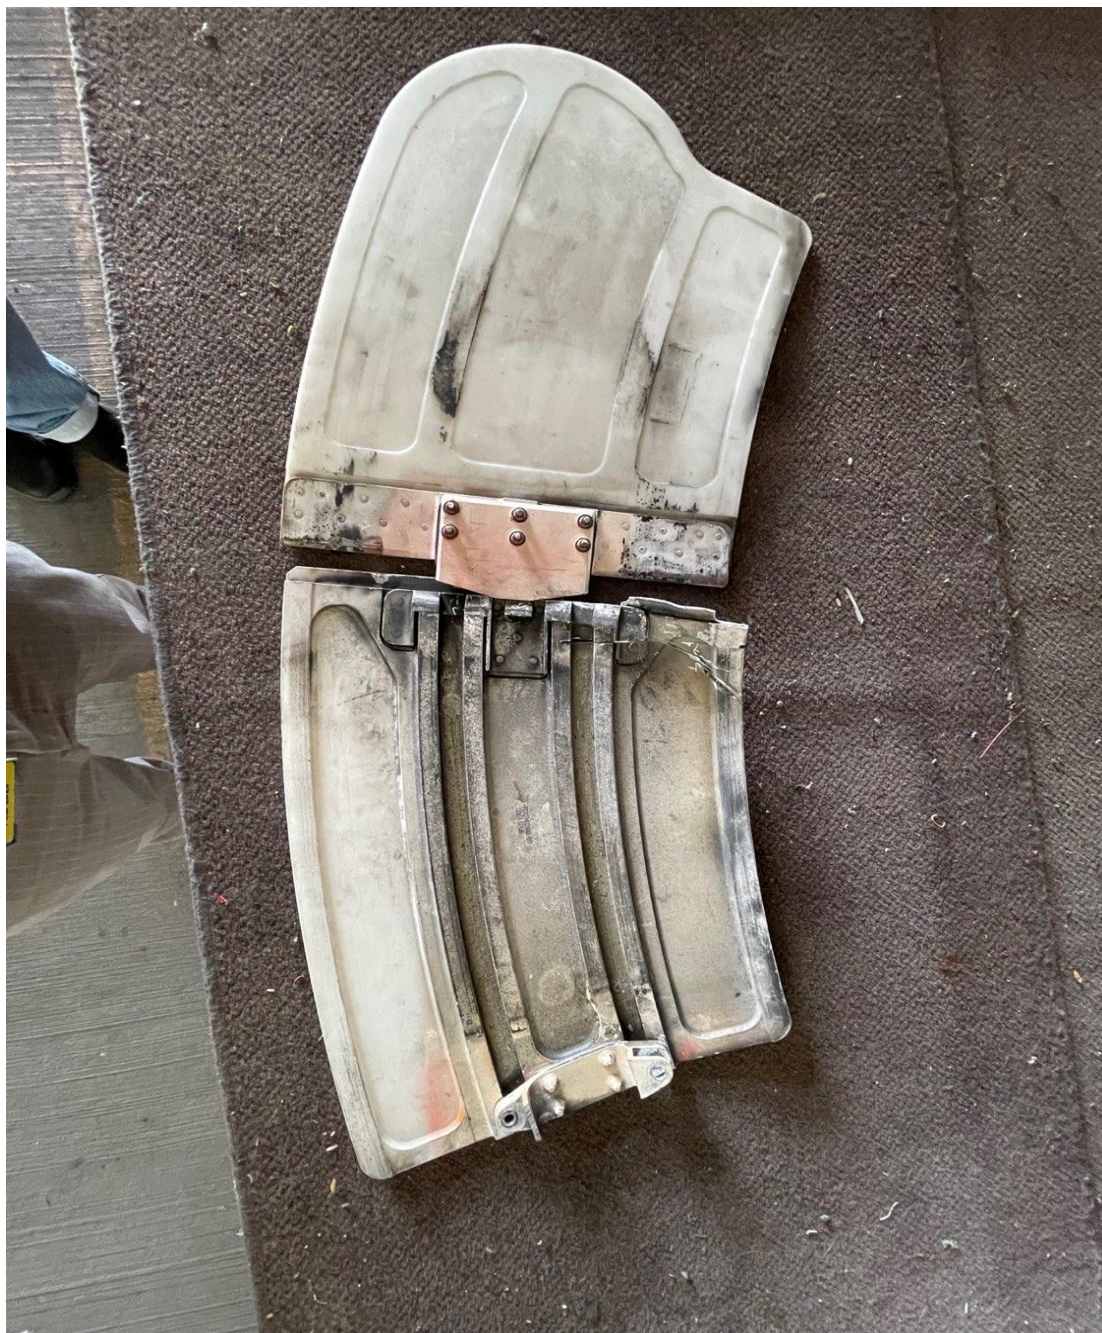
During aircraft inspection, sliding panels have been found torn.

Figure 8: Torn panel

In case of damage found on the sliding panel, the aircraft can be operated without the panel as per MCDL-53 02 and shall be replaced at the earliest opportunity

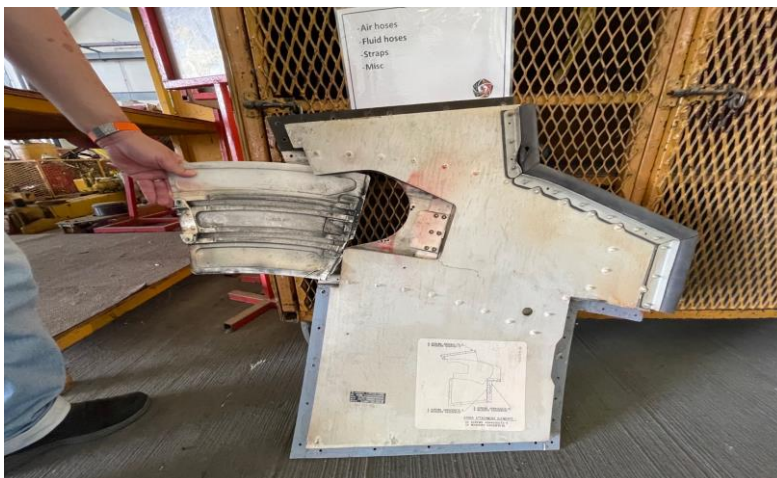
1. The sliding panels have been dislodge from its grooves, when the flap was in full extend position.

Figure 9: Sliding panel dislodged from Belly Fairing panel after extraction

This MSB is to create awareness on the operation of the sliding panels in relation to the flap movement. Awareness on the spring serviceability and the pin are not blocked inside the panel. Furthermore, it is good practice to ensure panel groove is also free of FOD and the panel is not dislodged.

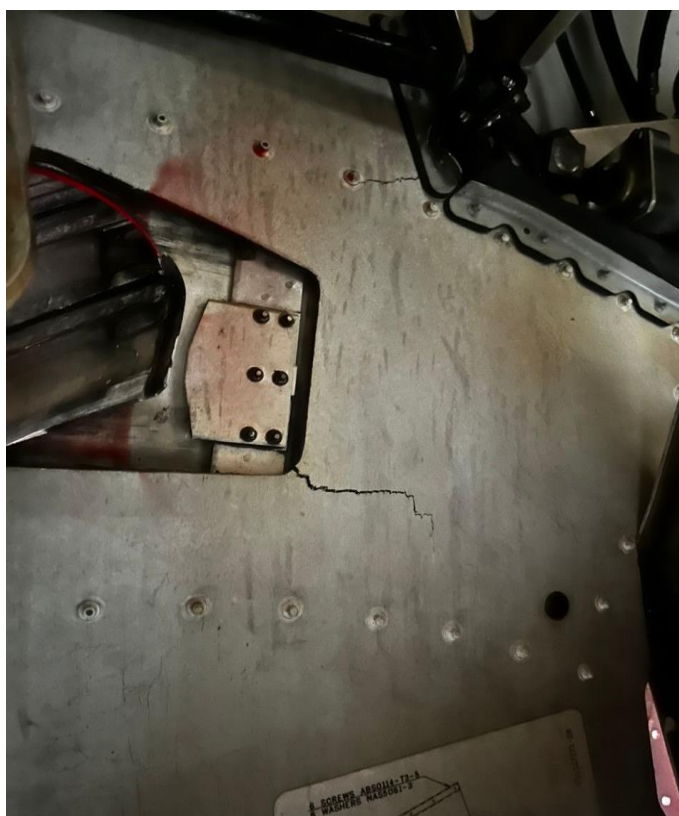
2. When the flap retracts from one to zero, the aft sliding panel (item 270 in IPC description) was unable to move further. The aft sliding panel starts to compress the panel assembly. Finally, this panel assembly cracked and hit left hand torque tube in the wheel well area.

Figure 10: Aft sliding panel compress panel assembly. Evidence of crack found

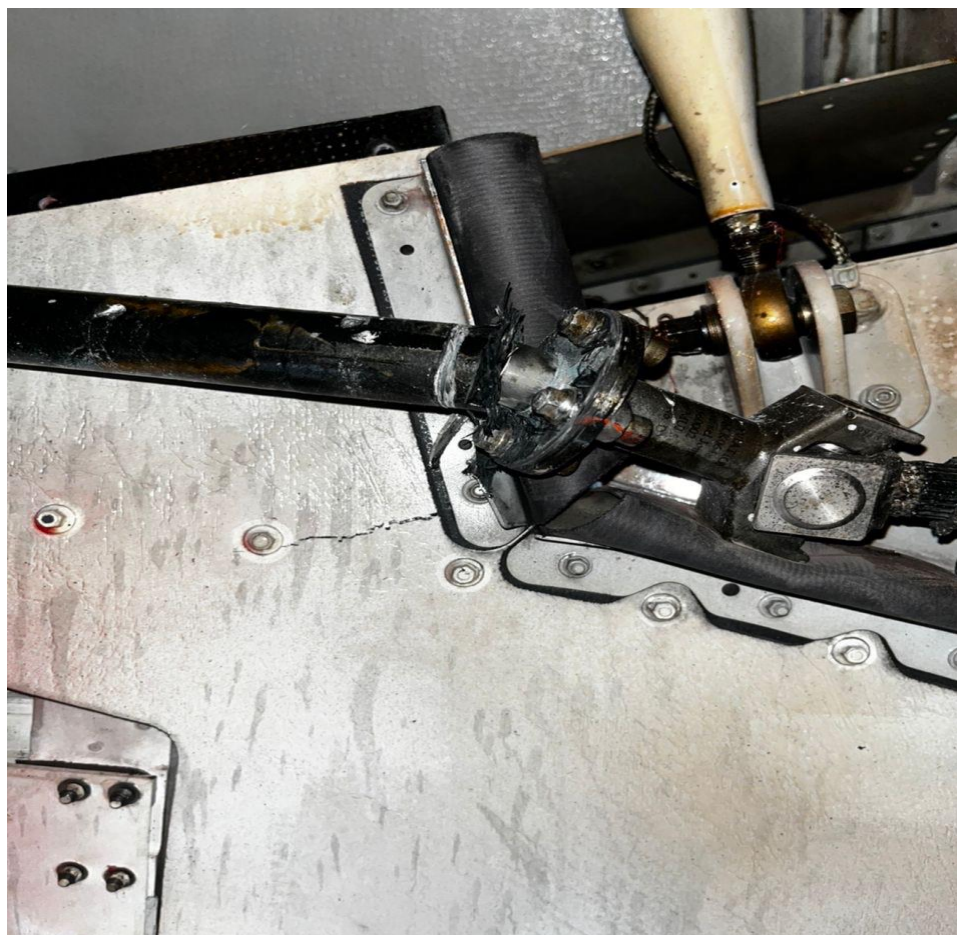
MAB had an incident on an A330 aircraft where the Left-Hand Torque Tube at Wheel Well area and Belly Fairing Sliding Panel 147AB was damage during retraction of Flap to full up position. Airbus in-service information reference no. 53.35.00030 was extracted to create awareness for all maintenance personals.

Figure 11: Panel assembly cracked and hit left hand torque tube in the wheel well area
