July 7, 2023

Address: 1713 Hilltree, Cincinnati, OH

Subject: FRONT PORCH INSPECTION REPORT

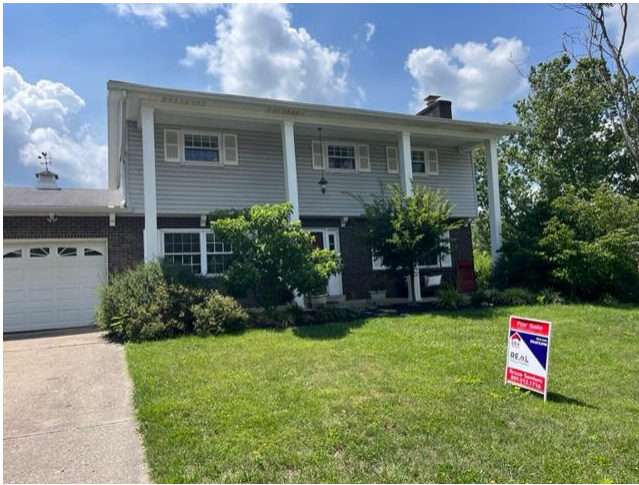
Image 1 – Front of House and porch

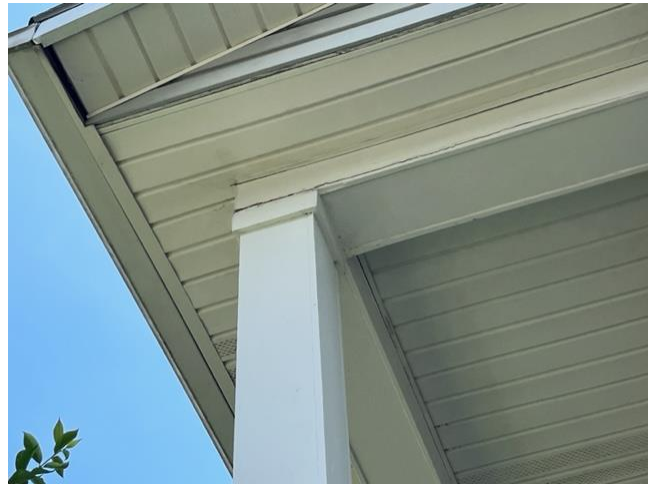
The far right-side porch column appears to be the only one affected with a slight inward lean to it. The columns can be straightened with some shim work and the shrubs can be removed. If the porch continues to settle, it can be lifted with pumping grout under the slab to fill any voids below the slab. The column does not appear to be compromising the porch's structural stability but is more cosmetic and can be straightened.

Image 2 – Right side post leaning inward

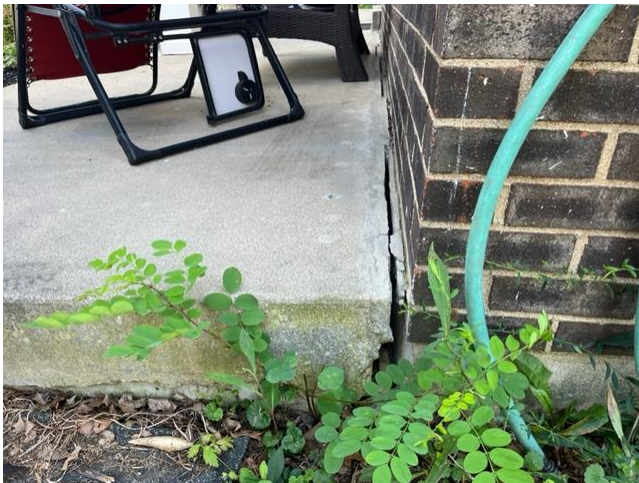
The front porch concrete slab has settled away from the house foundation over time due to settlement of the soil under the slab and possible root systems along and under the porch slab. The large shrubs can remove moisture in the soil causing it to shrink and create settlement issues for the concrete slab of the porch. This apparently has been happening for over 40 years as the porch has settlement cracks as well.

Image 3 – Porch slab has settled away from house

The front porch slab foundation and columns appear to be in fair to good condition and stable for a house of this age at the time of inspection. Remove all large landscaping along the front porch and monitor the slab. Keep all drainage away from the porch and foundation of the house.

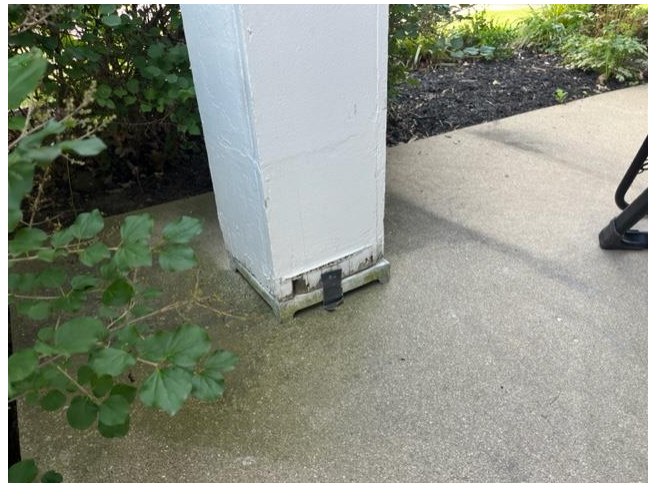
Image 4 – Right side post on slab and seat

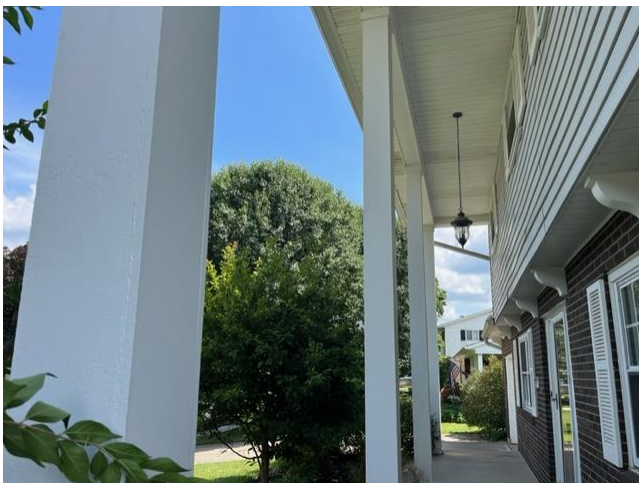
Image 5 – Other 3 posts are straighter

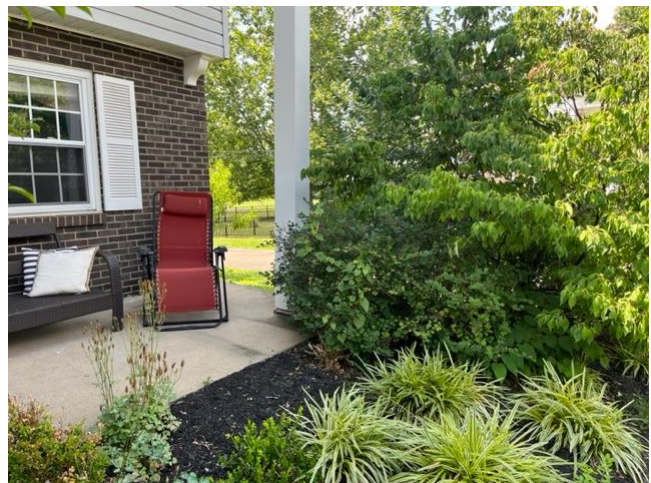
Image 6 – Large shrubs along porch corner
