The crooked rod sign: a new radiological sign to detect deformed threads in the distraction mechanism of magnetically controlled growing rods and a mode of distraction failure

Study Design: Case report

Objective: To report a unique mechanical failure of magnetically controlled growing rods (MCGR) that is related to continuous rod slippage.

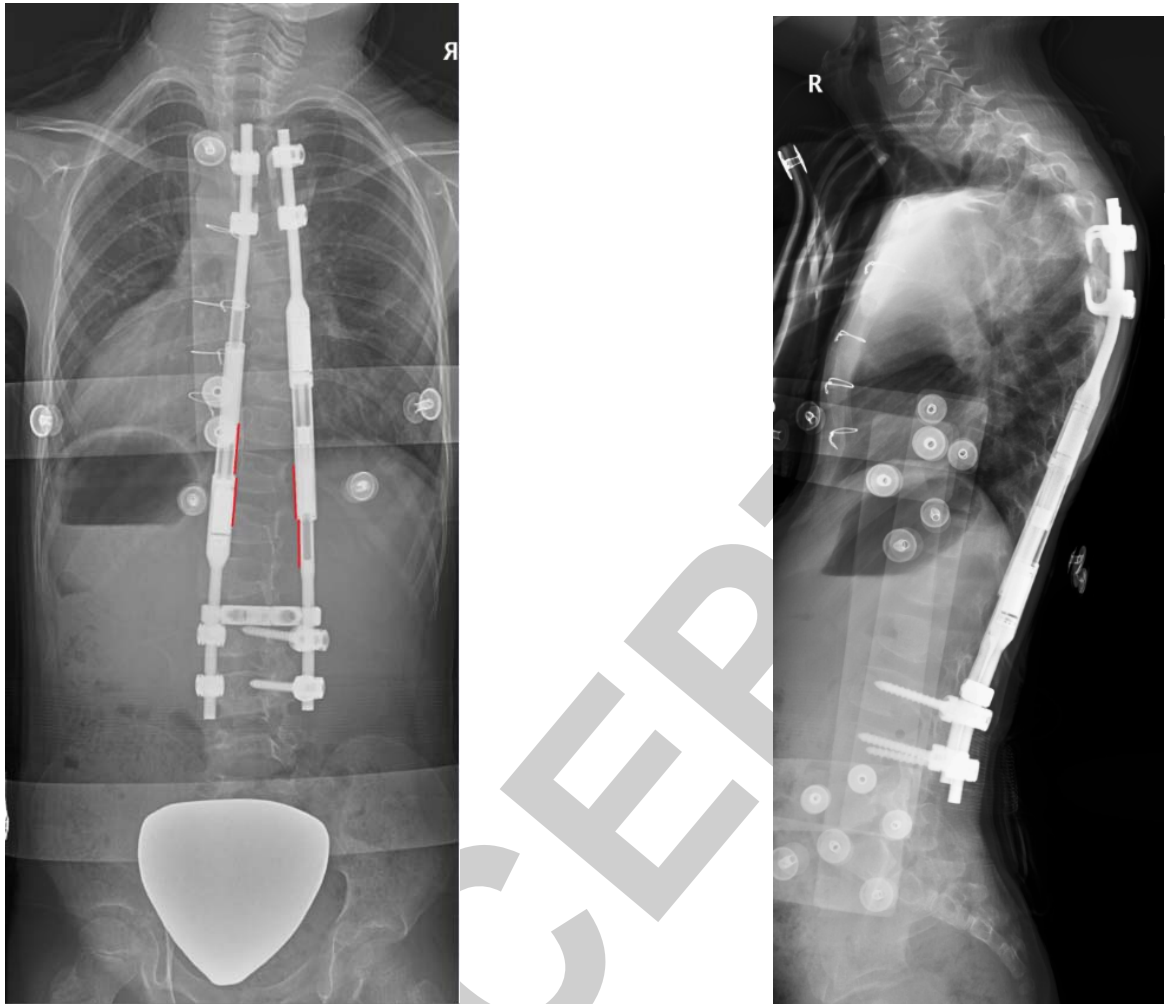
Figure 3: Posteroanterior (A) and lateral (B) radiographs immediately prior to continuous rod slippage showed no rod angulation (marked by lines).

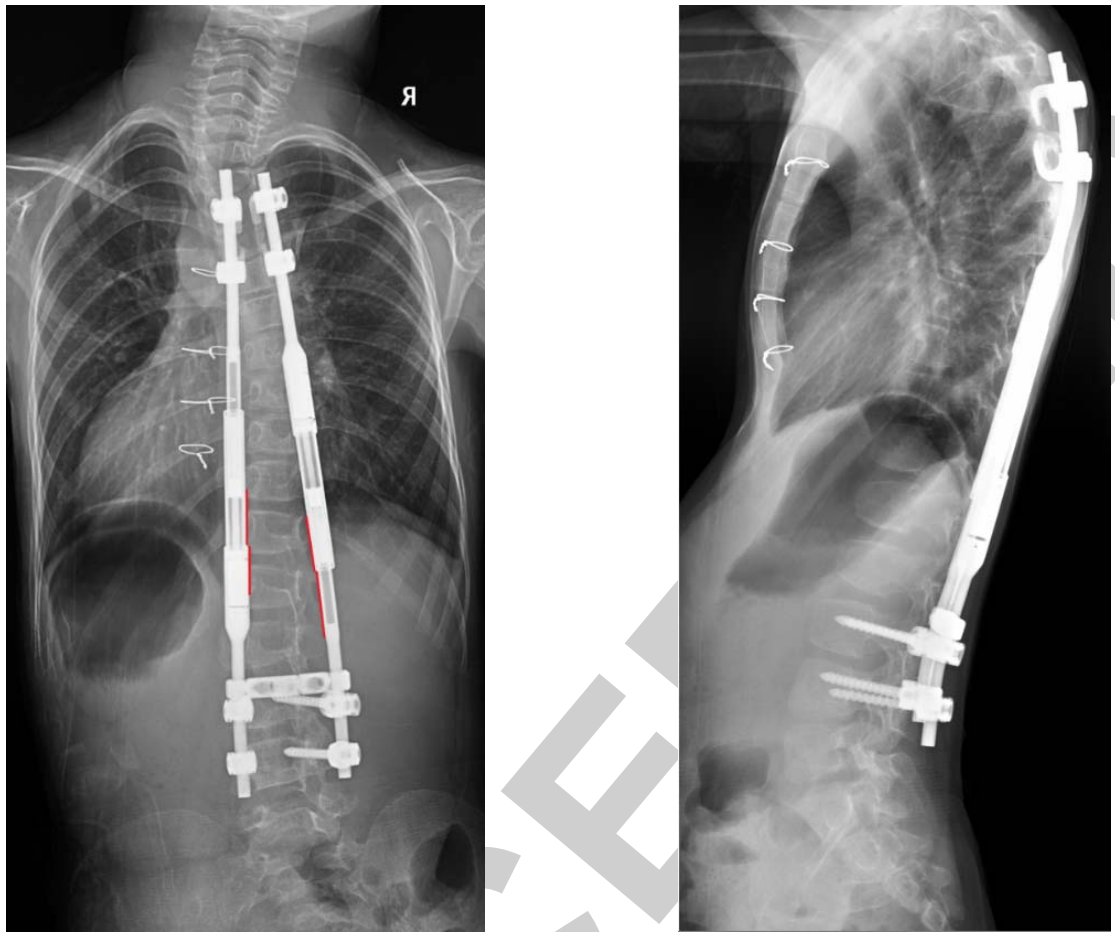
Retrospective examination of the radiographs acquired prior to the sedation procedure revealed rod angulation between the actuator and the extendable portion of the rod (**Figure 4AB**). Upon review of other patients in our series who have experienced distraction failures and continuous rod slippage (n=8), none observed similar crooked rod sign on follow-up radiographs. The extracted MCGRs were studied in our mechanical laboratory. Externally there was no rod fracture but there were many wearing marks at the junction between the extended portion of the rod and the actuator (**Figure 5A**). Rod angulation was also observed by placing the rod next to a straight bench edge (**Figure 5B**). After the extended portion and the actuator were dissected, it was revealed that the threads of the internal screw providing the distraction were no longer in-line with such deformation (**Figure 6**) and thus the screw refused to rotate with external magnetic force due to the increased resistance. After the screw was dislodged and re-inserted along the correct threads, the screw was able to rotate manually under external force and the distraction resumed.

Figure 4: Posteroanterior (A) and lateral (B) radiographs obtained during the admission for distraction under sedation showing rod angulation at the right rod (marked by lines).

Despite the finding of proximal junctional kyphosis (PJK) 5 months after the surgery, early distractions were smooth and successful monthly 2mm lengthening achieved on both rods as confirmed by ultrasound. At the 11th distraction, 1.5 years after rod implantation, rod slippage occurred in both rods and no lengthening was observed (**Figure 3AB**). Targeted 2mm distraction was continued at the next two clinics despite continuous rod slippage and failed lengthening. The difficulties were initially contributed to the uncooperative patient who became irritable during distraction sessions. Subsequently, a distraction session under sedation was performed to eliminate the soft tissue resistance contributed by muscle contraction. Despite successful distraction on the left rod, continuous slippage was still observed on the right rod. As further lengthening was unsuccessful, rod exchange was performed with proximal extension to T3-T4 to control the proximal junctional kyphosis. Intraoperatively metallosis was observed around the screw-rod junction. After rod exchange, smooth distractions were again observed for both rods. The patient is now two years after the rod exchange with monthly successful lengthenings.

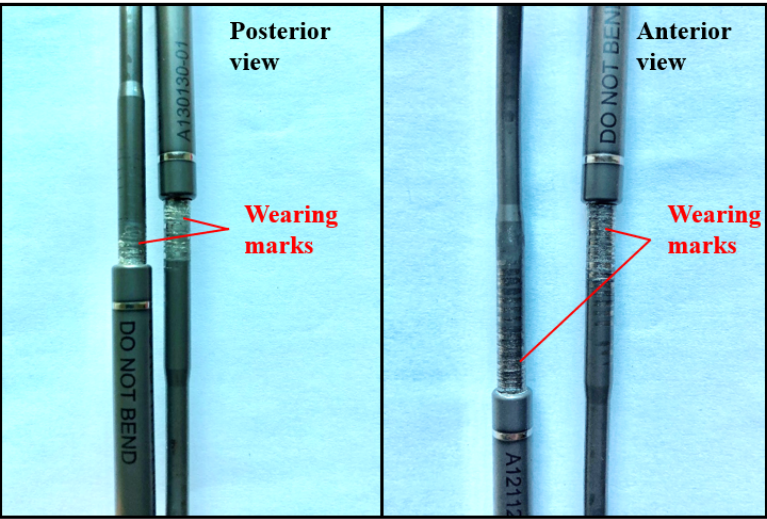
A: MCGR wearing marks

Figure 5: The explanted rod appearance with wearing marks (A) and rod angulation (B).

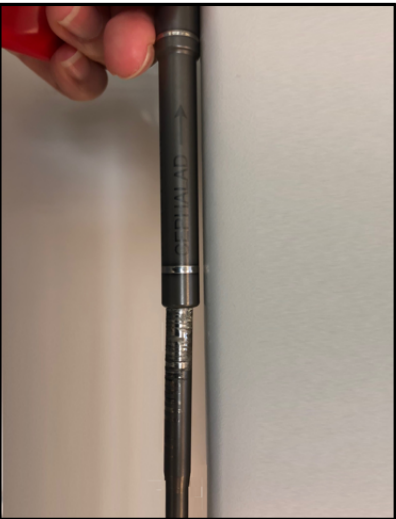
B: MCGR angulation

This is a new failure mechanism of MCGRs related to the increased rod internal screw friction and resistance to distraction caused by the deformation of the threads. This is another mechanical failure in addition to others reported including pin fractures, corrosive debris and metallosis.¹³⁻¹⁶ This complication may be identified with meticulous scrutiny of the radiographs during the period of interest. It is prudent for MCGRs users to keep a close eye on radiographs for subtle angulations between the actuator and the extendable portion of the rod, especially when rod slippage occurs. Although the immediate x-ray (**Figure 3**) prior to the continuous slippage showed no obvious abnormality, the next radiograph taken (**Figure 4**) during the distraction under sedation showed an angulation at the MCGR which should not be present in any functional MCGR. This is a very subtle finding that is only apparent to us with assessment of the rod at the laboratory (**Figure 5B**) and of the radiographs on

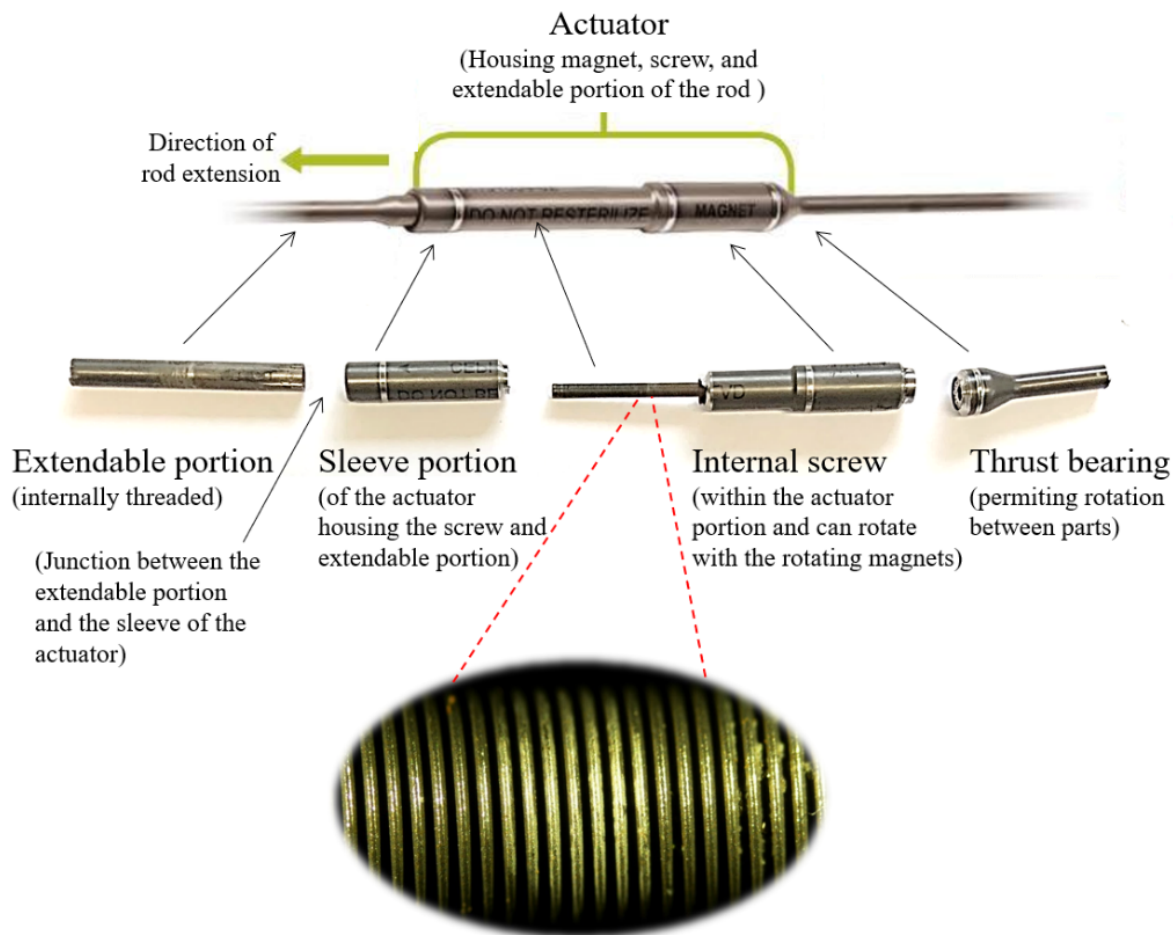
The rationale for the failed distraction can be comprehended as increased resistance from the deformed thread preventing the rotation of the internal screw under the magnetic driving force of the external controller, and thus preventing extension of the rod. It should be noted that the patient did not have any significant axial growth during the months where rod slippage occurred. Hence, soft tissue tension is significant and is likely the main reason for failed lengthening. The continuous rod slippage may be considered as a warning to avoid forcing further distraction. The PJK may have also contributed to the series of events as increased kyphosis may apply extra anterior loading to the proximal end of the MCGR. The relationship between rod alignment, increased anterior loading and deformed threads require further study.

Figure 6: The explanted rod after dissection with indications of the thread design and deformed threads. Microscopic analysis of the deformed threads with deformations shown by changes in the color.

Based on what we have observed with this complication, we recommend MCGR users to avoid distraction attempts if continuous rod slippage occurs as this may jeopardize the longevity of the MCGR. The relationship between continuous rod slippage and this deformed thread phenomenon requires further testing to reproduce and to understand its underlying mechanism. Radiographic images should be scrutinized for the “crooked rod sign” which represents angulation between the extended portion and the actuator. This sign is indicative of deformed threads in the internal distraction mechanism. Once it occurs, revision surgery with rod exchange is inevitable. Similar findings should be explored in other MCGR failures to determine its frequency of occurrence.
