Identification of Failing Septic Systems

Final Report

Huron River Watershed Council

10/2/12

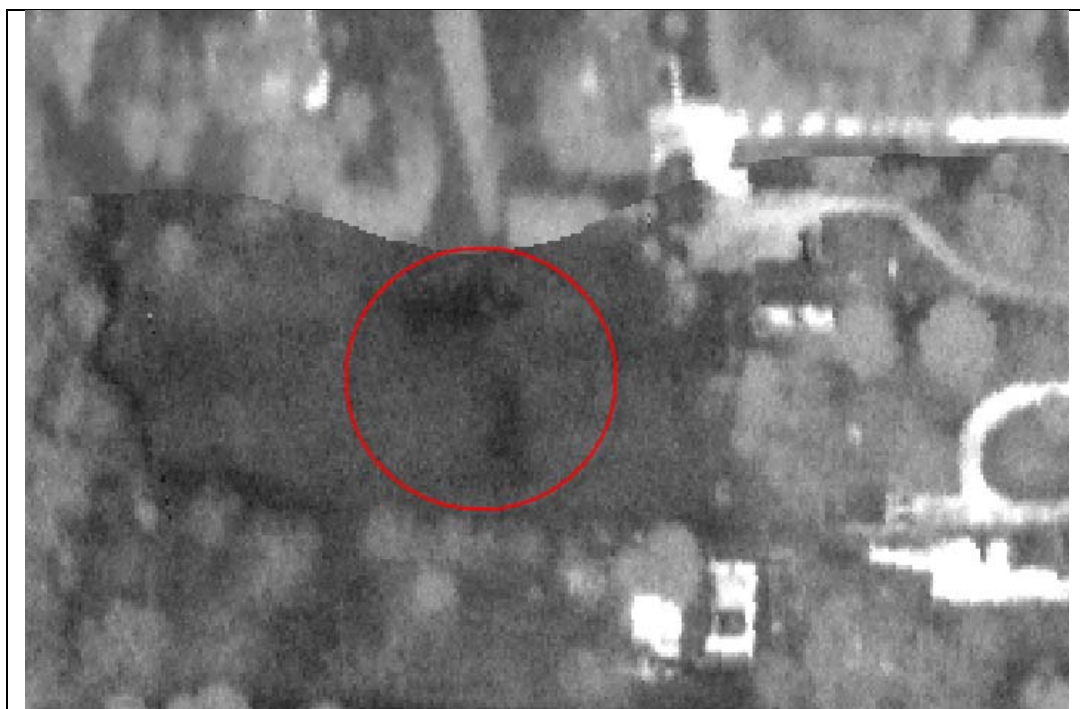
Figure 6: Possible septic signatures for a property in Scio Twp. These areas seem to indicate a lower temperature than the surrounding ground; this is probably an indication of a wetter area, which could indicate failure.

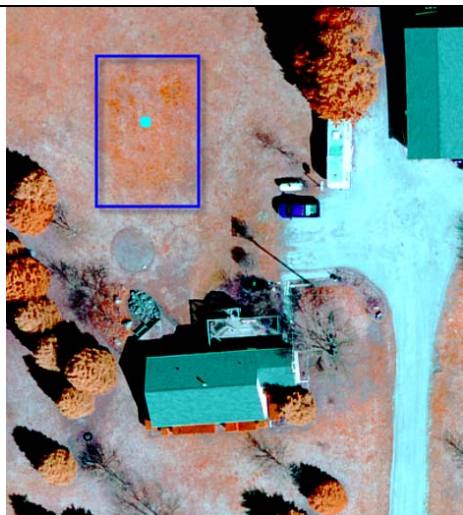
Object ID 48: Visible in both the CIR and Thermal imagery. No field sampling performed.

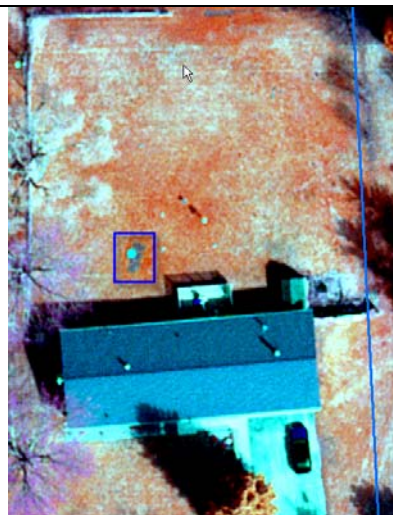
Object ID 60: Visible in the CIR, but no signature in the Thermal imagery. No field sampling performed.

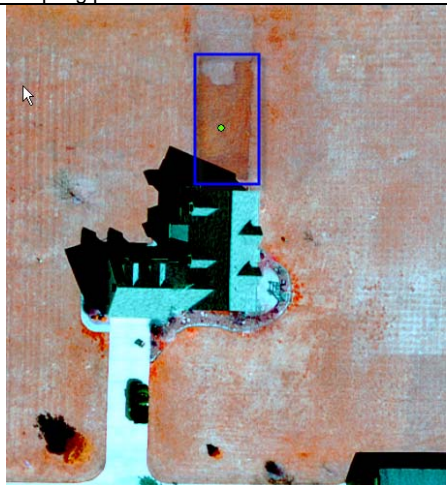
Object ID 74: Visible in both the CIR and Thermal imagery. No field sampling performed.

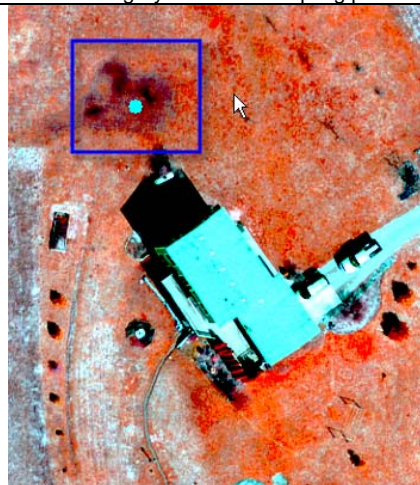
Object ID 100: Visible in the CIR, but no signature in the Thermal imagery. No field sampling performed.

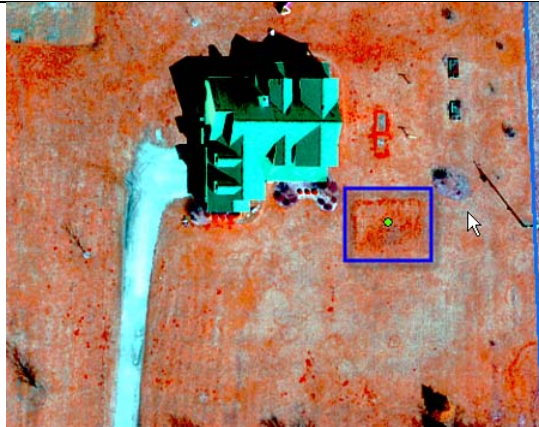
Object ID 101: Visible in the CIR, but no signature in the Thermal imagery. No field sampling performed.

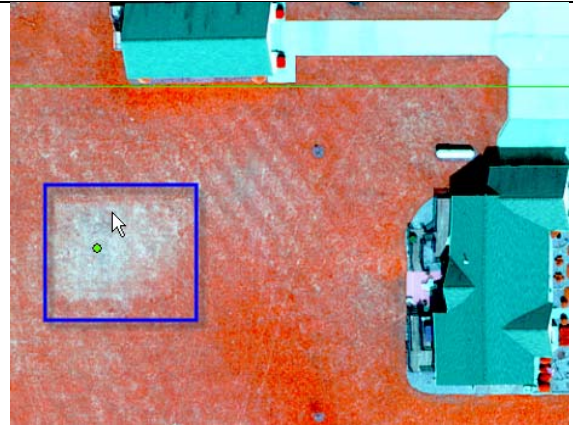
Object ID 152: Visible in both the CIR and Thermal imagery. Location confirmed by field sample 24 May 2012, field was found to have no saturation or biomat.

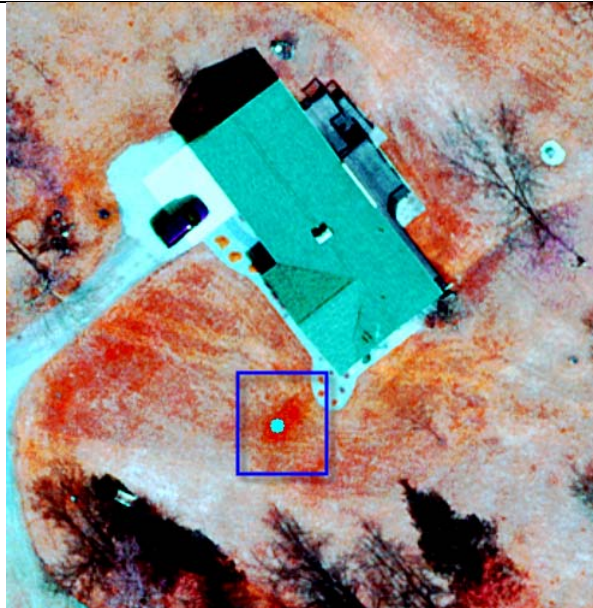
Object ID 1016: Visible in the CIR, but no signature in the Thermal imagery. No field sampling performed.

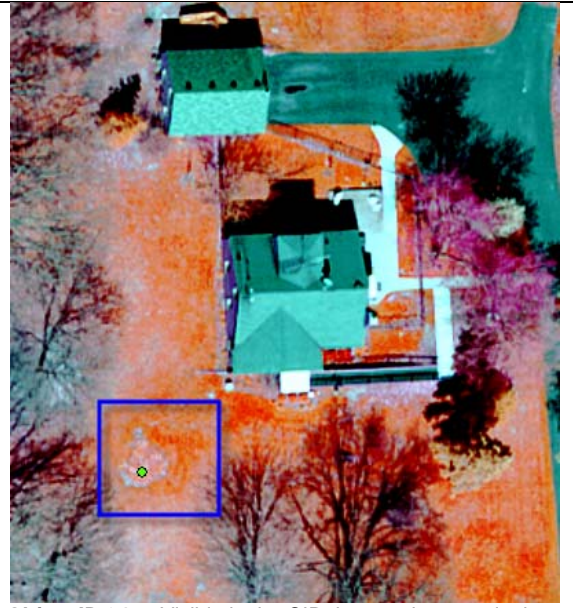
Object ID 947: Visible in the CIR, but no signature in the Thermal imagery. No field sampling performed.

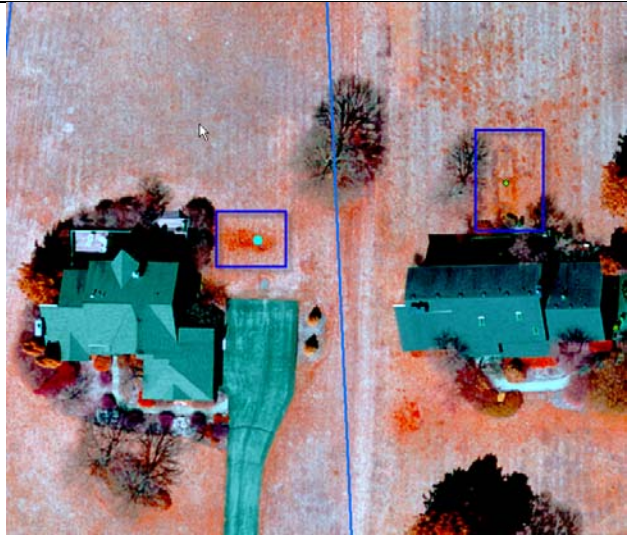
Object ID 925 and 926: Both locations were visible in the CIR, but no signature in the Thermal imagery. No field sampling performed.

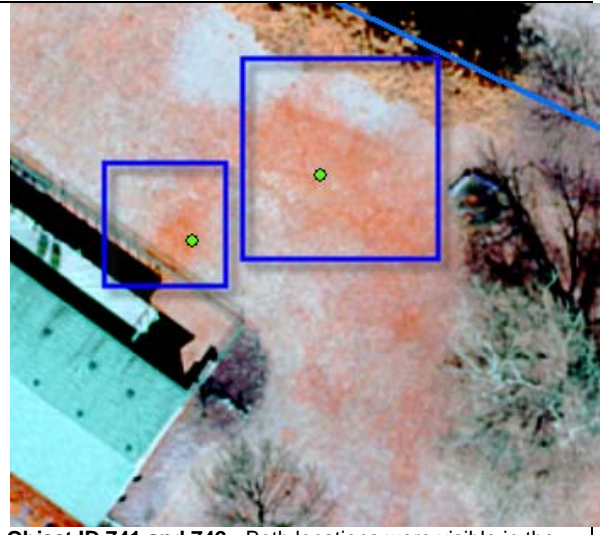
Object ID 741 and 742: Both locations were visible in the CIR, but no signature in the Thermal imagery. No field sampling performed.

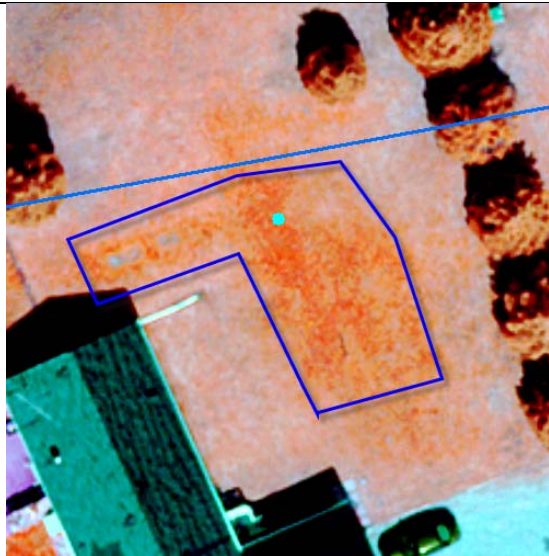
Object ID 676: Visible in both the CIR and Thermal imagery. No field sampling performed.

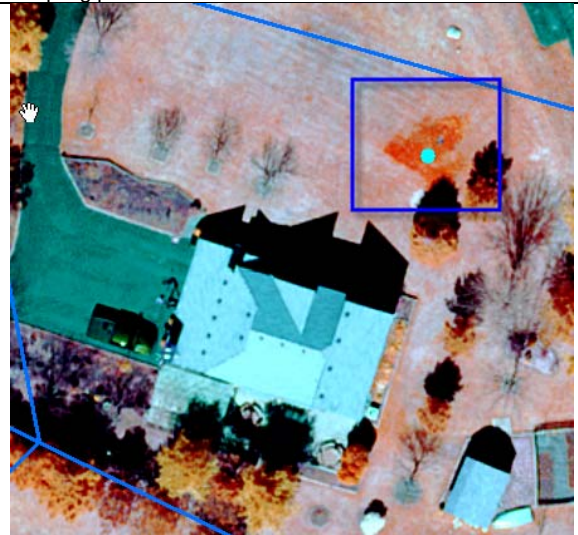
Object ID 621: Visible in both the CIR and Thermal imagery. No field sampling performed.

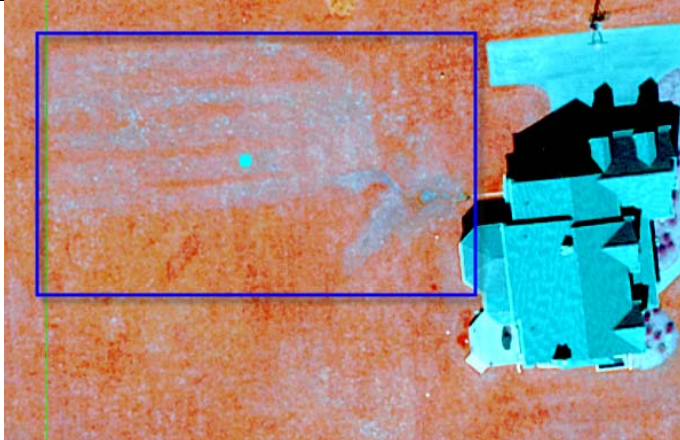
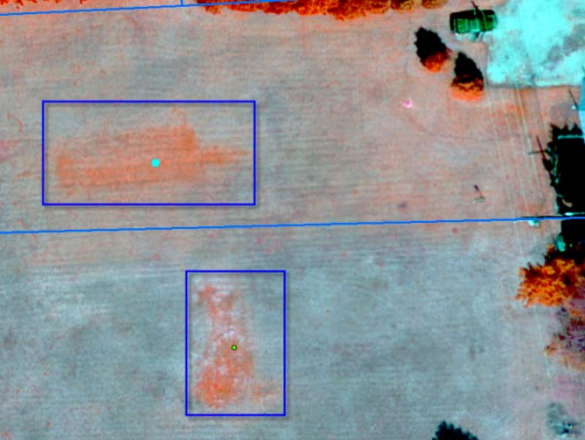
<p>Object ID 588: Visible in the CIR, but no signature in the Thermal imagery. No field sampling performed.</p>	<p>Object ID 353 and 354: Both locations were visible in both the CIR and Thermal imagery. No field sampling performed.</p>

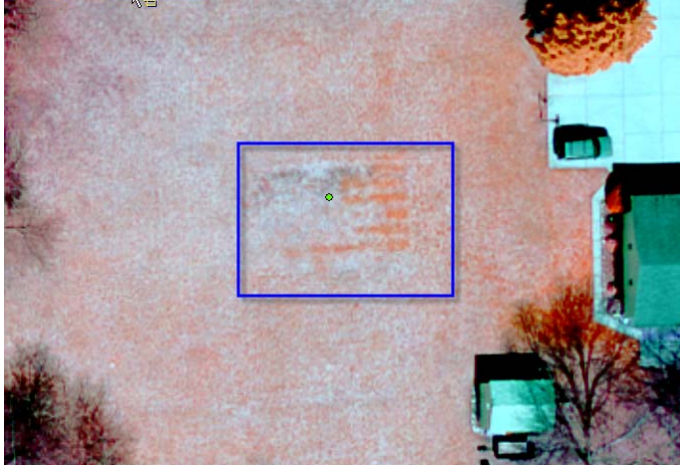
<p>Object ID 656: Visible in both the CIR and Thermal imagery. No field sampling performed.</p>

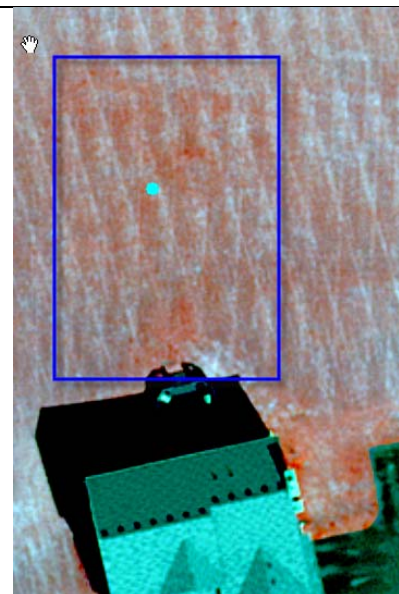
Object ID 2: Possible detections in both the CIR and Thermal imagery. No field sampling performed.

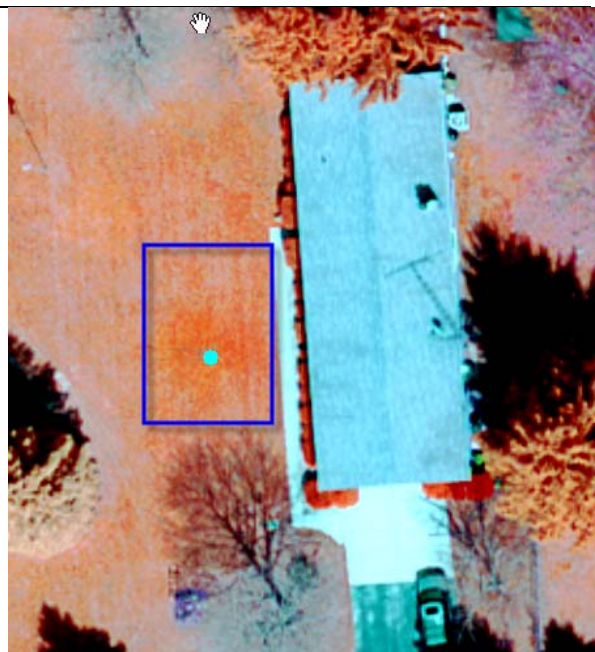
Object ID 14: Possible detection in the CIR imagery. Location confirmed by field sample 15 June 2012 as a septic tank. Field is 30 ft to the northwest, and was found to have no saturation or biomat.

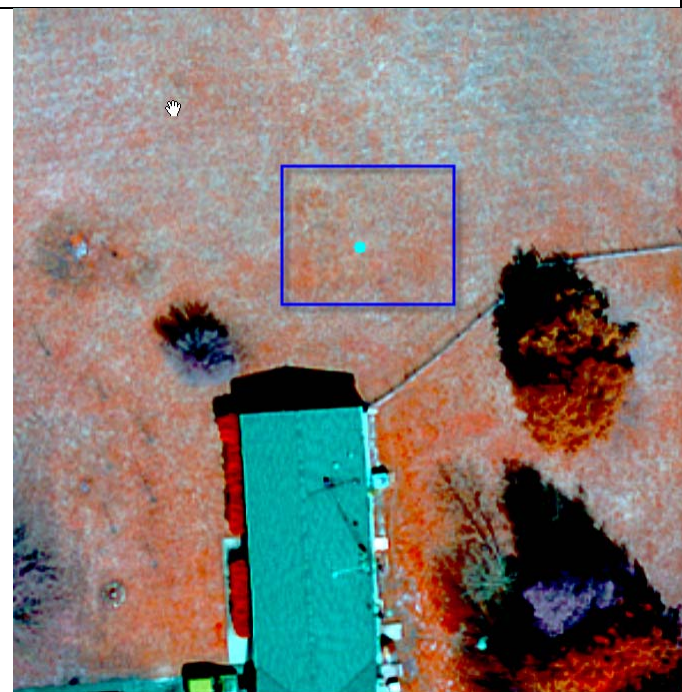
Object ID 18: Possible detection in the CIR imagery. Location was found in a field sample on 5 April 2012 to NOT be the septic field. Field is 90 ft to the north, and was found to have no saturation or biomat.

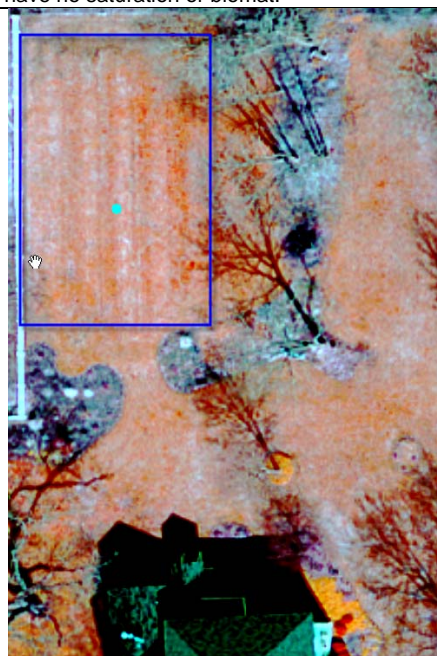
Object ID 19: Possible detections in both the CIR and Thermal imagery. No field sampling performed.

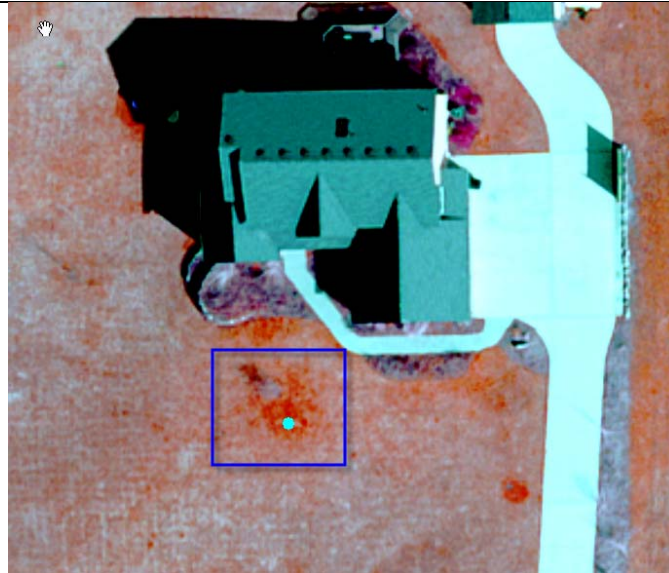
Object ID 38: Possible detection in the CIR imagery. No field sampling performed.

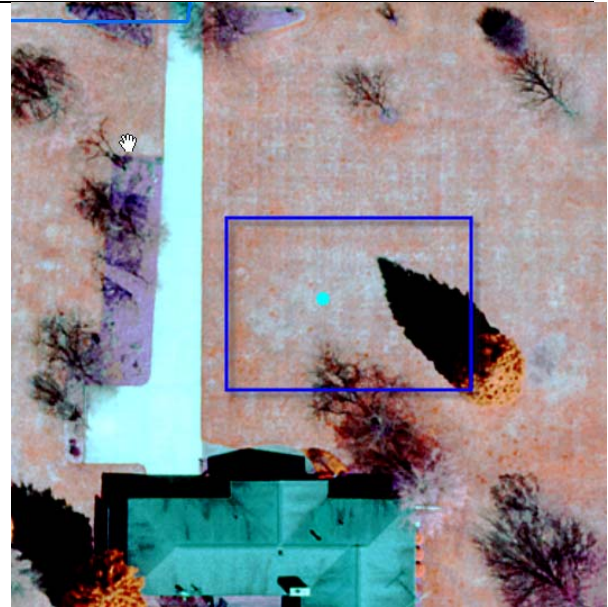
Object ID 73: : Possible detection in the CIR imagery. Location confirmed by field sample 20 June 2012; field was found to have no saturation or biomat.
