STM32F101xC/D/E and STM32F103xC/D/E high-density device limitations

Silicon identification

This errata sheet applies to the revisions Z, Y, 1, 2, 3 and X of the STMicroelectronics STM32F101xC/D/E access line and STM32F103xC/D/E performance line high-density products. These families feature an ARM® 32-bit Cortex®-M3 core, for which an errata notice is also available (see [Section 1](#) for details).

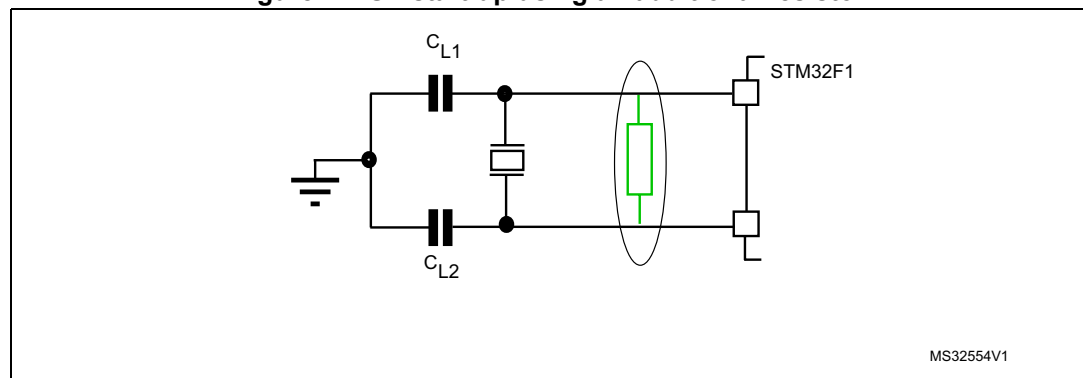
Figure 1. LSE start-up using an additional resistor

The LSE (Low Speed External) oscillator system has been designed to minimize the overall power consumption of the STM32F1 microcontroller. It is extremely important to take specific care in the design of the PCB to ensure this low power oscillator starts in harsh conditions. In some PCB designs without coating, an induced low leakage may prevent the LSE to start-up, regardless of the 32.768 KHz crystal used. This phenomenon is amplified in humid environments that create frost on the OSC32_IN/OSC32_OUT tracks. This unwanted behavior may happen only at the first back-up domain power-on of the device.

It is recommended to mount an additional parallel feedback resistor (from 16 M Ω to 22 M Ω) on board to help the oscillation start-up in all cases (see [Figure 1](#)). For more details on compatible crystals and hardware techniques on PCB, refer to AN2867 application note.
