# *Inspection Report*

General information	
name	TestLongEnoughName COMPANY
line1	3001 South King Dirve
line2	Apt215
City	Chicago
State	IL
Country	United State
Zipcode	60616
Total Failure	6
Tips	HAHAHA

Inspection Area Info	
MODULE MODEL	CHINA SUNERGY CSUN310-72P
MODULE STC DC RATING	310W
MODULES PER SOURCE CIRCUIT	19
TOTAL MODULE COUNT	8,436
TOTAL STC DC SYSTEM SIZE (KW)	2615.16
TOTAL AC SYSTEM SIZE (KW)	2000
INVERTER MODEL	(2) SOLECTRIA SGI 750XTM (750kW) AND (1) 500XTM (500kW)
RACKING SYSTEM	GAME CHANGE
MODULE TILT	25°
ARRAY AZIMUTH	180°
SITE LATITUDE	36°N

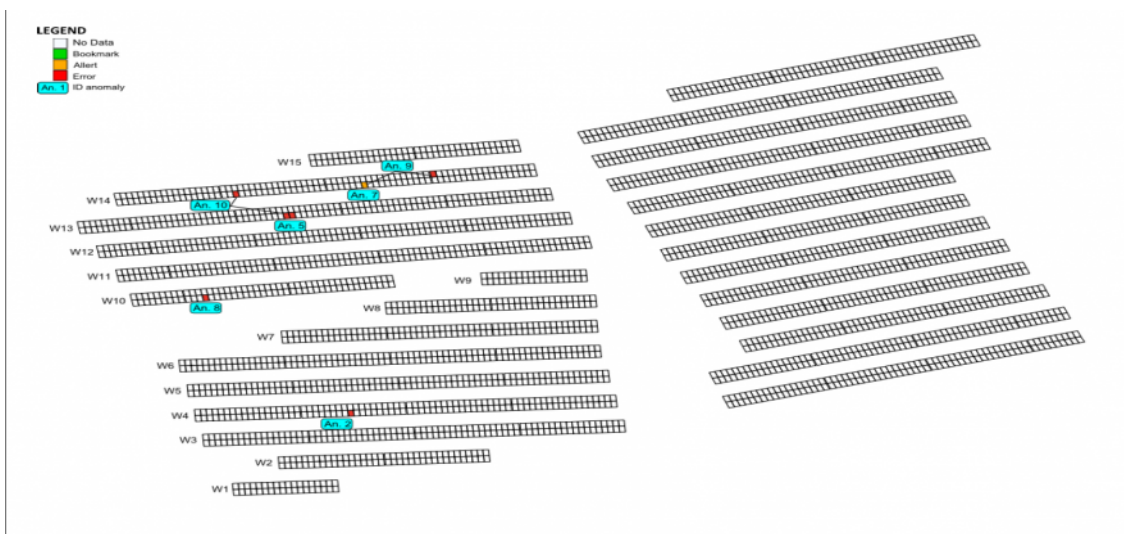
### *Index map of detected failures*

Panel Label	Issue
CB-1.1-2.3	Cell Hotspot
CB-1.1-2.13	Defective Bypass Diode
CB-1.1-7.2	Connector or Fuse Issue
CB-1.3-9.14	Cell Hotspot
CB-1.4-15.14	Cell Hotspot
CB-1.7-10.13	Connector or Fuse Issue
