## Inspection Report

General information	
<b>name</b>	<i>TestLongEnoughName COMPANY</i>
<b>line1</b>	<i>3001 South King Dirve</i>
<b>line2</b>	<i>Apt215</i>
<b>City</b>	<i>Chicago</i>
<b>State</b>	<i>IL</i>
<b>Country</b>	<i>United State</i>
<b>Zipcode</b>	<i>60616</i>
<b>Total Failure</b>	<i>6</i>
<b>Tips</b>	<i>HAHAHA</i>

Inspection Area Info	
MODULE MODEL	CHINA SUNERGY CSUN310-72P
MODULE STC DC RATING	310W
MODULES PER SOURCE CIRCUIT	19
TOTAL MODULE COUNT	8,436
TOTAL STC DC SYSTEM SIZE (KW)	2615.16
TOTAL AC SYSTEM SIZE (KW)	2000
INVERTER MODEL	(2) SOLECTRIA SGI 750XTM (750kW) AND (1) 500XTM (500kW)
RACKING SYSTEM	GAME CHANGE
MODULE TILT	25°
ARRAY AZIMUTH	180°
SITE LATITUDE	36°N

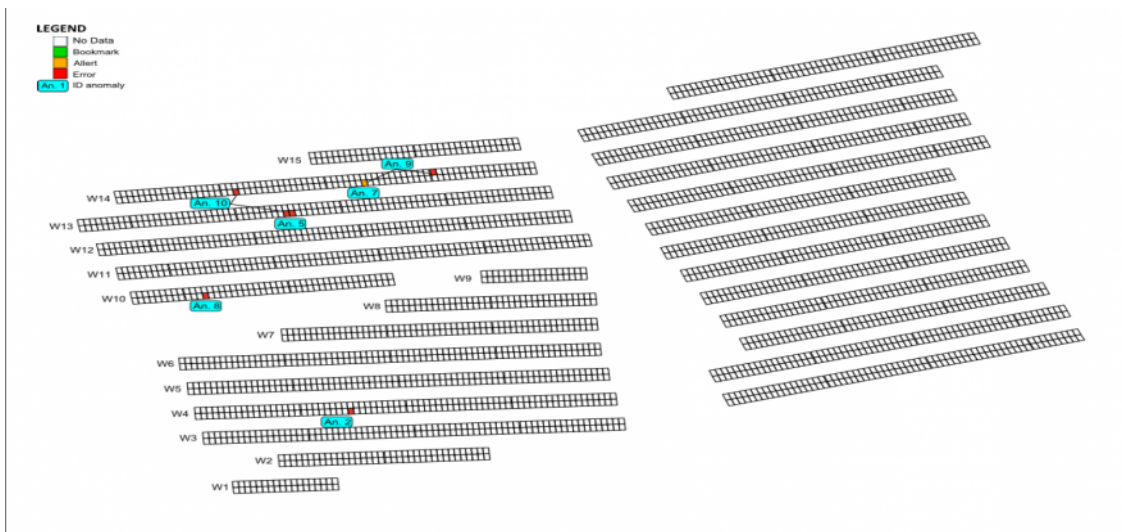
## Index map of detcted failures

Panel Label	Issue
CB-1.1-2.3	Cell Hotspot
CB-1.1-2.13	Defective Bypass Diode
CB-1.1-7.2	Connector or Fuse Issue
CB-1.3-9.14	Cell Hotspot
CB-1.4-15.14	Cell Hotspot
CB-1.7-10.13	Connector or Fuse Issue
