Tunnel Principal Inspection Report

Islington Tunnel

Regents Canal

RE-007-005

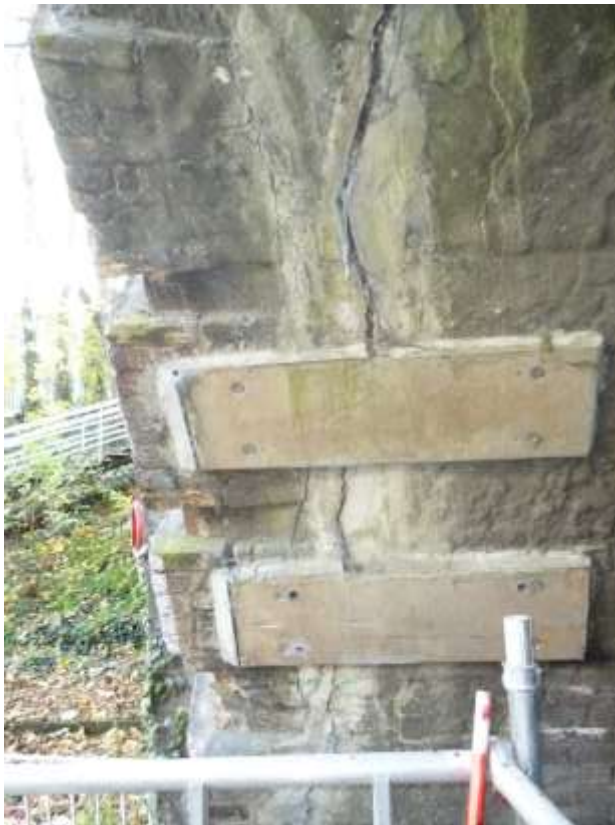
There is an existing circumferential crack at ch.1m in from the East Portal. This crack is open with further movement evident since the installation of the stainless-steel panels (open mortar joints around the panels).

Ch.1m LHS – Circumferential crack with plate repair (with further movement noted since installation)

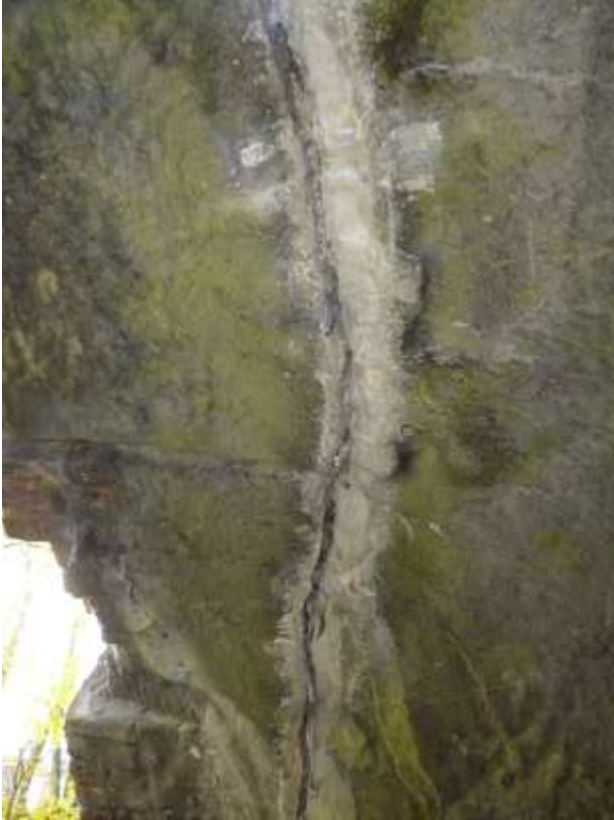
Ch.1m Crown – Circumferential crack

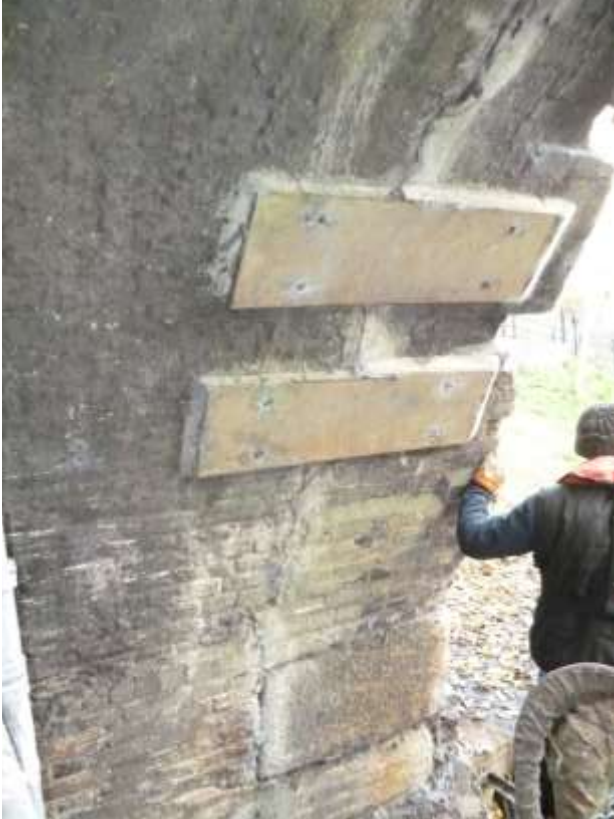
Ch.1m RHS – Circumferential crack with bolted plate repairs

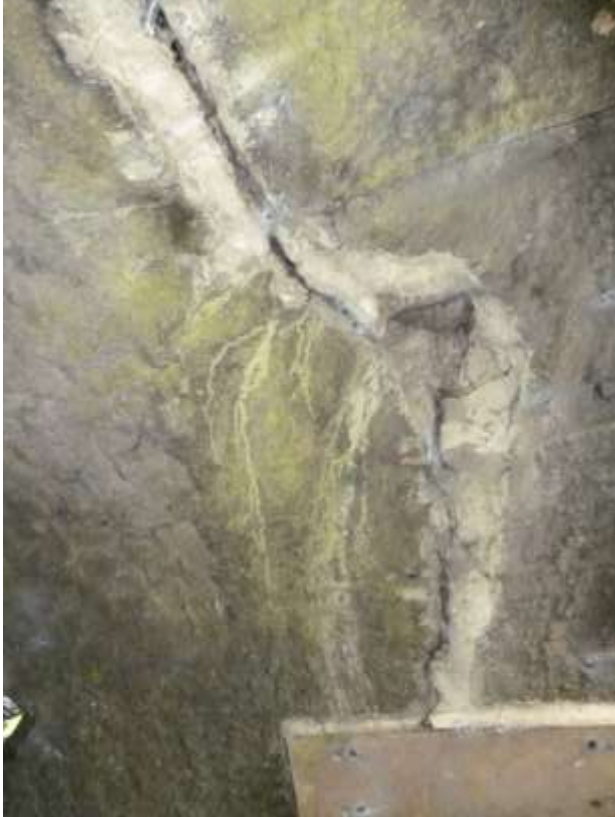
Ch.1m RHS – Circumferential crack

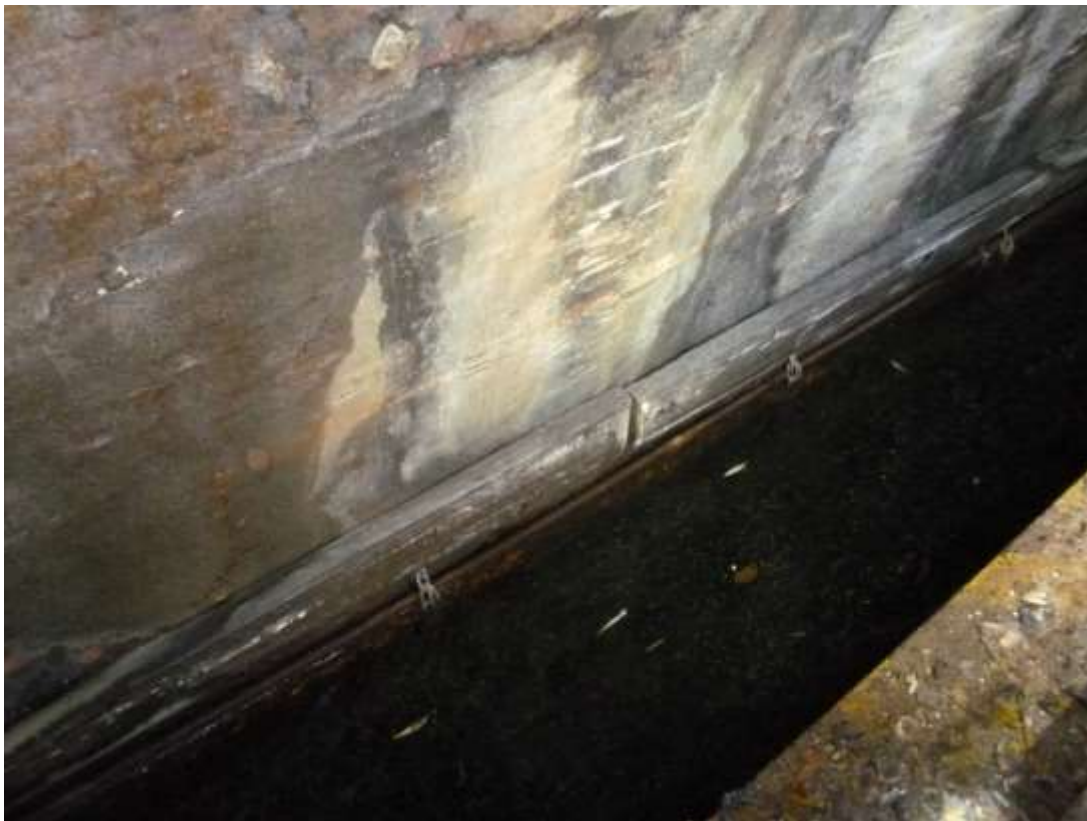
Ch.160m RHS – Grab chain hanging loose (this is a widescale issue)

The fender is intact, but the grab chain is broken and hanging loose over a long length. The fibreoptic cable ducting is extensively corroded and at least two short sections are missing leaving the cable exposed. Another section of ducting near the west end is hanging loose.

The grab chain is hanging loose over a considerable length of the tunnel and requires re-connecting.

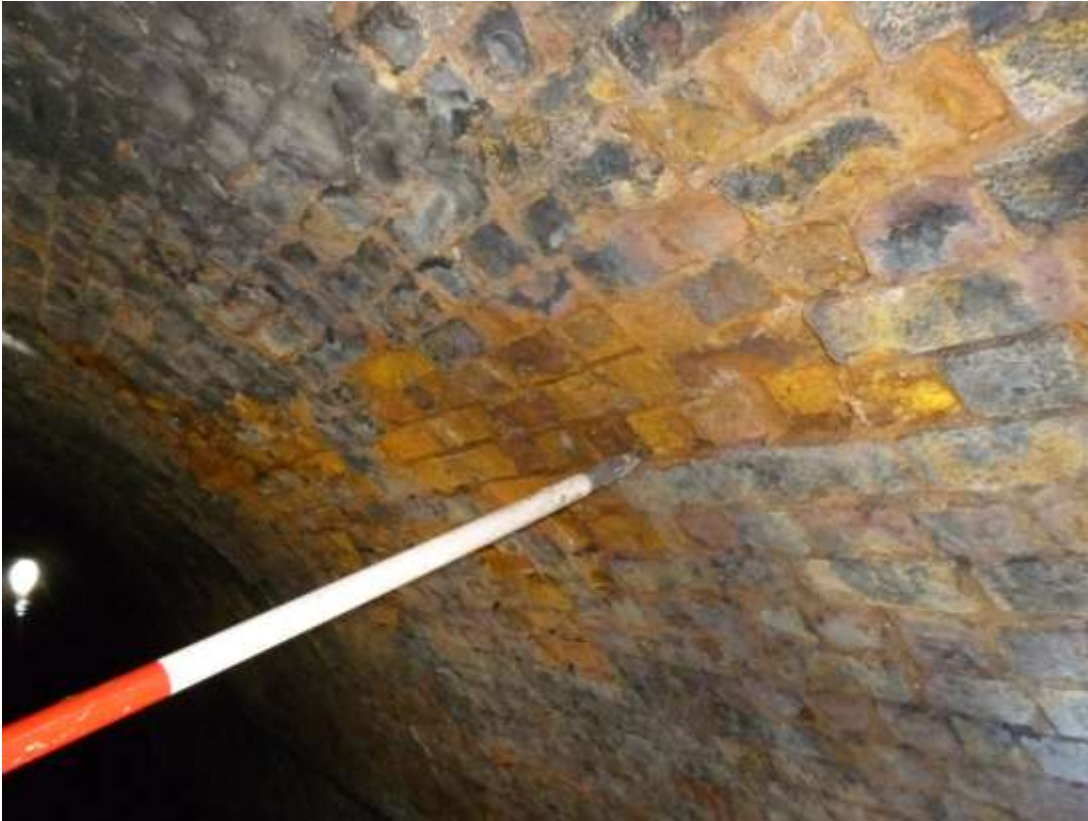
Ch.257m LHS – Damp, soft, perished brick faces, and soft mortar

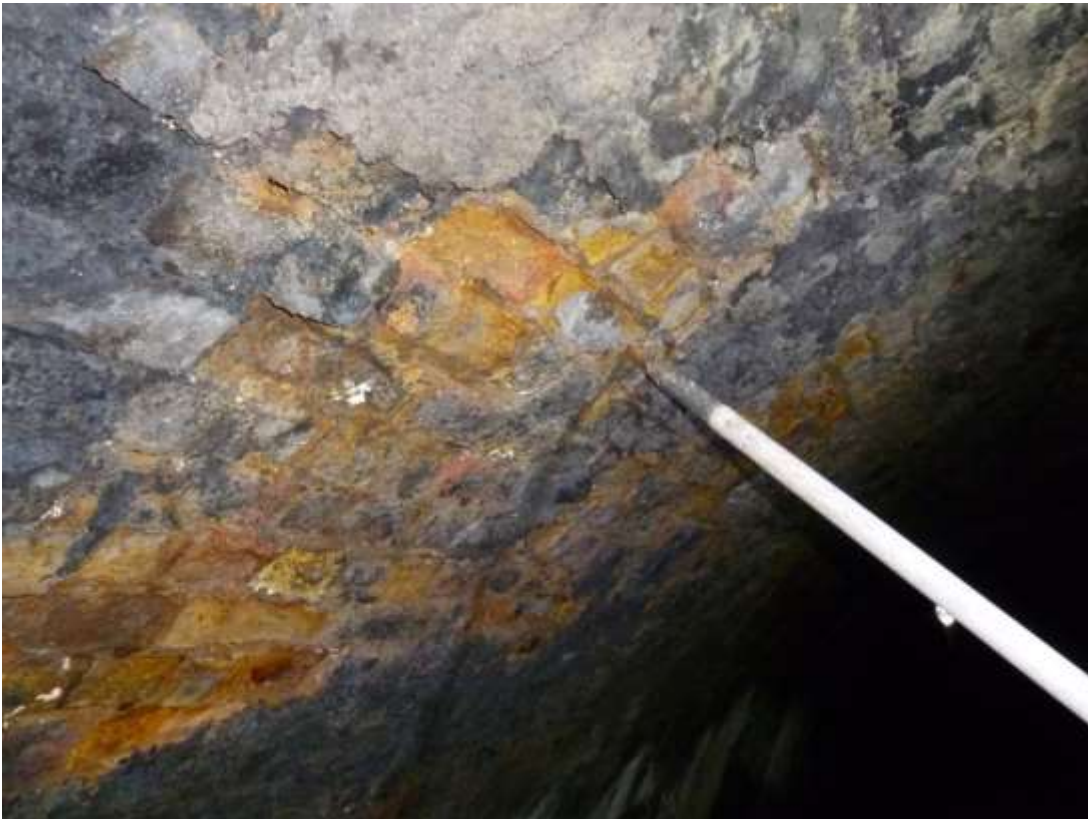
Ch.282m RHS – Damp, soft, perished brick faces, and soft mortar

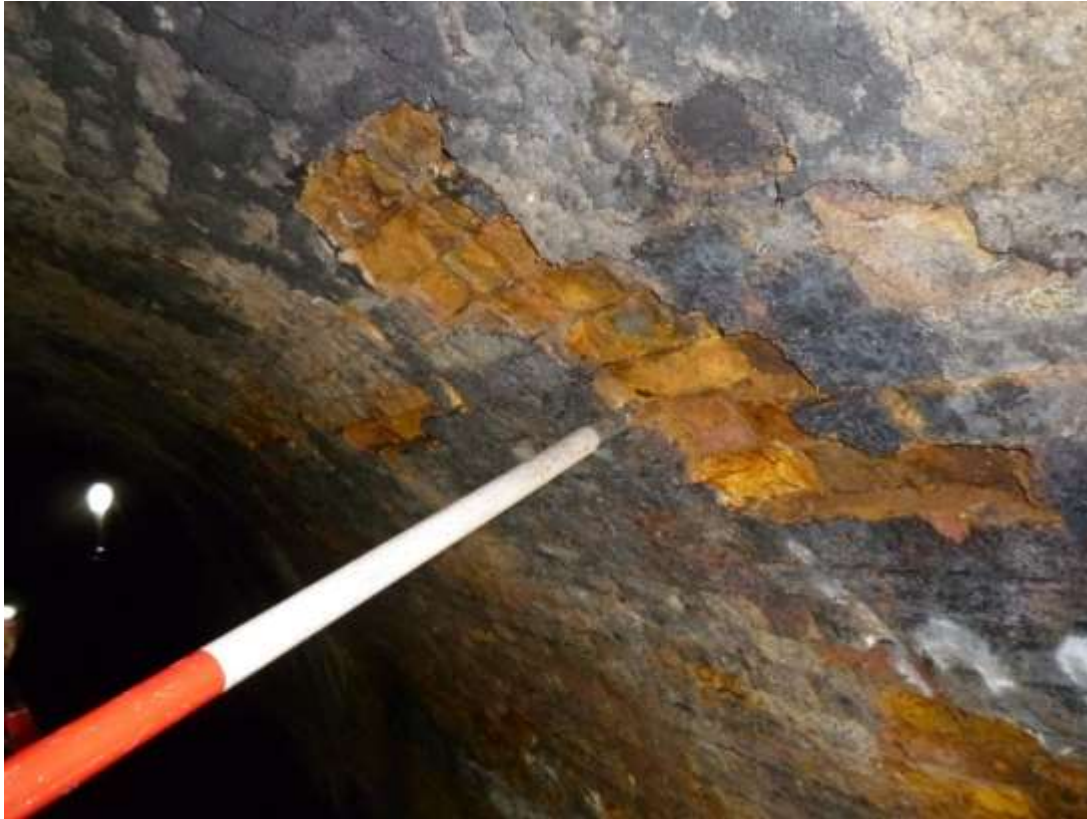
Ch.282m LHS – Damp, soft, perished brick faces, and soft mortar

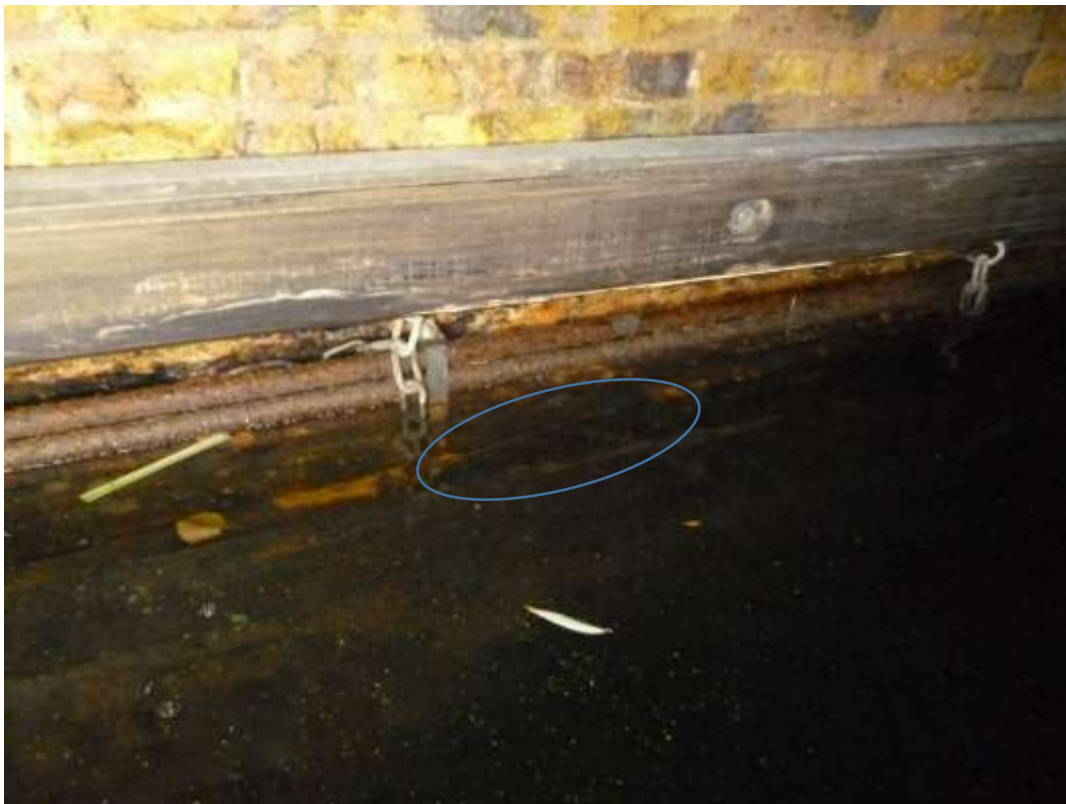
Ch.301m RHS – Fiberoptic cable pipe hanging down and corroded/missing. Grab chain hanging loose.

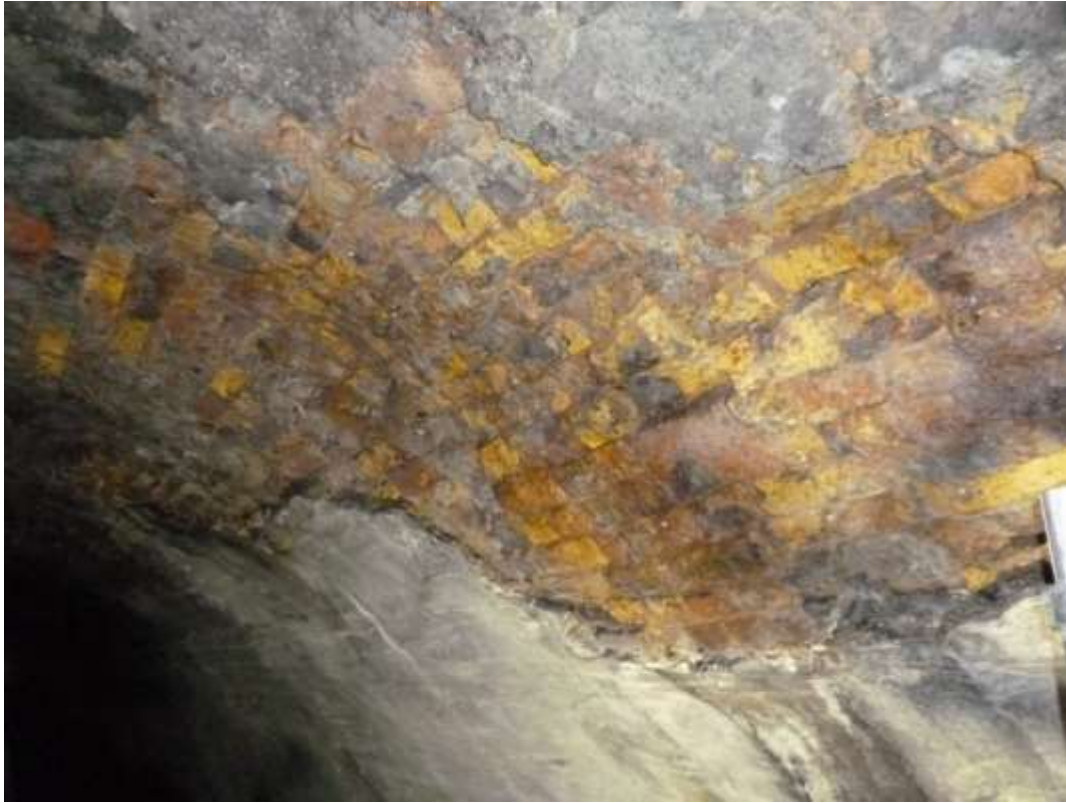
Ch.327m LHS – Missing shotcrete repair revealing spalled brickwork behind the repair

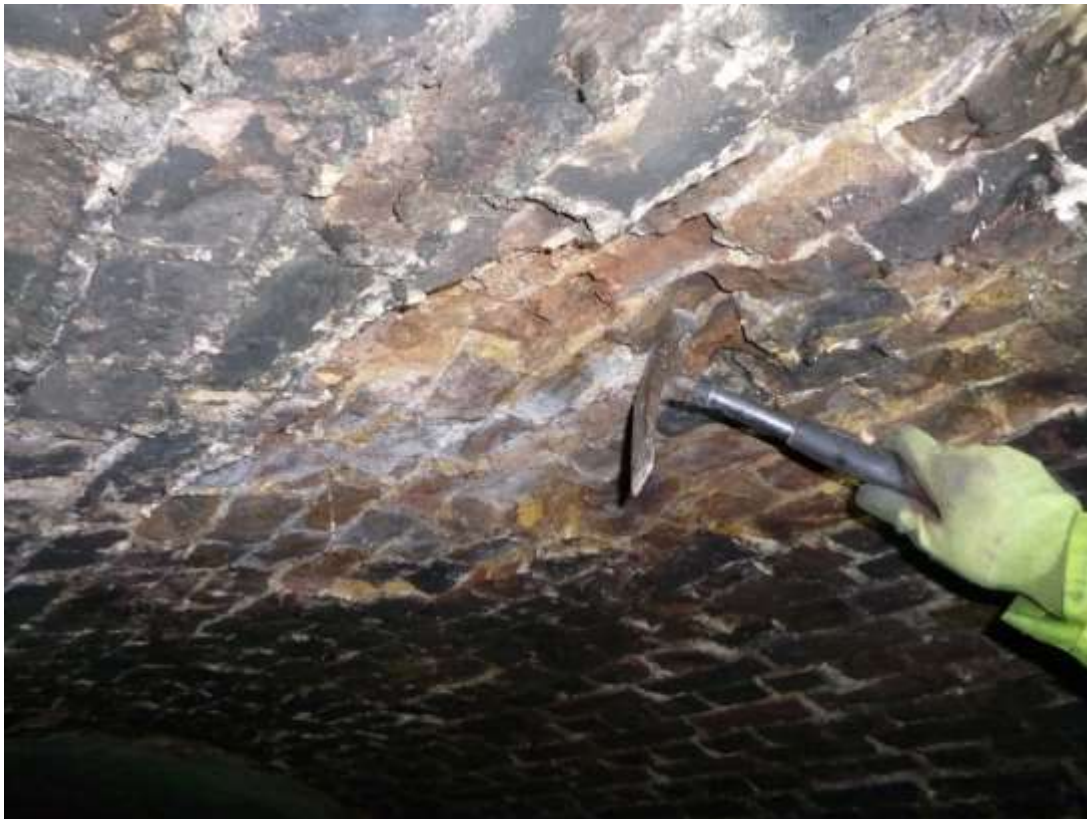
Ch.476m Crown – Spalled brickwork, trimmed on PI

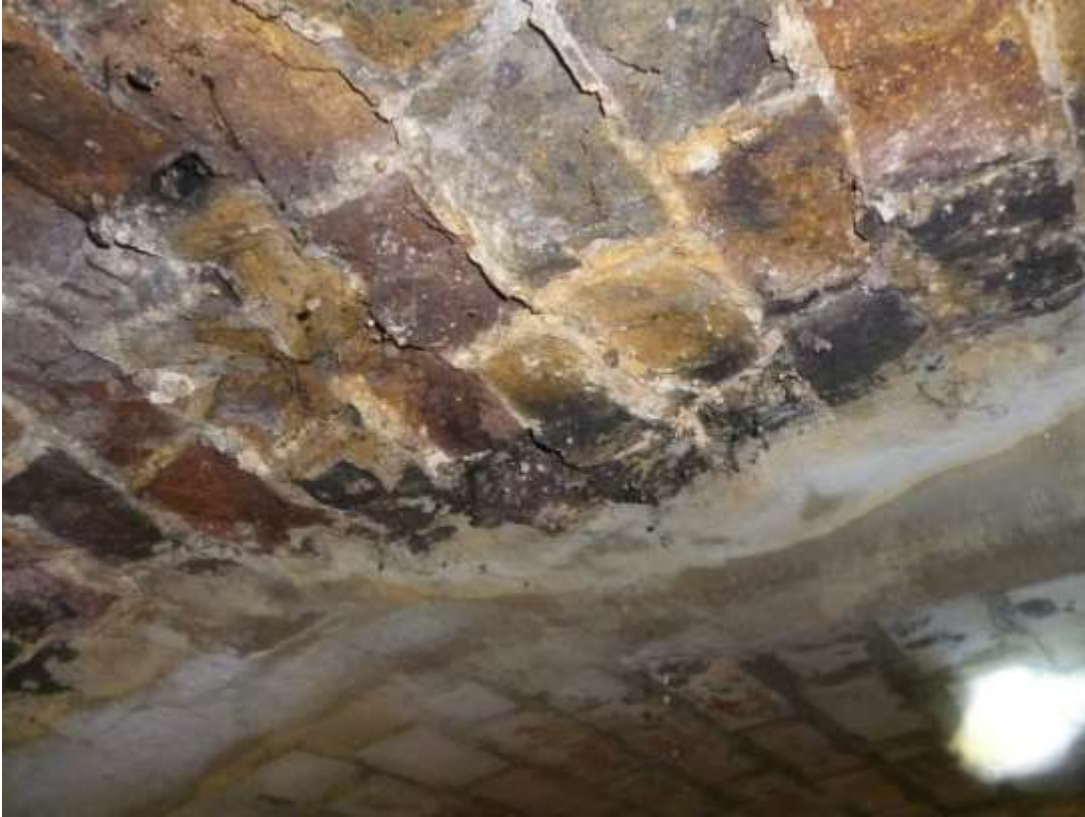
Ch.604m Crown – Spalled brickwork outside new brickwork repair

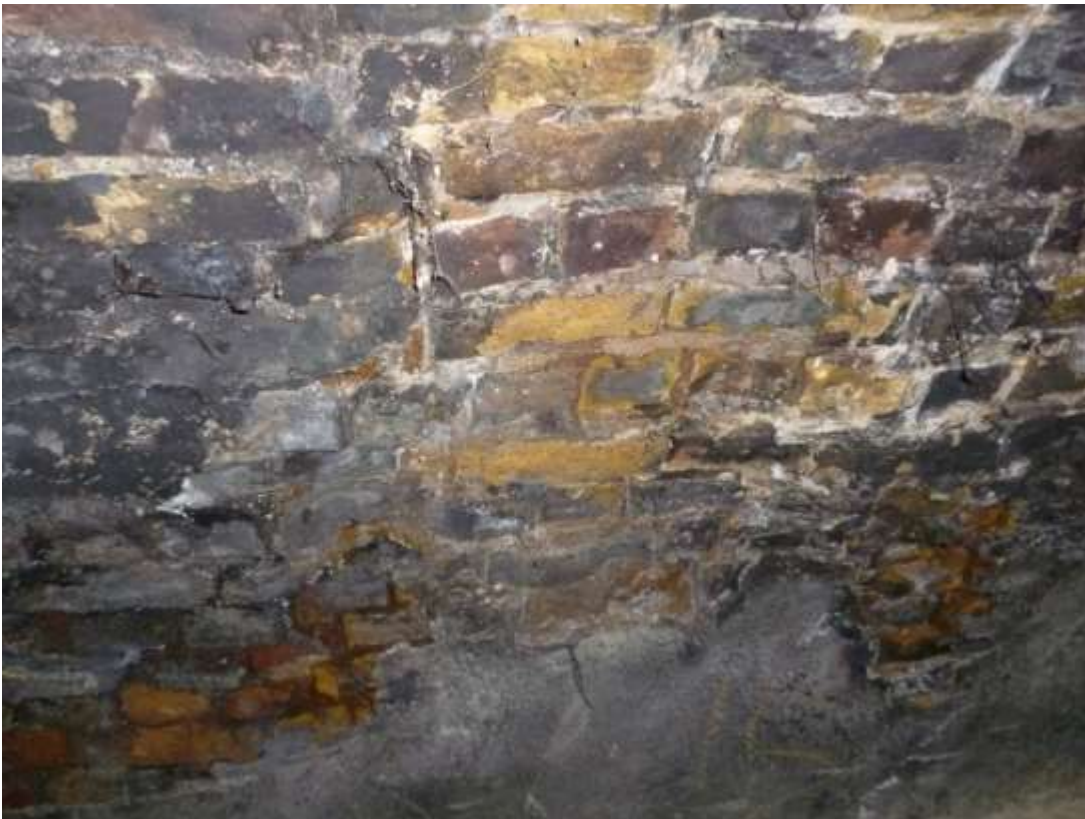
Ch.690m RHS – Spalled brickwork, trimmed on PI

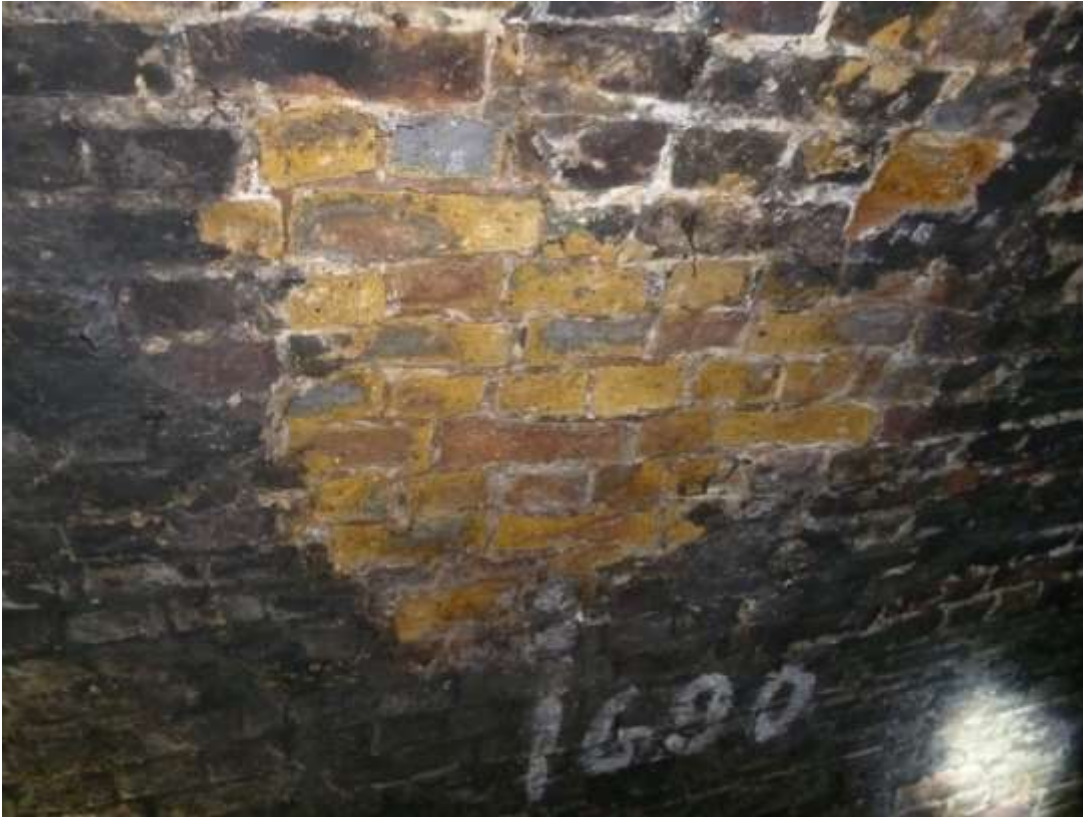
Ch.690m LHS – Spalled brickwork, trimmed on PI

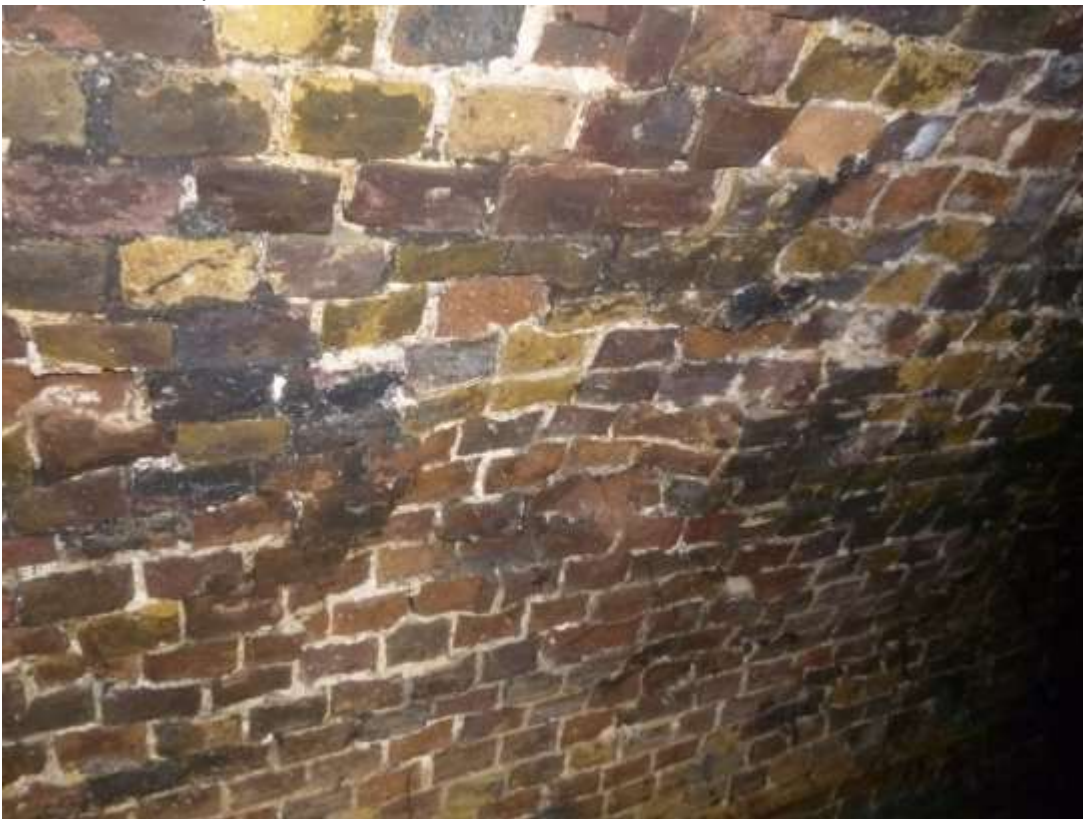
Ch.810m RHS – Spalled brickwork, trimmed on PI

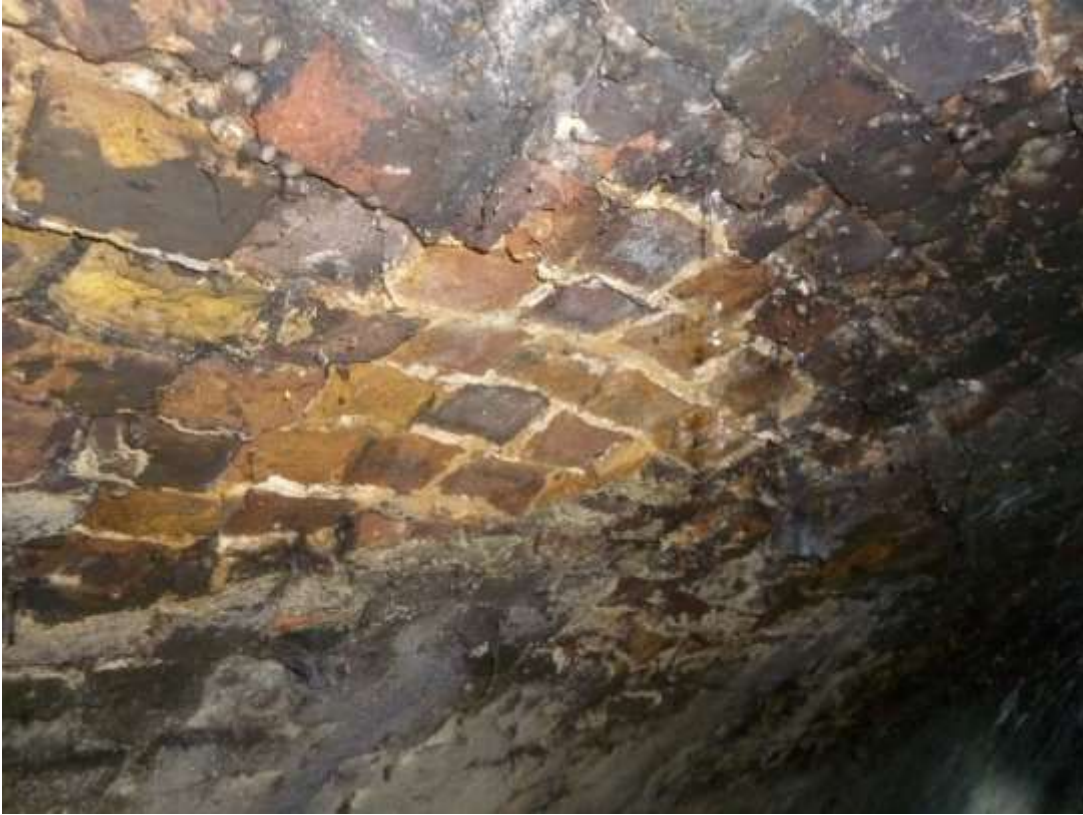
Ch.842m LHS – Spalled brickwork, trimmed on PI

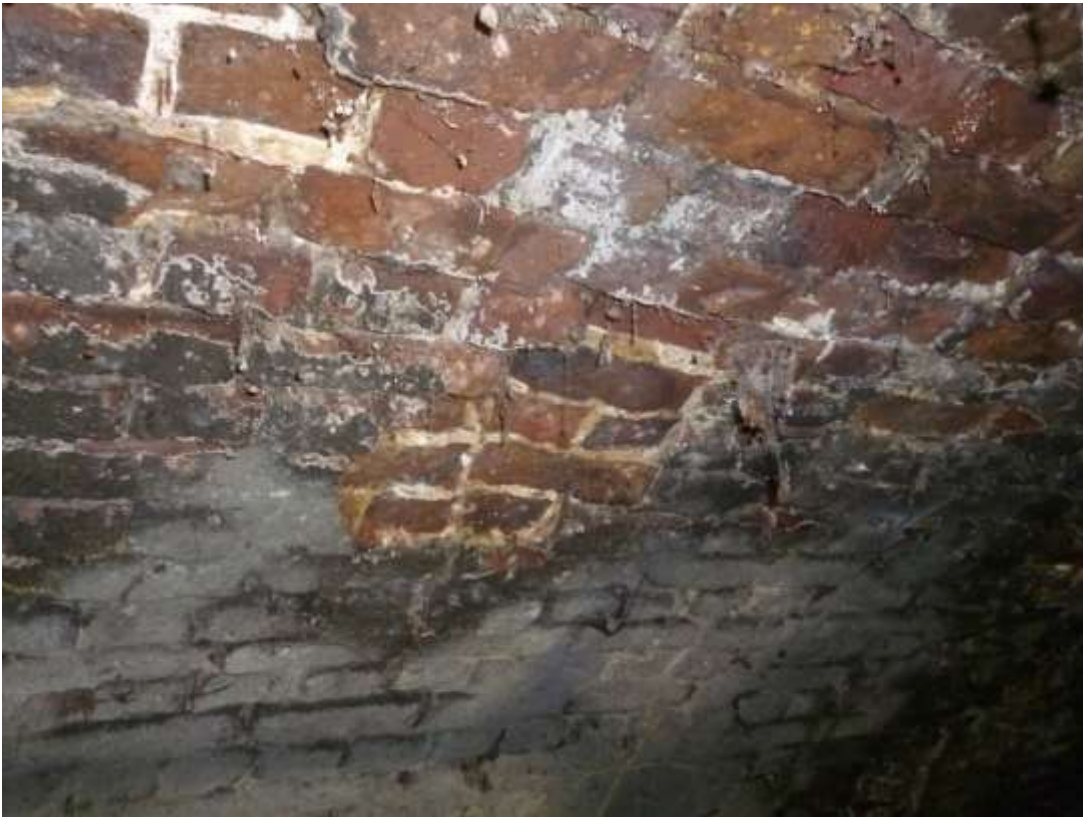
Ch.849m RHS – Spalled brickwork, trimmed on PI

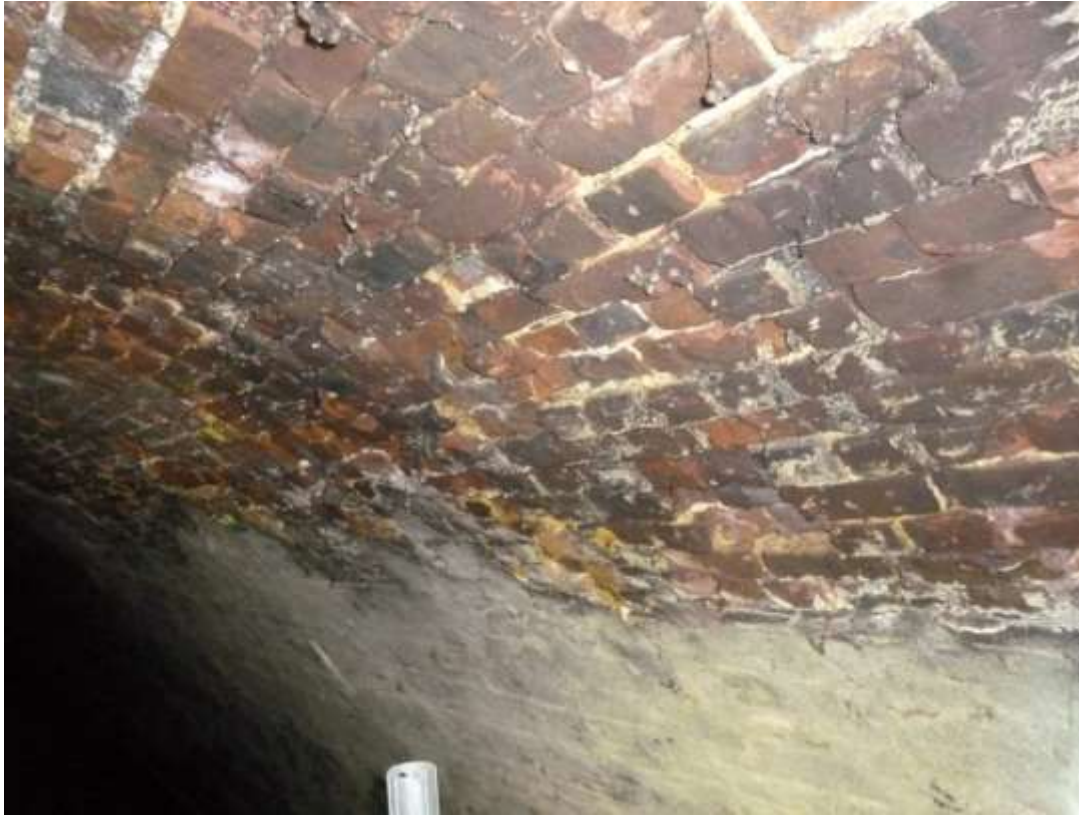
Ch.849m LHS – Spalled brickwork, trimmed on PI

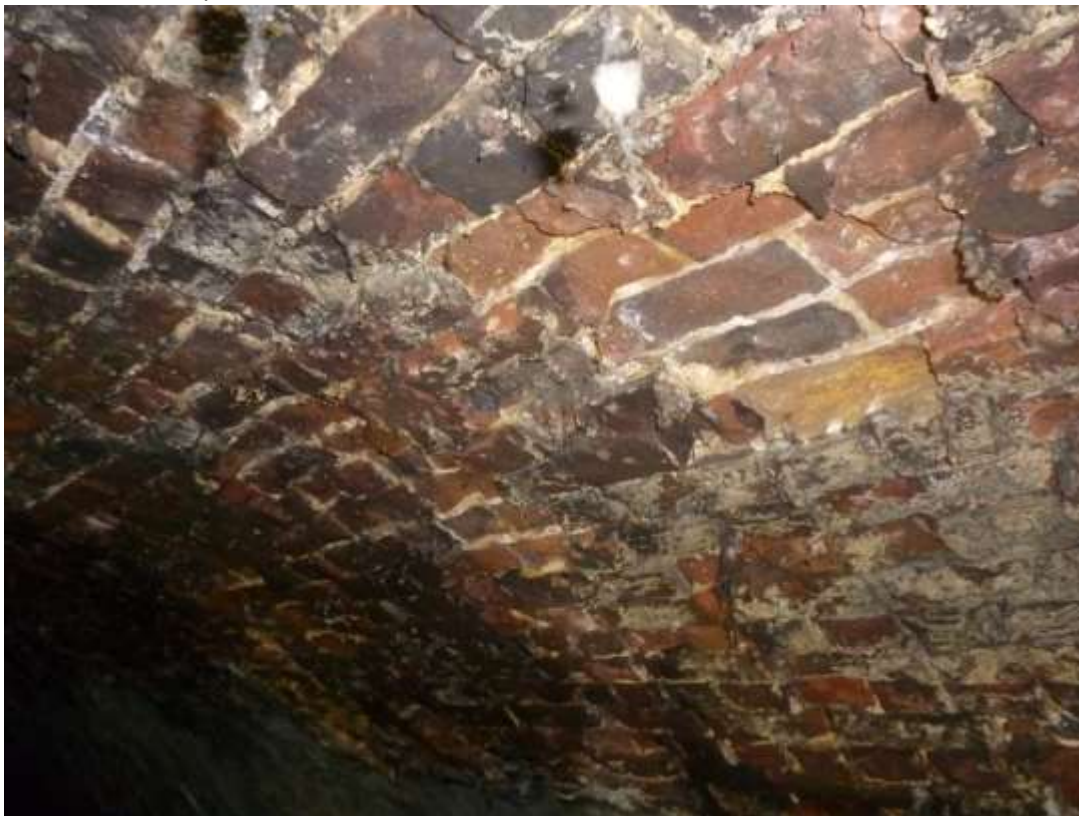
Ch.849m LHS – Spalled brickwork, trimmed on PI

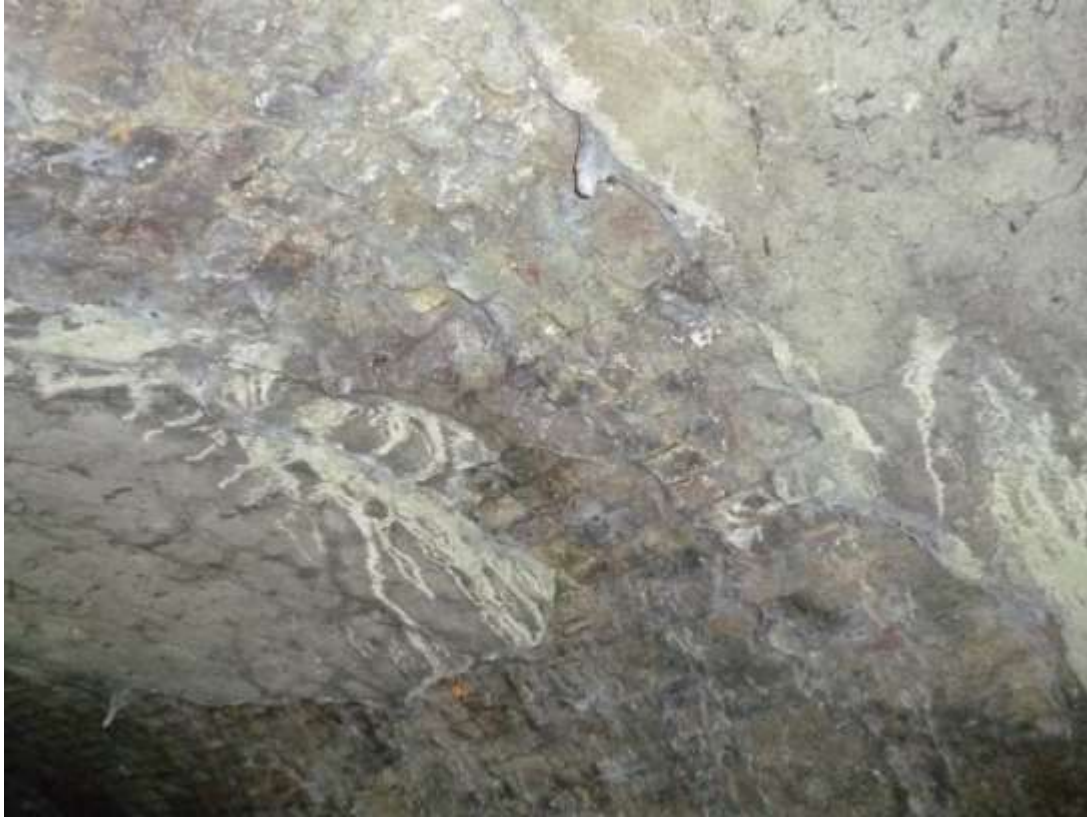
Ch.873m LHS – Circumferential crack

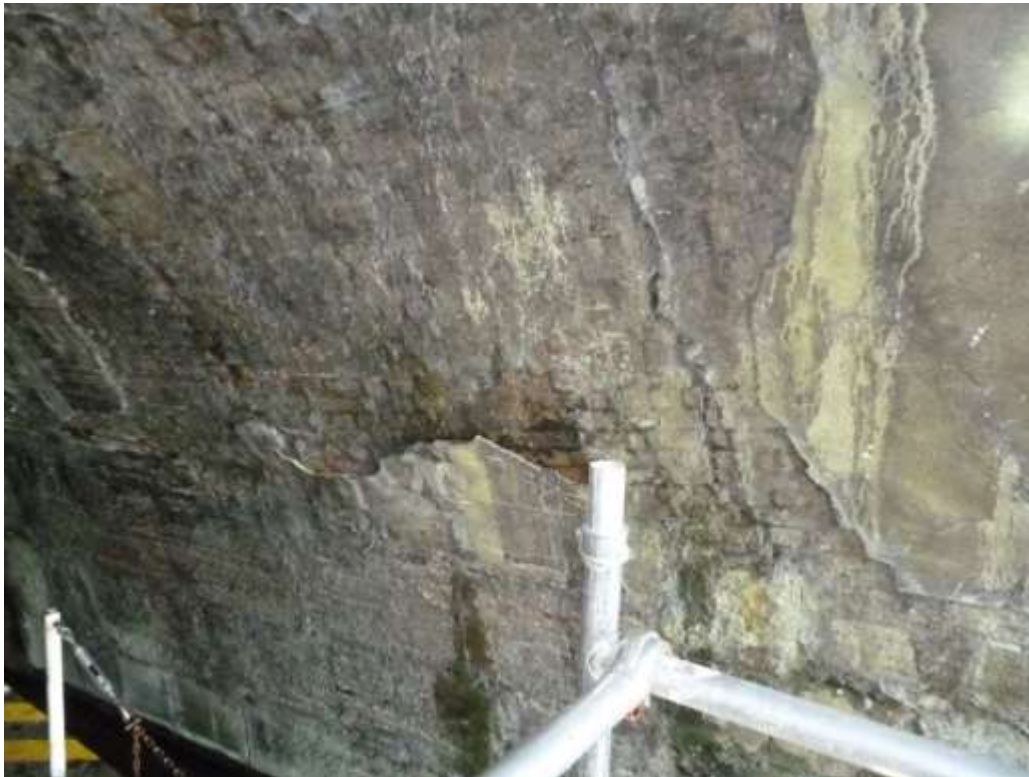
Ch.873m LHS – Circumferential crack

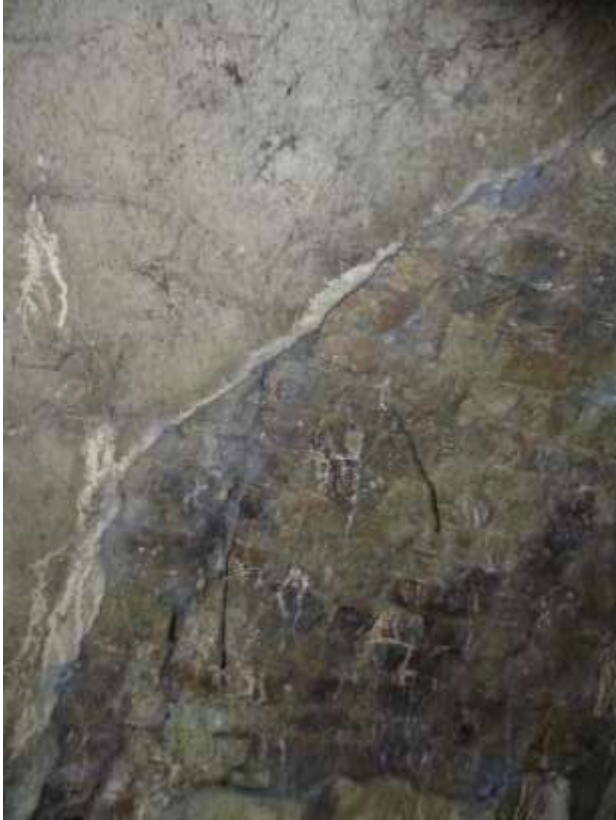
Ch.873m RHS – Circumferential crack

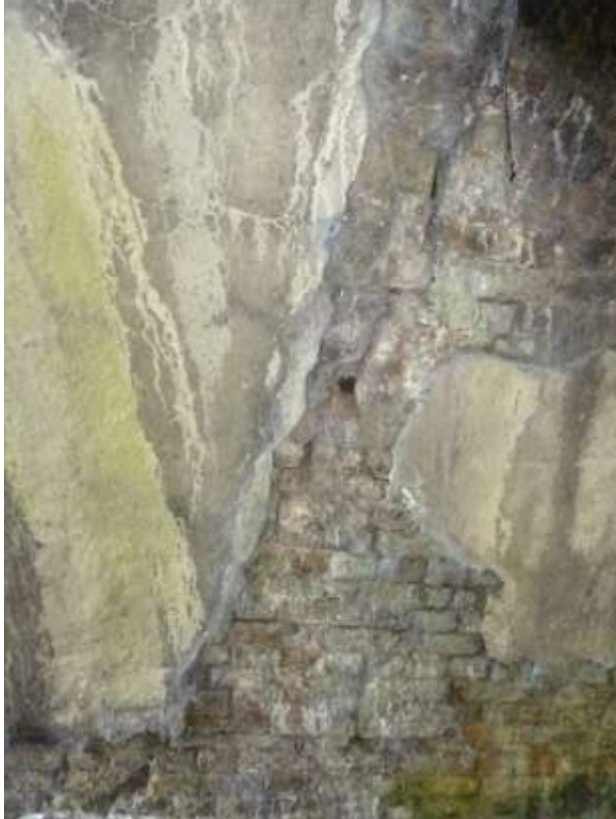
Ch.873m RHS – Circumferential crack

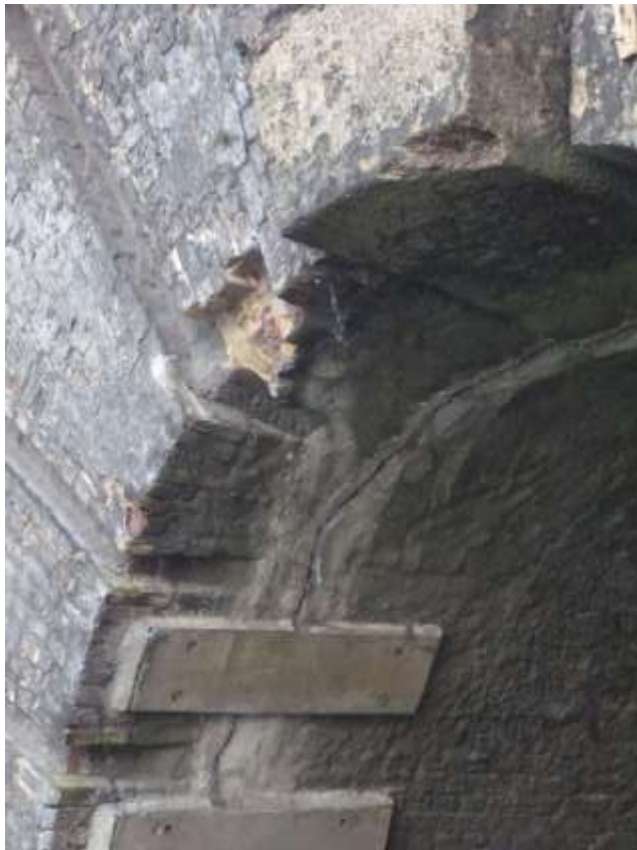
East Portal – circumferential crack to the intrados of the arch on the south side of the tunnel

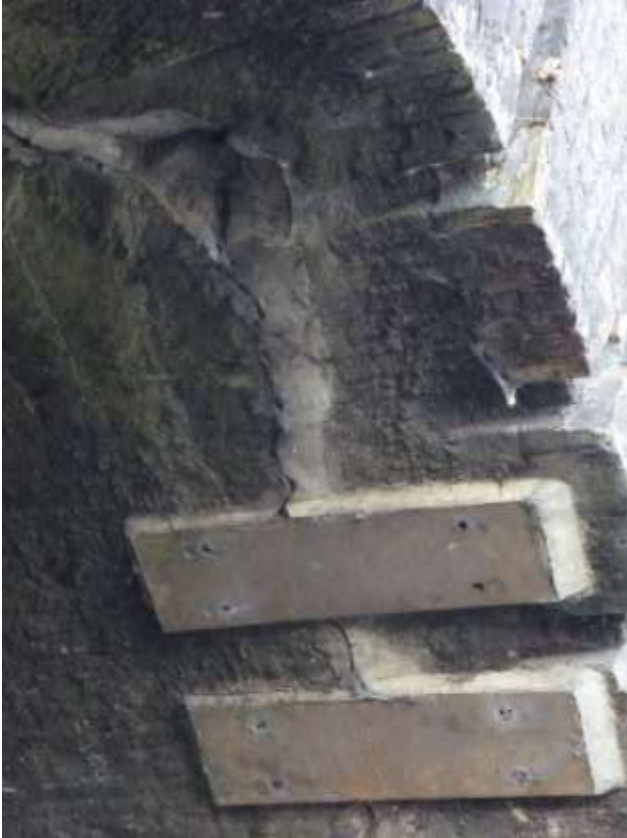
East Portal – circumferential crack to the intrados of the arch on the north side of the tunnel

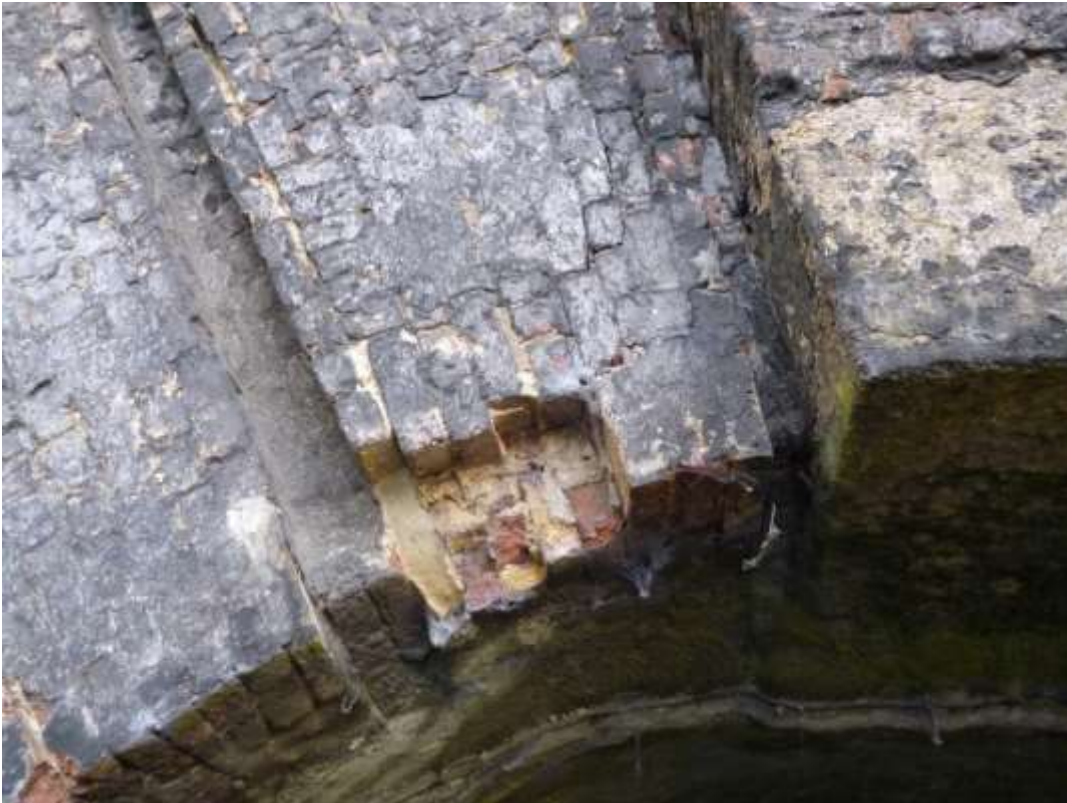
A section of five loose bricks were trimmed from the front face of the East Portal arch ring on the PI in 2005 (in the first panel of voussoir brickwork to the south side of the keystone) and there are hairline radial cracks in the portal face and a circumferential hairline crack within the tunnel. This has created a small area of brickwork which could become loose and fall out in an uncontrolled manner. This defect is not considered to affect the structural stability of the portal but is a safety related issue with a recommendation to repoint the spandrel and patch repair the small missing areas.

East Portal – Missing bricks in first panel to the south of the keystone

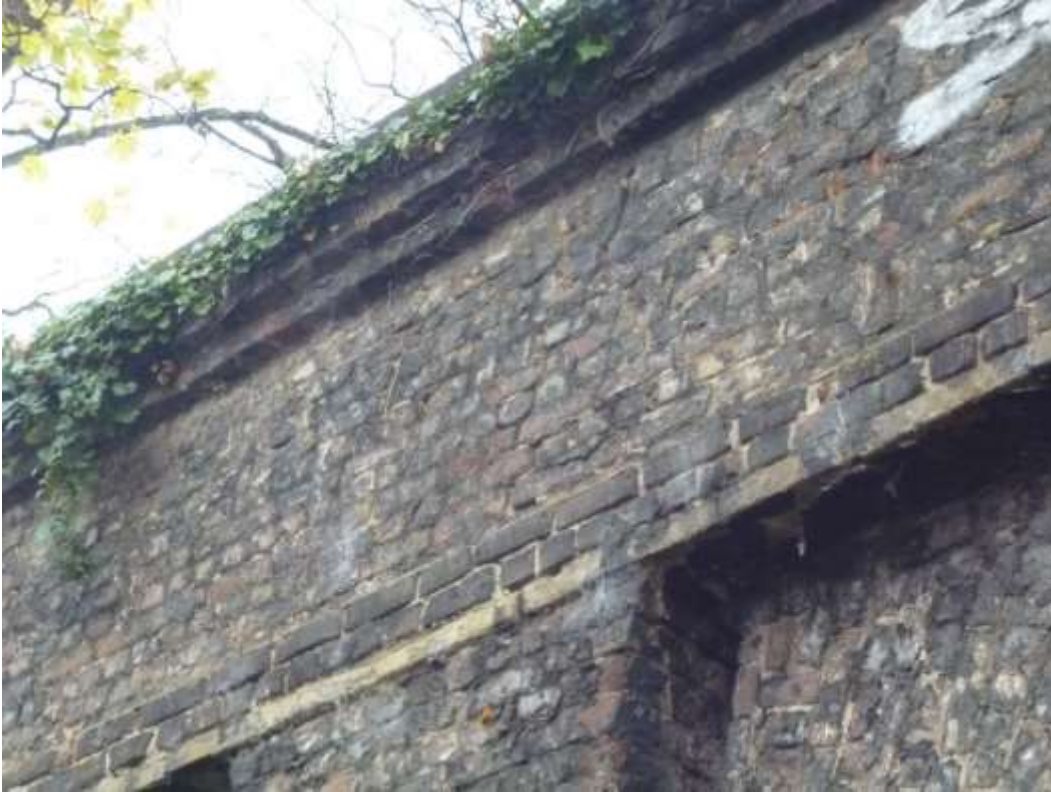
East Portal parapet – Slight crack near the centre of the wall

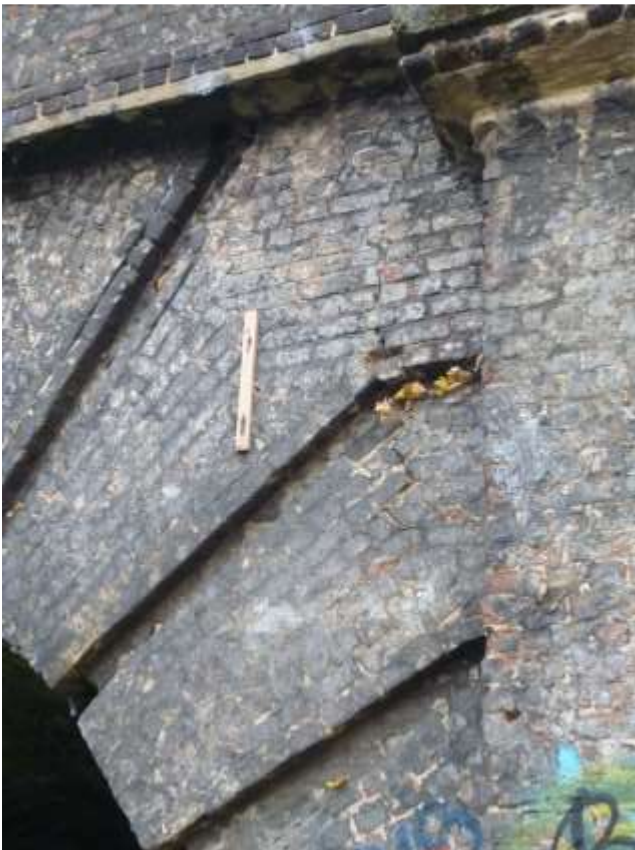
East Portal – Crack to the north side of the spandrel

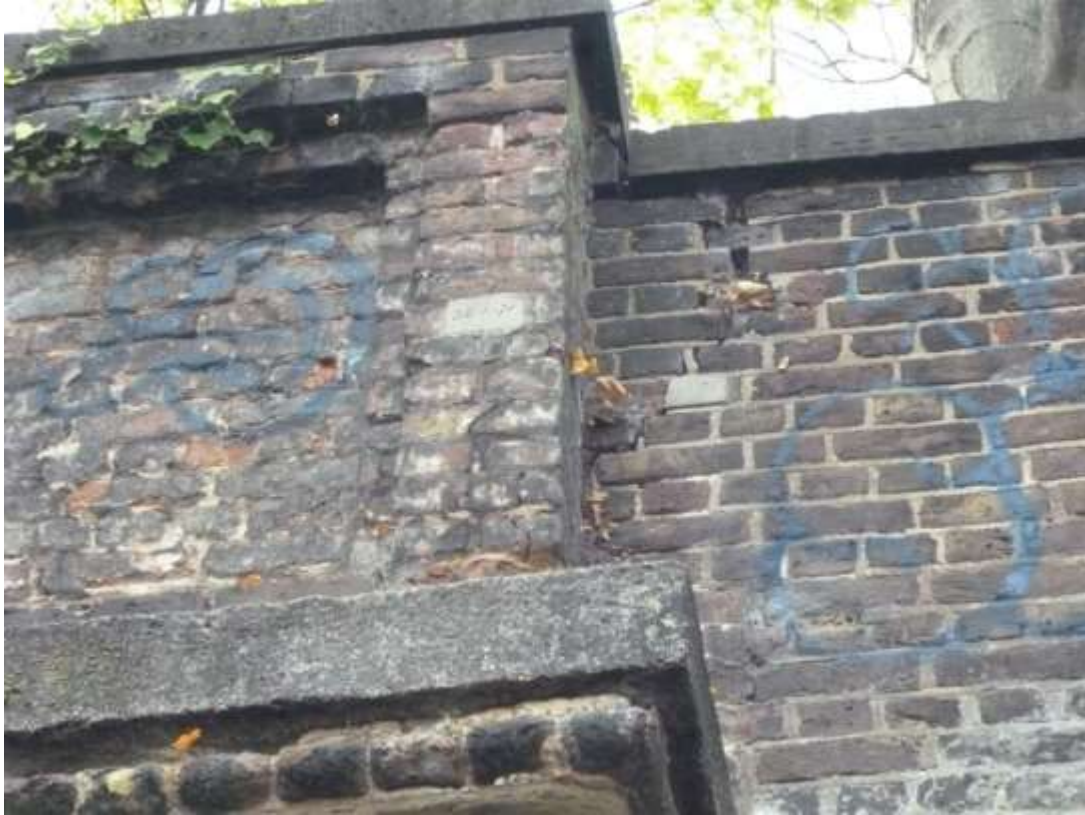
East Portal – Crack extends through the parapet on the north side of the spandrel (old tell-tails present)
