Tunnel Principal Inspection Report

Islington Tunnel

Regents Canal

RE-007-005

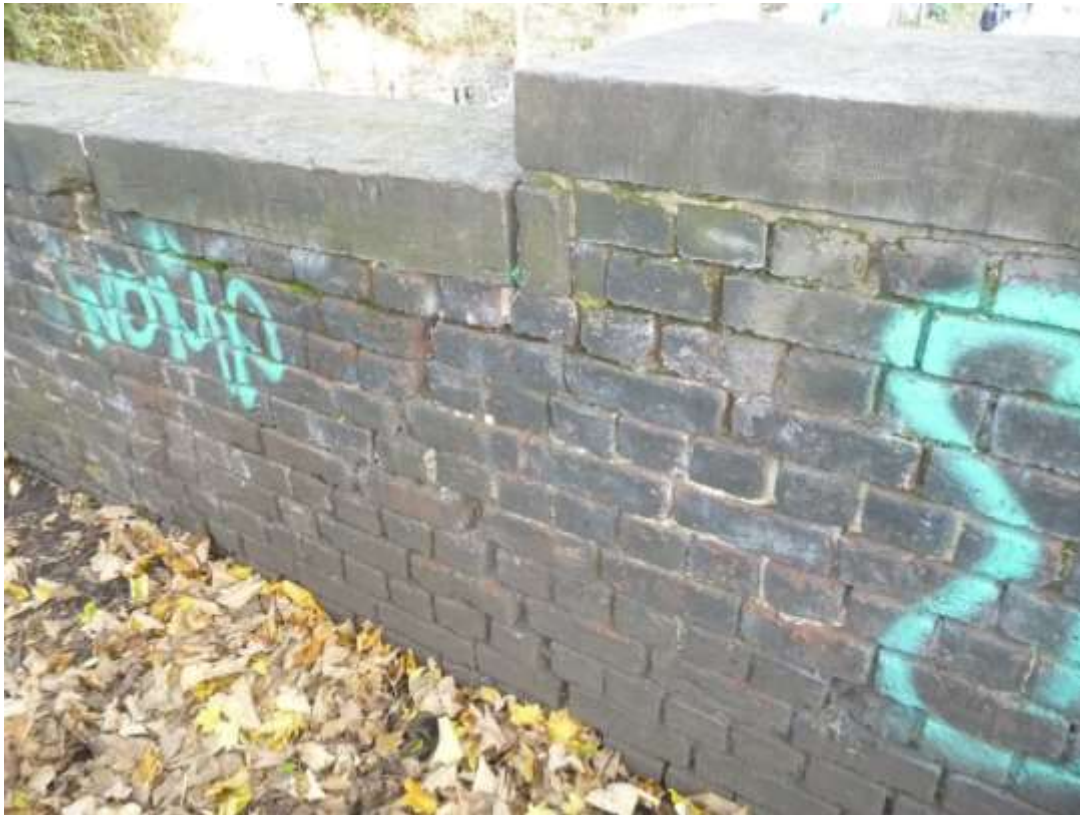
East Portal – Crack extends through the parapet on the north side of the spandrel

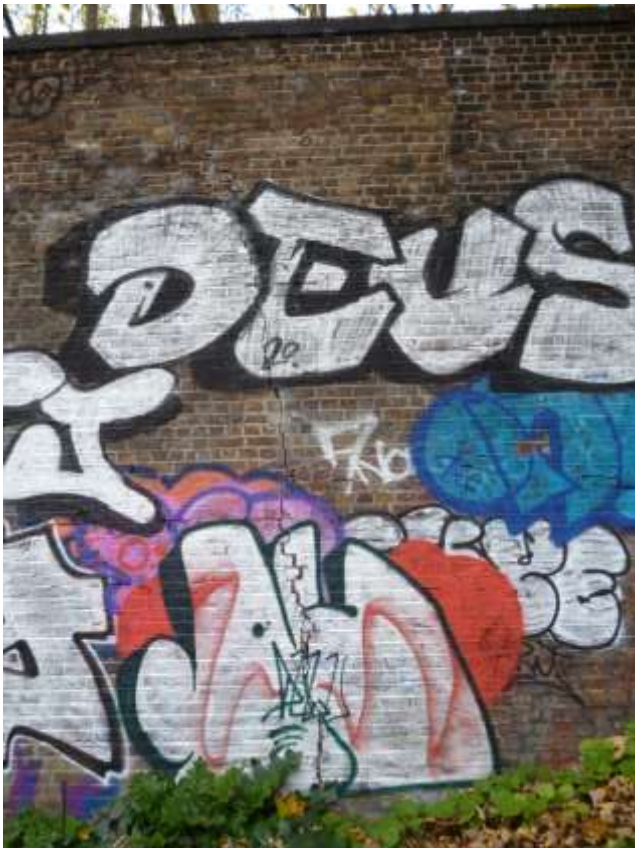
East Portal – North wingwall – Old, vertical movement crack (south crack)

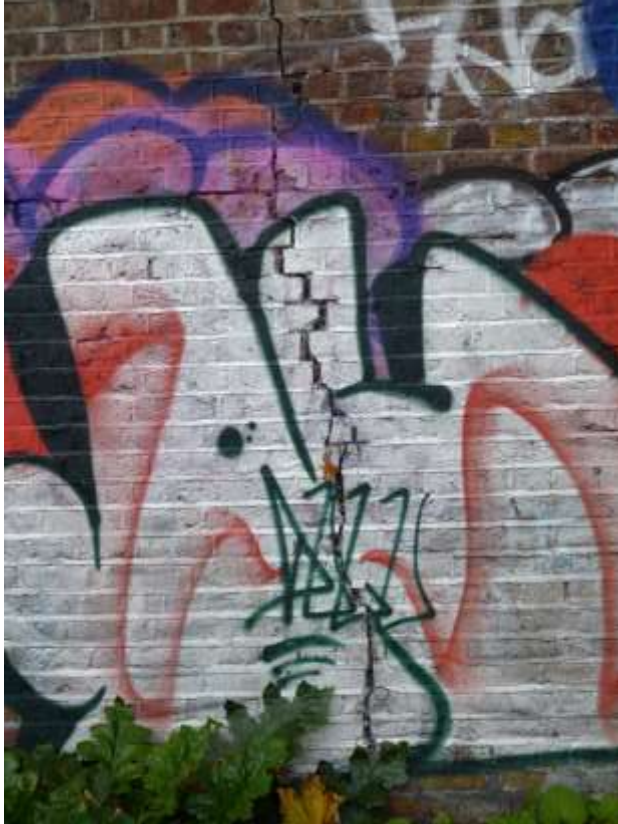
East Portal – North wingwall – Old, vertical movement crack (south crack)

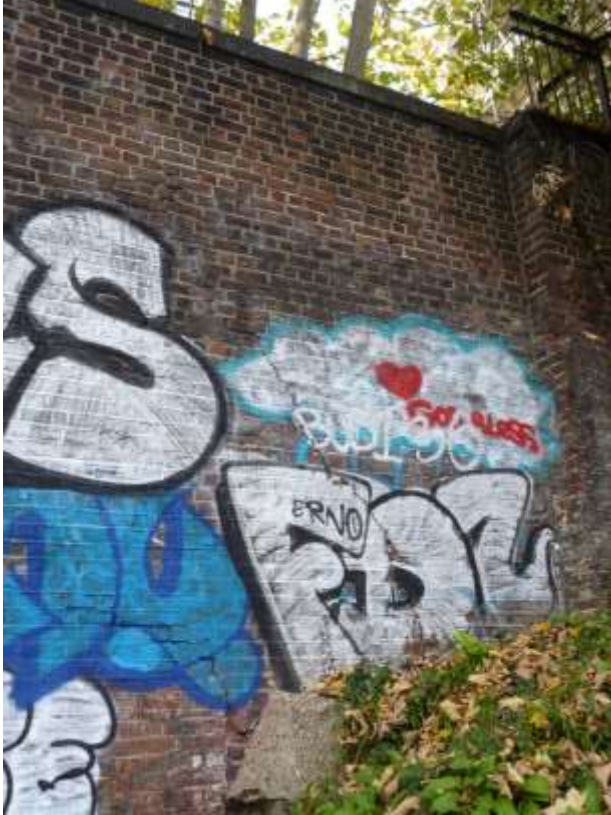
East Portal – North wingwall – Old, movement cracks (North crack extending up to the top of the wall)

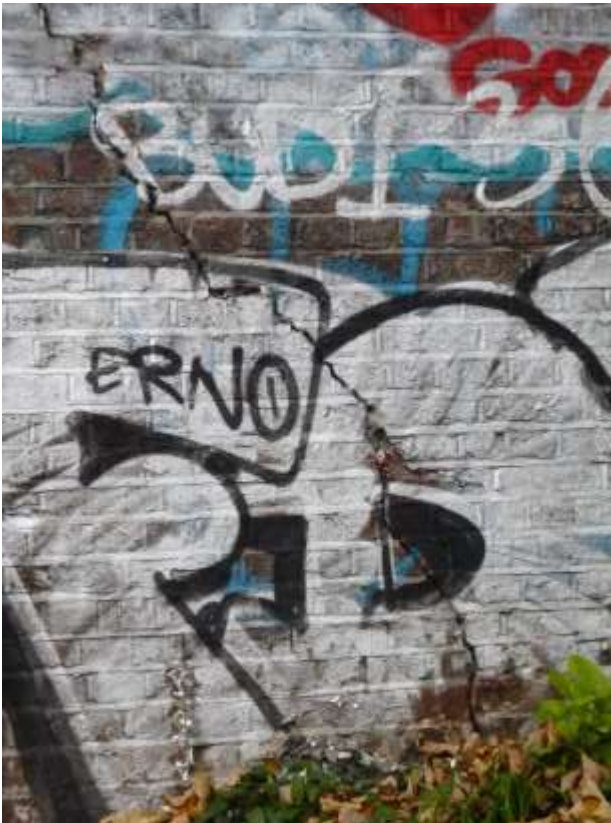
East Portal – North wingwall – North crack

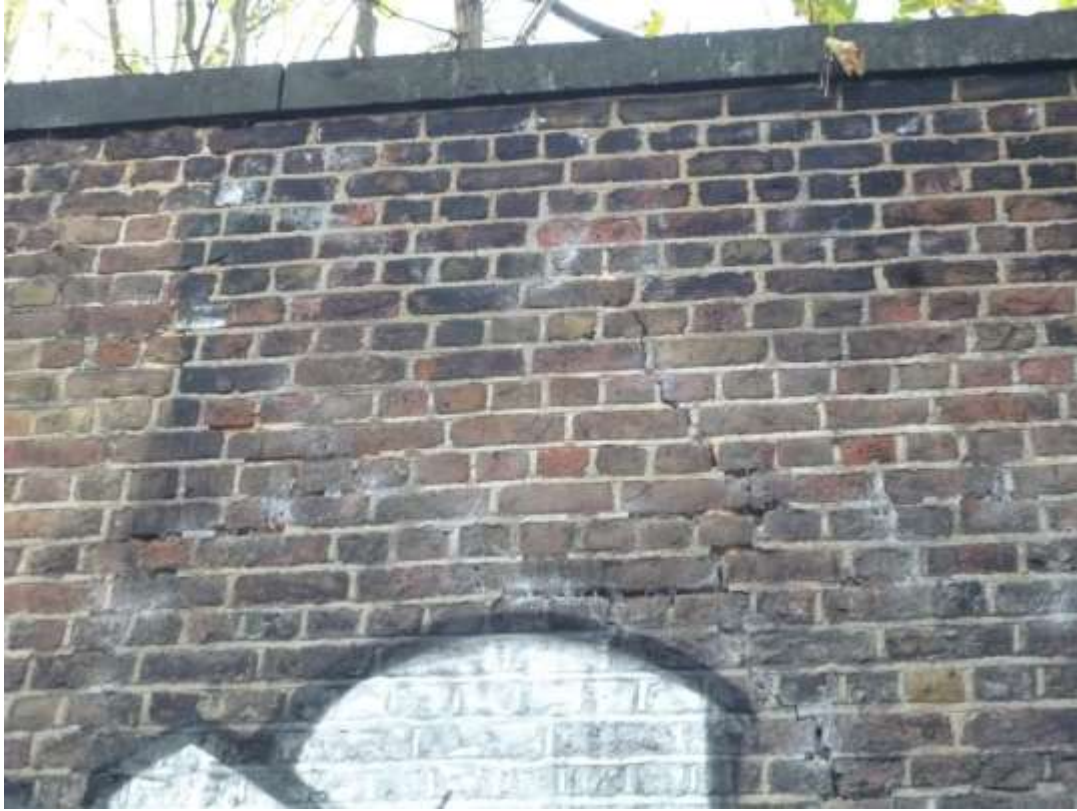
East Portal – North wingwall – North crack

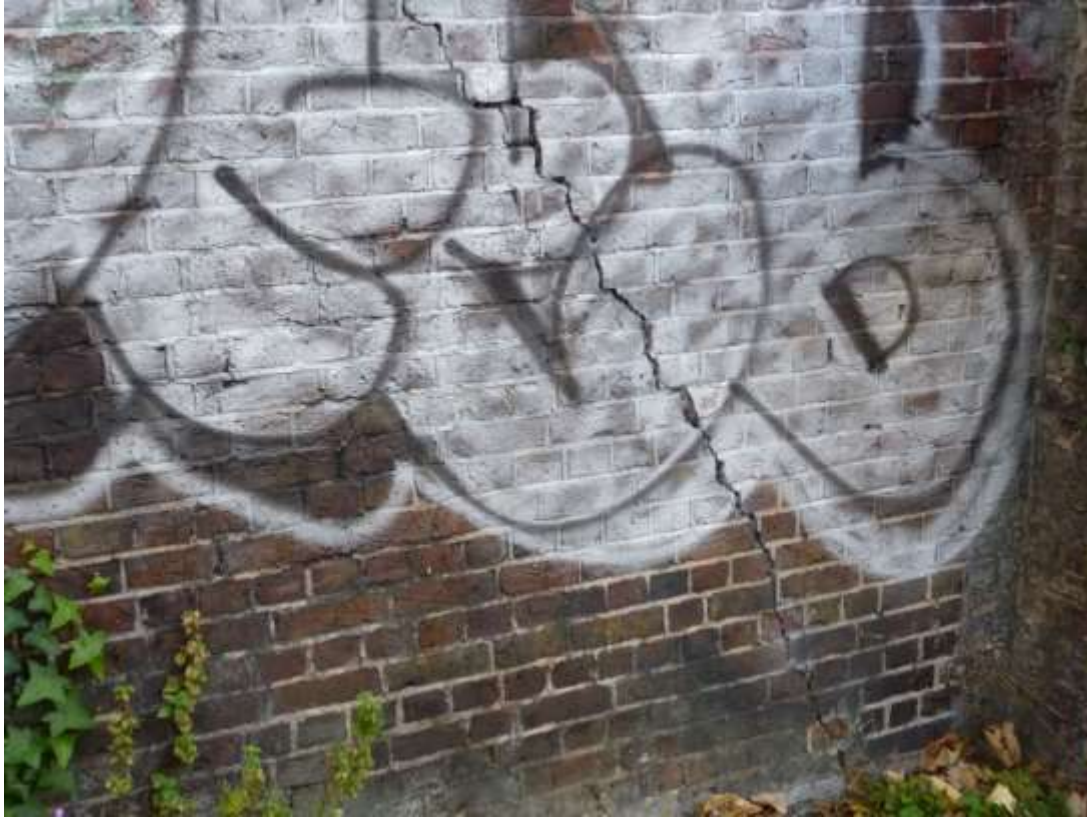
East Portal – South wingwall – Old, vertical movement crack (North crack extending up to the top of the wall, including old tell tails at mid wall height)

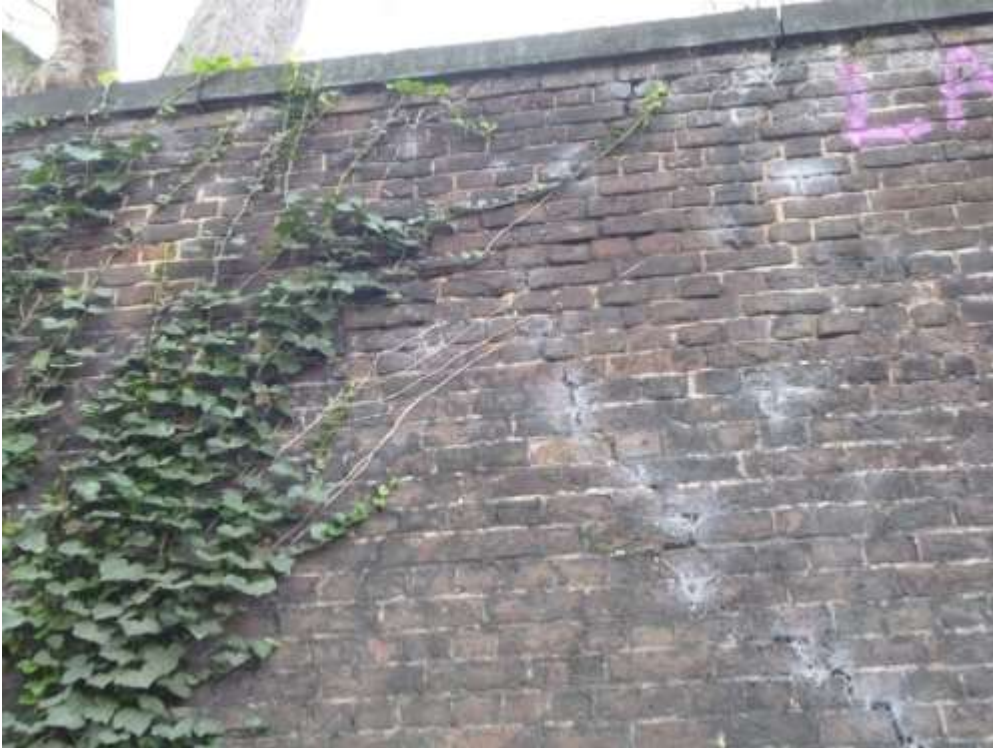
East Portal – South wingwall – Old, vertical movement crack (North crack extending up to the top of the wall)

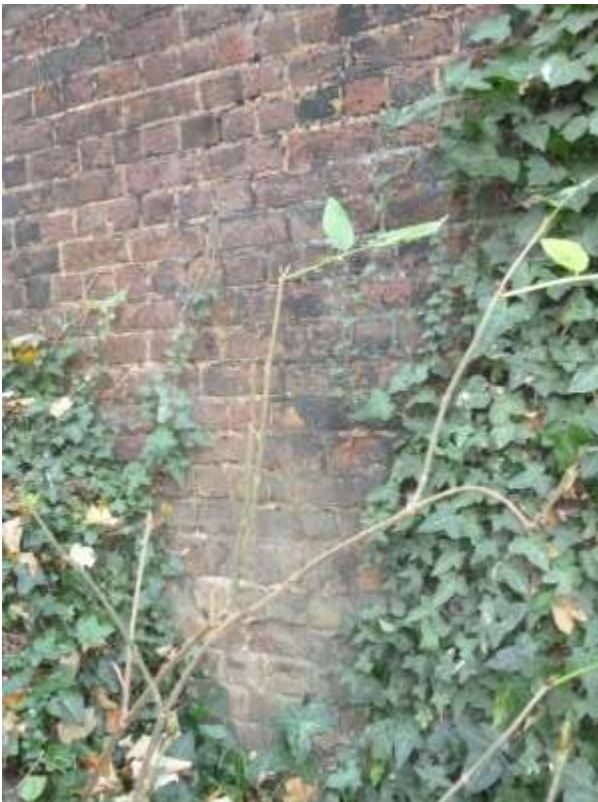
East Portal – South wingwall – Old, vertical movement crack (South crack extending up to the top of the wall)

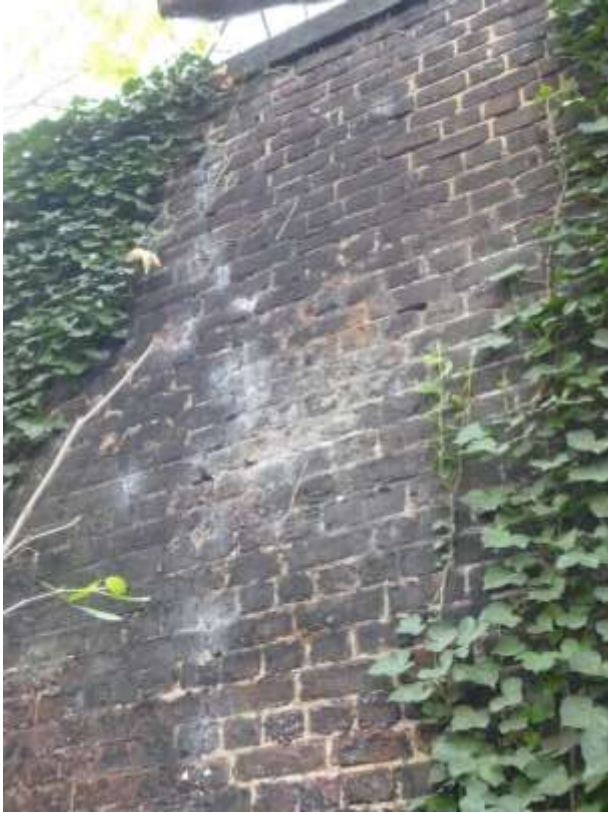
East Portal – South wingwall – Old, vertical movement crack (South crack extending up to the top of the wall)

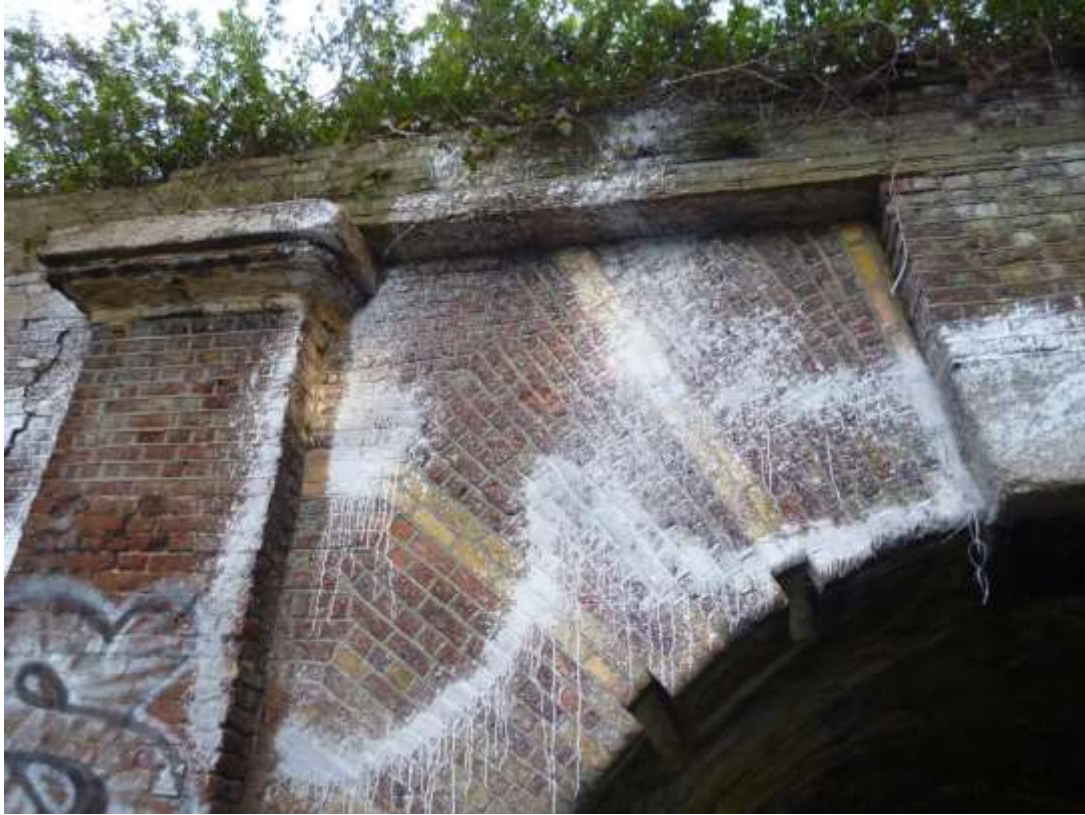
West Portal – Brickwork repairs to the spandrel

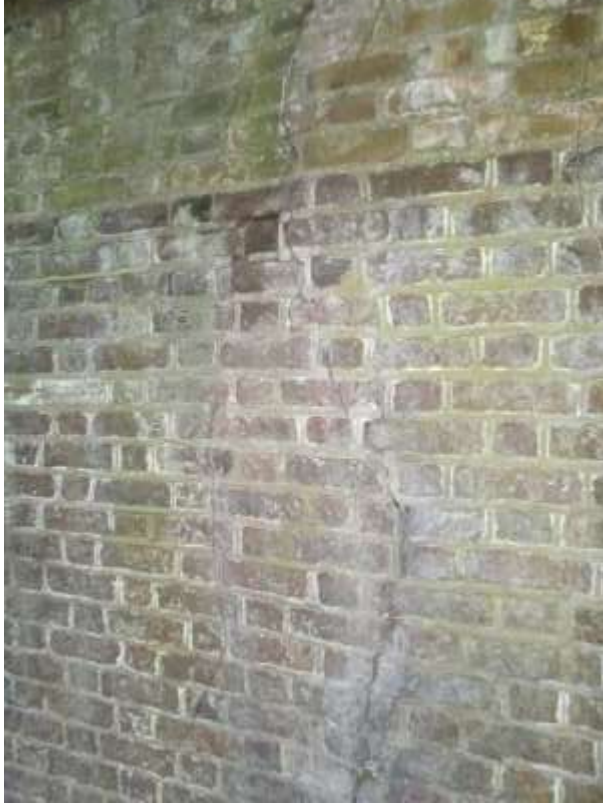
West Portal – South wingwall – Old, vertical movement crack (South crack extending up to the top of the wall)

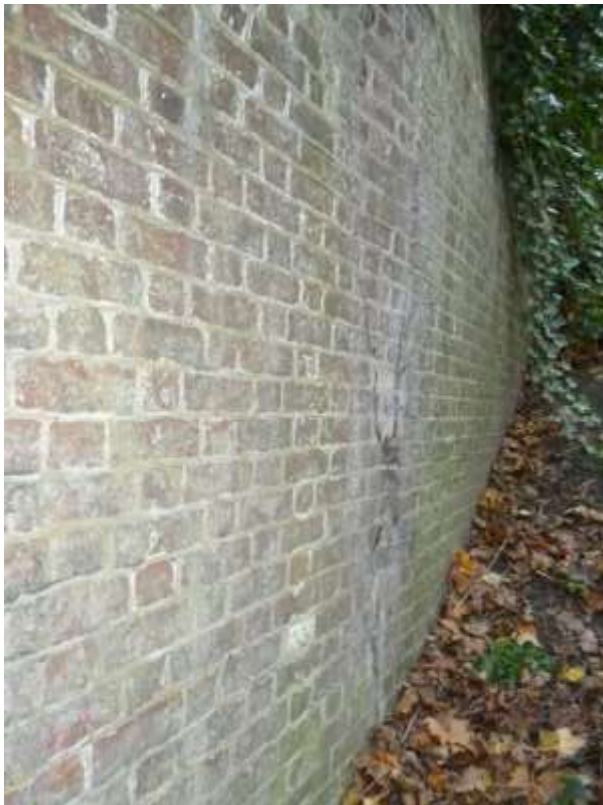
West Portal – South wingwall – South crack is slightly displaced near the base of the wall

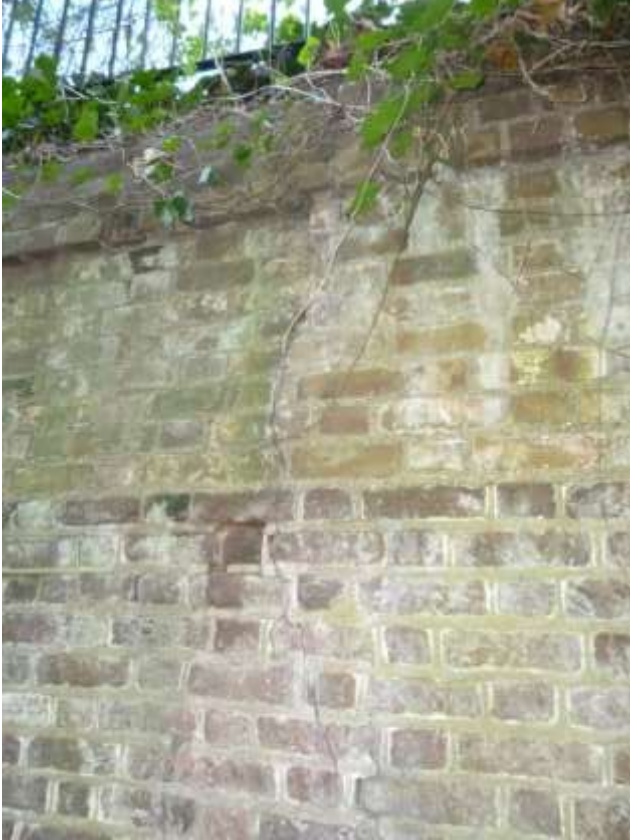
West Portal – South wingwall – South crack is displaced at the top

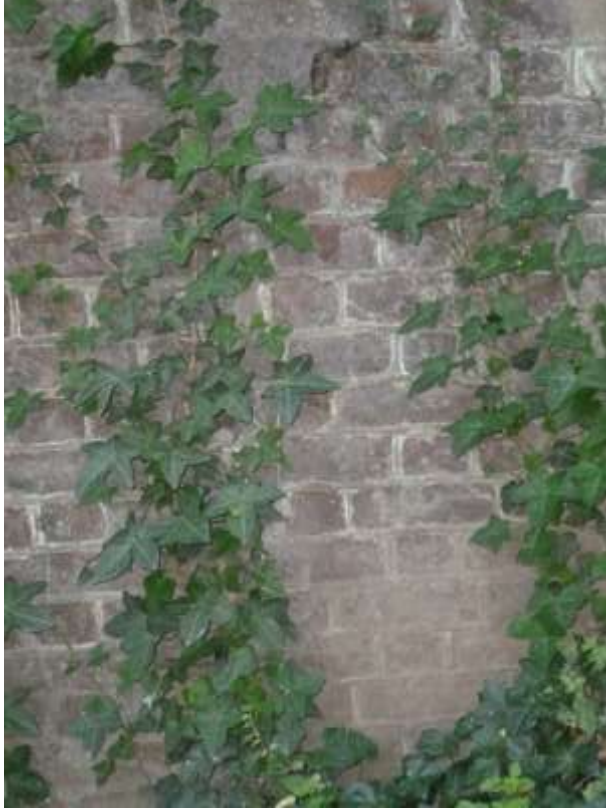
West Portal – South wingwall – Base of an old, vertical movement crack (North crack extending up to the top of the wall)

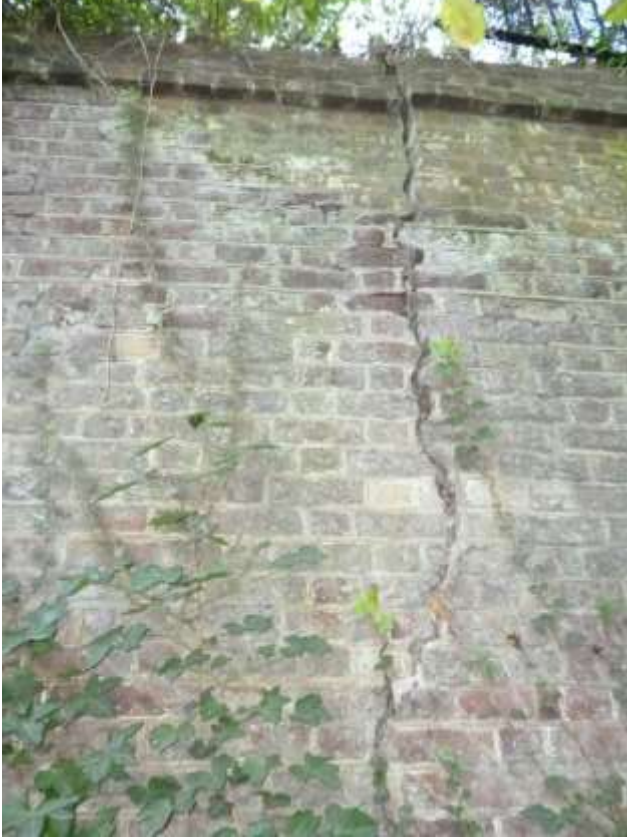
West Portal – South wingwall – North crack displaced near the top of the wall.

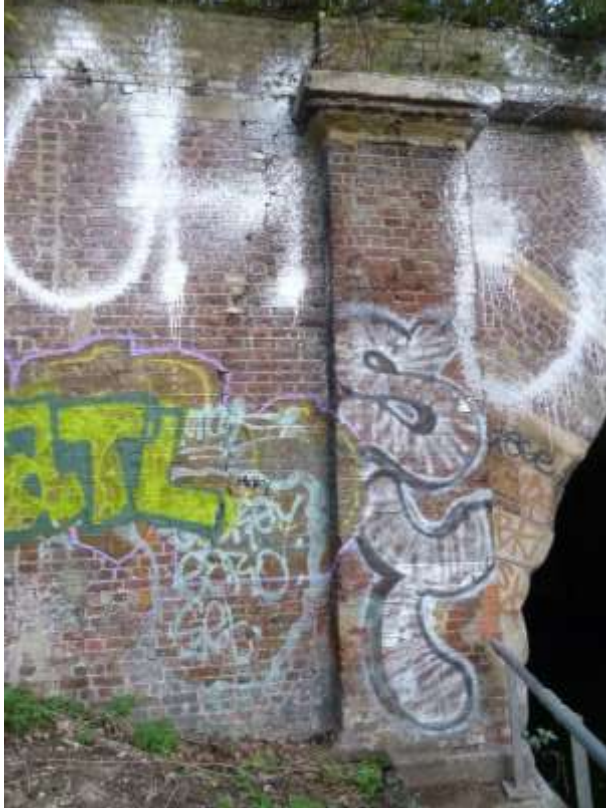
West Portal – North wingwall – Old, vertical movement crack (South crack extending up to the top of the wall with old tell-tails present)

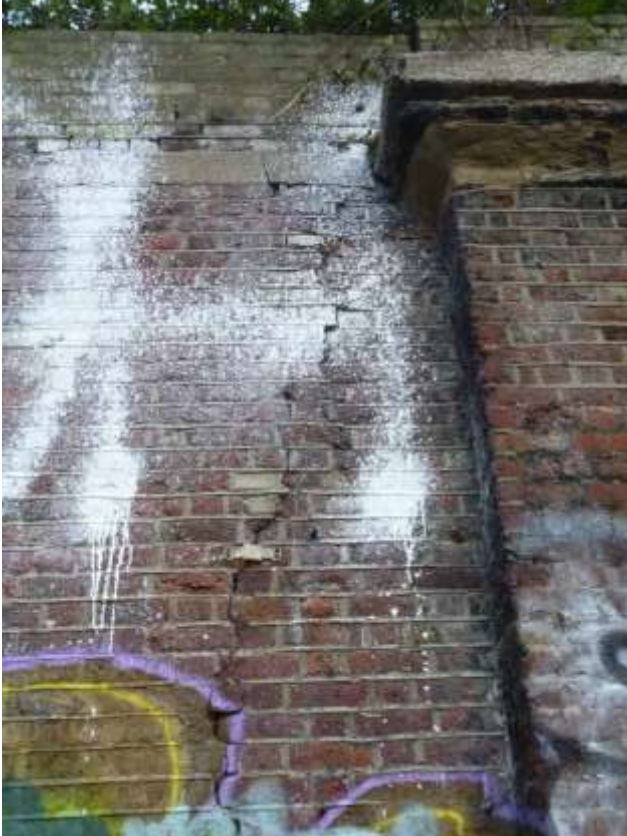
West Portal – North wingwall – South crack – Tell-tails are broken

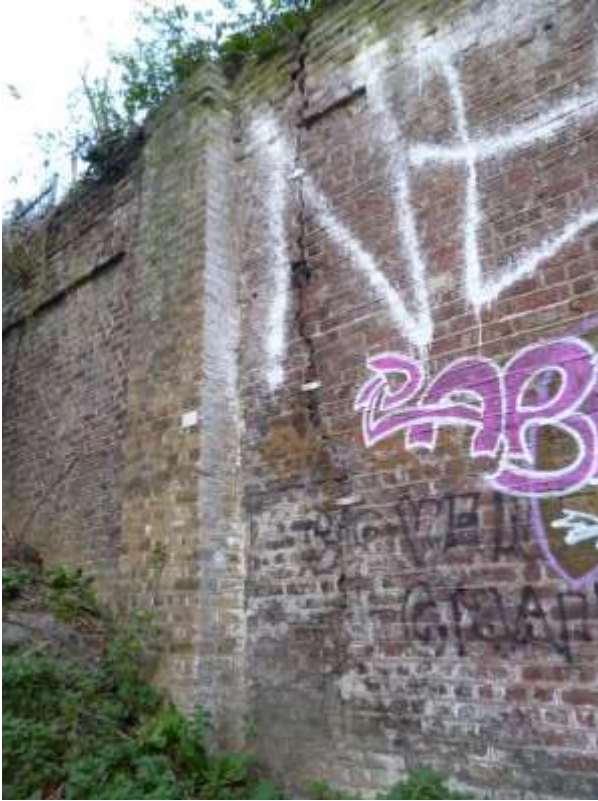
West Portal – North wingwall – Old, vertical movement crack (North crack extending up to the top of the wall with old tell-tails present)

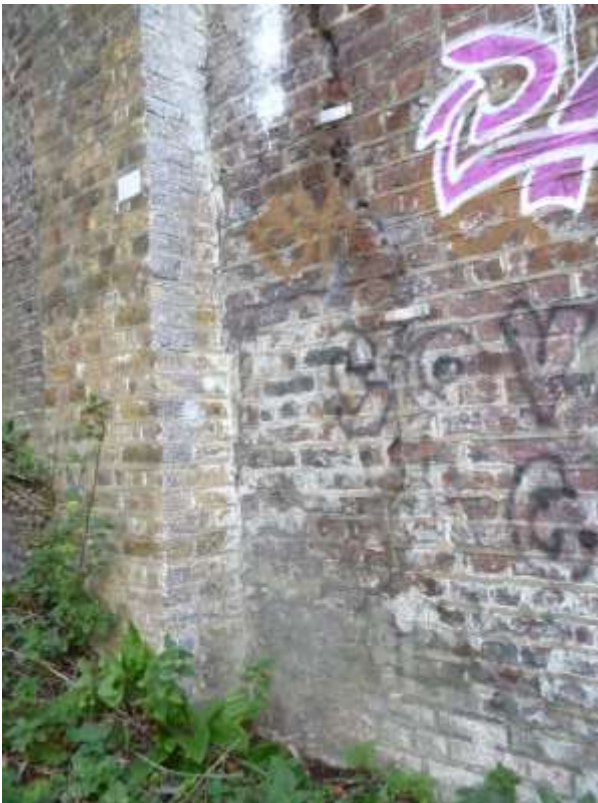
West Portal – North wingwall – North crack – Tell-tails are broken

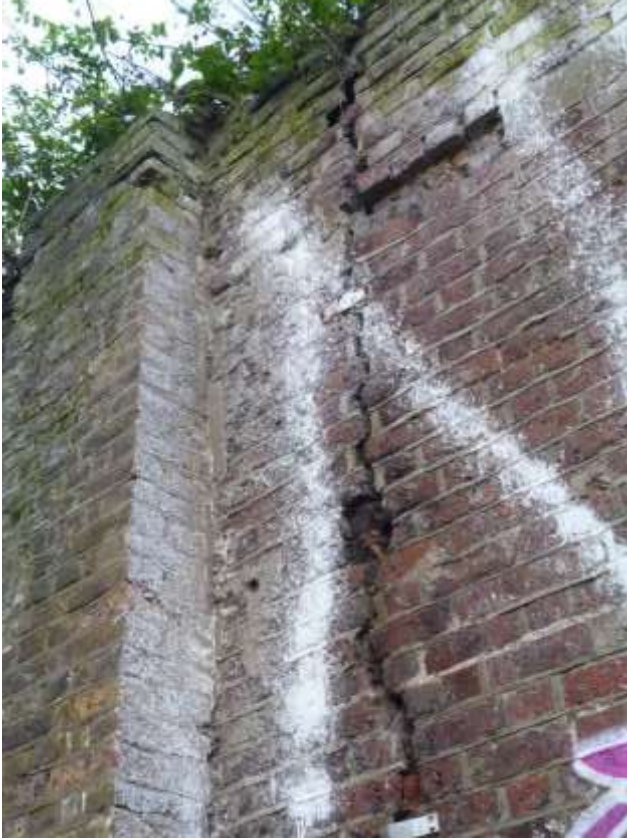
West Portal – North wingwall – North crack – Wall is displaced near the top

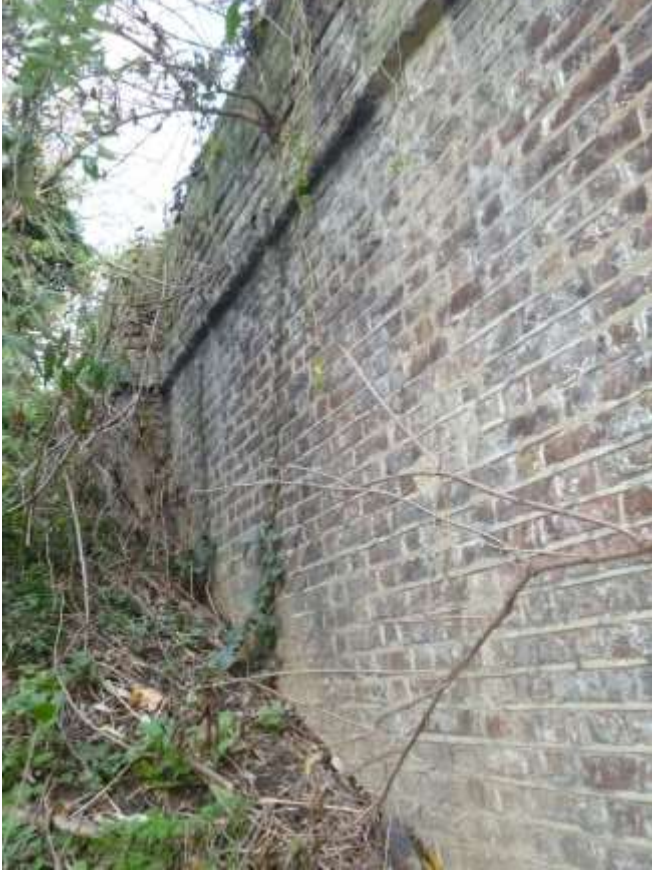
West Portal – Crack through north end of the north wing wall with vegetation growing on the wall.

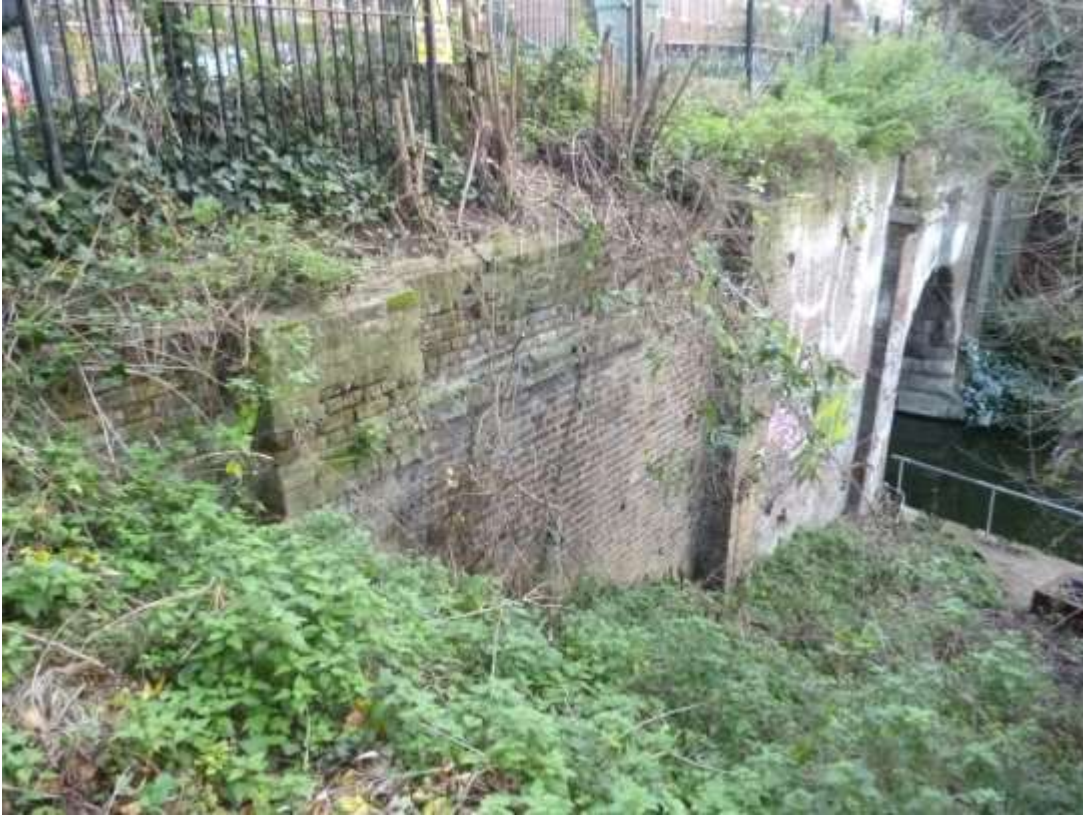
West Portal – Vegetation growth

Vegetation growth also affects both portals with some ivy growth on the front faces and large trees growing immediately behind the parapet wall of the East Portal and small trees and ivy growth on the West Portal. Poor pointing and open cracks are likely to suffer further damage if this vegetation continues to take hold and develop.
