dsPIC33EPXXX(GP/MC/MU)806/810/814 and PIC24EPXXX(GP/GU)810/814

dsPIC33EPXXX(GP/MC/MU)806/810/814 and PIC24EPXXX(GP/GU)810/814 Family Silicon Errata and Data Sheet Clarification

The dsPIC33EPXXX(GP/MC/MU)806/810/814 and PIC24EPXXX(GP/GU)810/814 family devices that you have received conform functionally to the current Device Data Sheet (DS70616G), except for the anomalies described in this document.

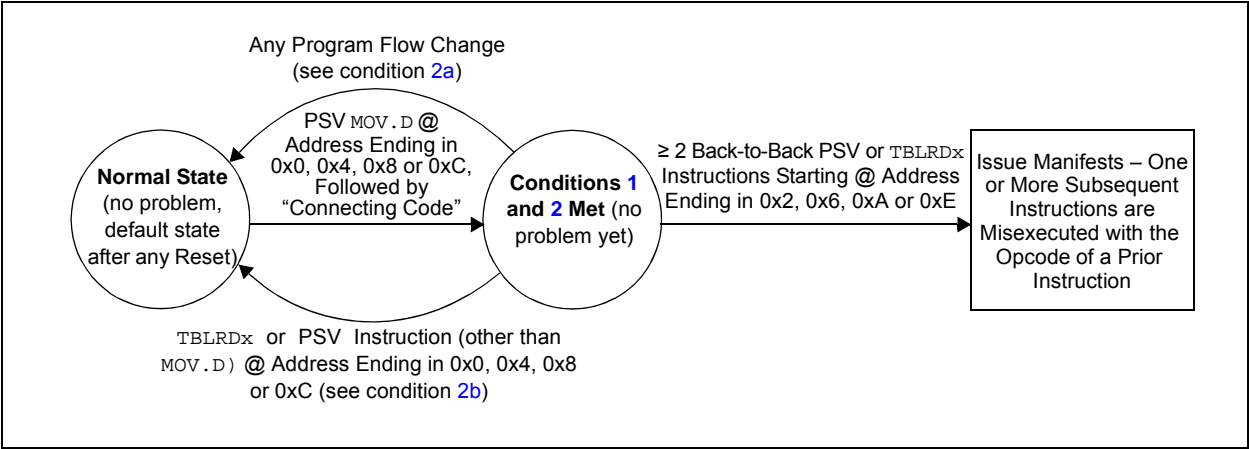
FIGURE 1: SIMPLIFIED BEHAVIOR

When two or more data Flash read instructions (via Program Space Visibility (PSV) read or table read) are executed back-to-back, one or more subsequent instructions can be misexecuted when all of the conditions in [Table 3](#) occur.

[Figure 1](#) provides an example of the effective behavior.

The issue can be avoided by ensuring any one or more of the requirements are not met. For example:

1. All instances of PSV `MOV.D` can be replaced with two PSV `MOV` instructions instead. Non-PSV `MOV.D` instructions acting on RAM/SFRs do not need to be modified; or
2. If not already present, a program flow change instruction (such as `BRA $+2`) can be inserted above back-to-back data Flash read sequences; or
3. Back-to-back data Flash read instruction sequences can be broken up by inserting a non-Flash read instruction (such as a `NOP`) in between the Flash read instructions; or
4. The alignment of the code can be shifted to avoid the required opcode location addresses.

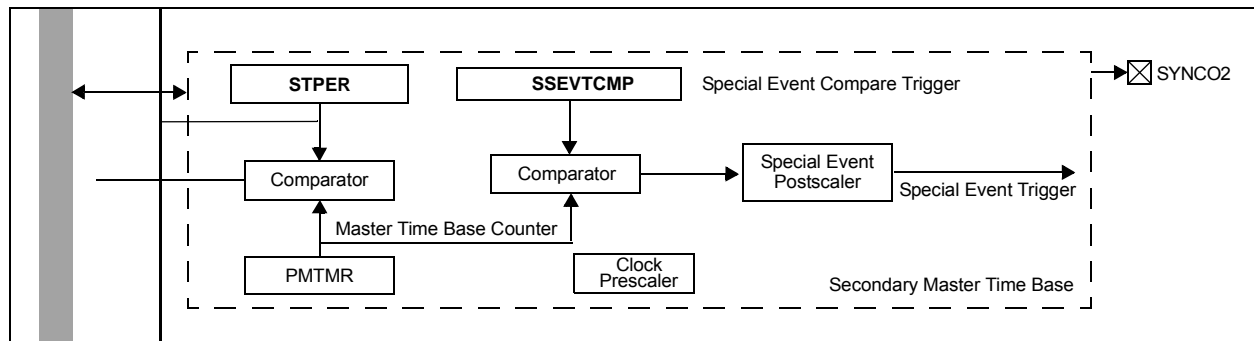
FIGURE 16-2: HIGH-SPEED PWM MODULE REGISTER INTERCONNECTION DIAGRAM

In **Figure 16-2: High-Speed PWM Module Register Interconnection Diagram**, the Secondary Master Time Base section has been updated. The updated text is shown in **bold** in [Figure 16-2](#) below.
