## MSP430F5419A Device Erratasheet

### 1 Revision History

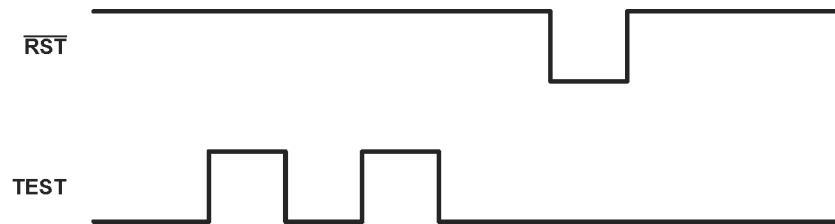
Note: This sequence is not subject to timing constraints and the appropriate level transitions are sufficient to trigger an exit from BSL mode.

- Toggle the TEST pin twice when nRST is high and then pull nRST low.

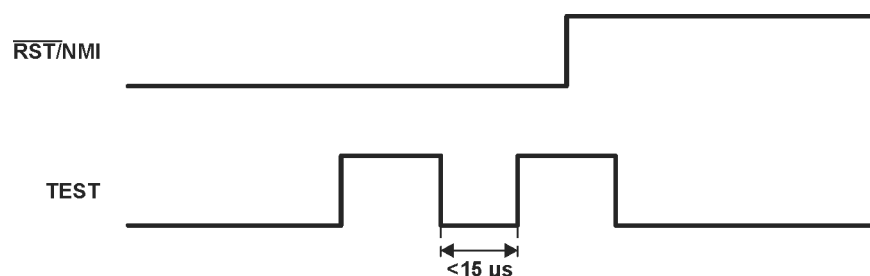
**Function** BSL entry sequence is subject to specific timing requirements

**Description** The BSL entry sequence requires that the low phase of the TEST/SBWTCK pin does not exceed 15us. This timing requirement is faster than most PC serial ports can provide, as shown in the following picture. If this requirement is not met, the entry sequence fails and the SYSBSLIND is not set.

**Workaround** An external hardware solution is recommended to provide the appropriate BSL entry sequence. See [http://processors.wiki.ti.com/index.php/BSL\\_\(MSP430\)](http://processors.wiki.ti.com/index.php/BSL_(MSP430)) for

recommendations on available BSL hardware.
