<b>Device</b>	<b>XMC1100</b>
<b>Marking/Step</b>	<b>EES-AB, ES-AB, AB</b>
<b>Package</b>	<b>PG-TSSOP-16/38, PG-VQFN-24/40</b>

## Overview

This “Errata Sheet” describes product deviations with respect to the user documentation listed below.

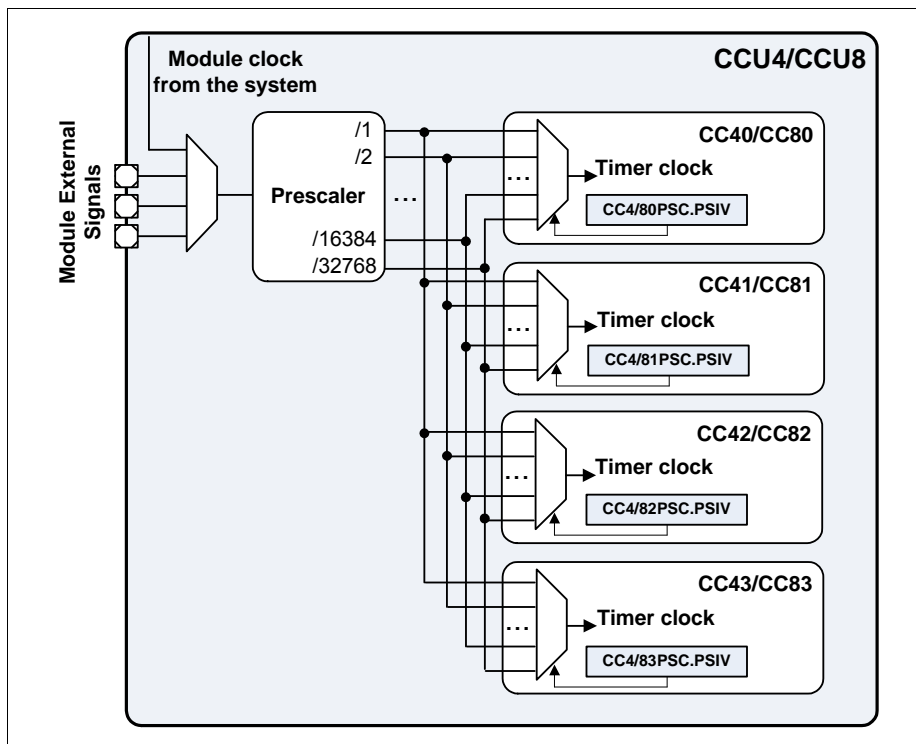
**Figure 1** Clock Selection Diagram for CCU4/CCU8

### **CCU AI.005 CCU4 and CCU8 External IP clock Usage**

Each CCU4/CCU8 module offers the possibility of selecting an external signal to be used as the master clock for every timer inside the module Figure 1. External signal in this context is understood as a signal connected to other module/IP or connected to the device ports.

Currently is only possible to use an external signal as Timer Clock when a division ratio of 2 or higher is selected. When no division is selected (divided by 1), the external signal cannot be used.

The user must program the PSIV field of each Timer Slice with a value different from 0000<sub>B</sub> - minimum division value is /2.

## Workaround

None.
