Device	XMC1300
Marking/Step	EES-AB, ES-AB, AB
Package	PG-TSSOP-16/38, PG-VQFN-24/40

Overview

This “Errata Sheet” describes product deviations with respect to the user documentation listed below.

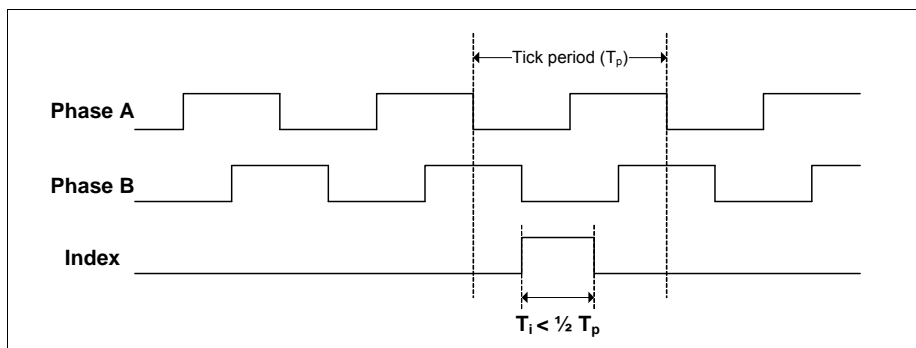
Figure 4 Different index signal types

When the index signal is smaller than 1/2 of the tick period, the POSIF module is not able to decode this signal properly, Figure 2 - notice that the reference edge of the index generation in this figure is the falling of Phase B, nevertheless this is an example and depending on the encoder type, this edge may be one of the other three.

Due to this fact it is not possible to use the POSIF to decode these type of signals (index with duration below 1/2 of the tick period).
