MECHANICAL ENGINEERING 224

United Airlines Flight 232: The Impossible Landing

December 6, 2018

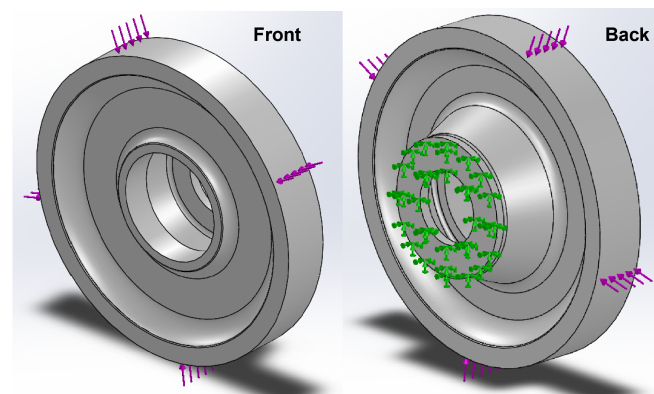
Fig. 1: Loads applied to fan disk during operation.

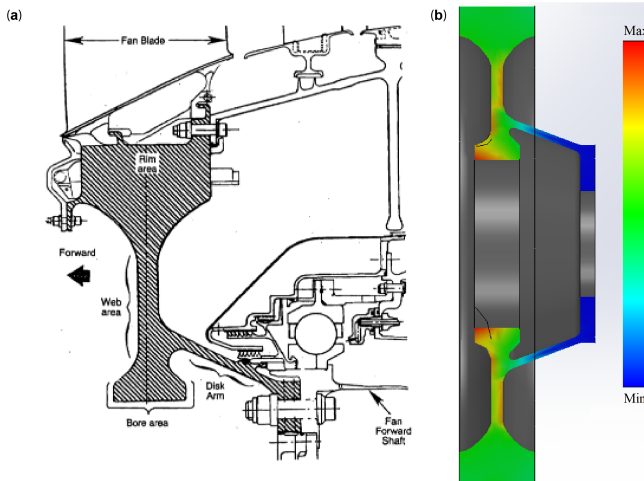
The fan disk of the CF6-6 engine is shown in Figure 1. The assembly consists of the large stage-1 fan disk and the attached fan blades (Figure 8). The analysis will focus only on the fan disk as it was the component that initially failed. The fan disk weighed 370 pounds, consisting of the rim, the bore, the web and the disk arm as labeled in Figure 2. The primary loads imposed on the fan disk were radially tensile loads. These loads were from the disk holding the fan blades against centrifugal forces during rotation of the assembly. The loads imposed by the fan blades caused radial stresses in the disk rim. These radial stresses decreased towards the bore, becoming zero at the bore since there was no material inboard of this location to resist the stress. Hoop stresses were greatest along the inside diameter of the bore, with the forward corner of the bore experiencing the maximum hoop stress (as shown in the finite element analysis (FEA), Figure 2).

Fig. 2: (a) Cross section of fan disk and surrounding components [1]. (b) Effective stress distribution in the fan disk during operation.

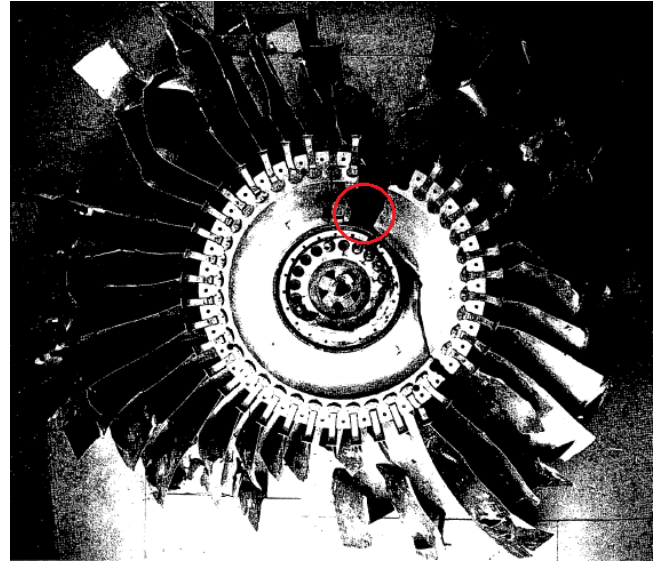
Fig. 3: Reconstruction of the broken fan disk. The red circle shows the initial separation. [1].

The inspection process started with a thorough visual examination. During this visual inspection, 2 main fracture areas were identified (Figure 3).

The first fracture area progressed circumferentially through the rim of the disk. The second fracture area progressed in the radial direction through the bore, web, disk, arm, and rim, showing signs of overstress. These markings of overstress were linked to a preexisting radial/axial fatigue crack in the bore of the fan disk. [1].

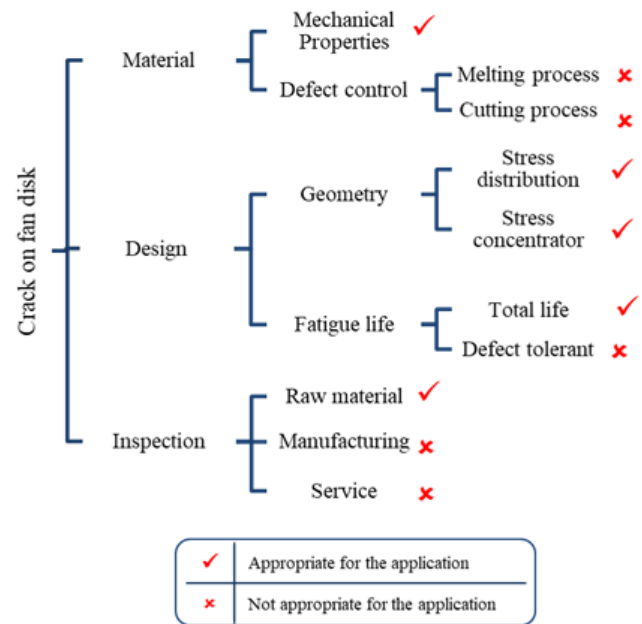
Fig. 4: Fault tree analysis of the fatigue crack in the fan disk.

Numerous methods of failure prevention could have avoided the crash of UAL flight 232 (Figure 4), beginning with the original manufacturing of the fan disk. As noted in the previous section, the hard-alpha inclusion was formed during the melting process and the associated cavity was formed during the shot peening process. A macroetch inspection after the shot peening process may have detected this surface defect; however, at the time, this inspection was only performed prior to the

shot peening process. The manufacturers did not perform this inspection because they feared the process would remove surface material, changing the overall mass and performance of the components. Additionally, to promote the melting or dissolution of the hard alpha inclusions during the ingot manufacturing, the temperature of the molten pool could have been increased in the furnace or the time the material was in the liquid state could have been increased (from double- to triple-vacuum-melting process). Although these changes do not guarantee the complete dissolution of the inclusions, they would have increased the amount of opportunities for dissolution of the flaw. Additionally, after ingot manufacturing, a smaller diameter billet (13- or 14-inch diameter) would have increased the likelihood of a crack being detected below the surface [1].

The manufacturer assumed a defect-free approach and calculated a predicted service life of 54,000 cycles (18,000 cycles with a safety factor of 3) [1]. Since the hard alpha inclusion introduced a cavity early in the operation of the fan disk, a defect tolerant approach should have been taken during the design phase. Using a defect-tolerant approach, we calculated the service life of 789 cycles from the last inspection.

Proper inspection of the fan disk in service would have also prevented failure of the device. Post analysis concluded that approximately a half inch crack existed on the surface of the bore during the time of the last inspection. This crack was sufficiently open, therefore the FPI fluid was able to enter into the crack, making it detectable [1]. If the inspector adequately prepared the part for inspection and rotated the part during inspection, the crack should have been detected. Additionally, nondestructive inspection operators at the time typically worked alone with very little supervision. Had regulation required another person to oversee the inspection process, it is more likely the crack would have been detected.

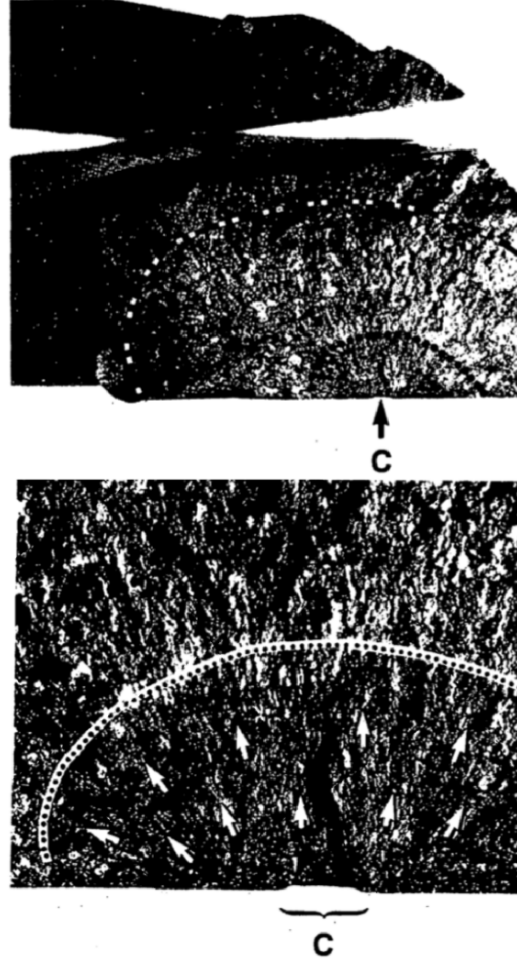
The preexisting crack was further examined by metallography, fractography and chemical analysis. This analysis revealed that the crack initiation occurred in a cavity on the surface of the disk bore. This cavity was created by a nitrogen-stabilized hard alpha inclusion that went undetected during the ultrasonic inspection performed by GE. The cavity went undetected because during the time of the inspection, the fatigue origin was nearly filled with hard alpha material, making it undetectable by ultrasonic inspection.

Scanning electron microscopy (SEM) showed that the stabilized alpha inclusion had microcracks oriented parallel to the cavity surface and that microporosity was present around the core of the inclusion. Additionally, areas with brittle fracture features and no fatigue striations were found intermixed with ductile-appearing bands and fatigue striations [1]. The fatigue striations were found near the end of the stabilized-alpha area of the inclusion. The fatigue striations spacing was measured and was found to vary over the area. The closer spaced striations were referred to as minor striations and the wider spaced striations were referred to as major striations. The total number of these major striations was correlated with the total number of takeoff/landing cycles (15,503 cycles) [1] and showed evidence of the growth of the fatigue crack since the early life of the fan disk.

1988. At the time of this inspection, the crack was approximately 13 mm (0.476 inch) [1] in the axial direction, which went undetected due to naked eye limitation. However, the inspection left a discolored area that was evident during post-failure examination. During the 760 takeoff/landing cycles after the last inspection [1], the crack grew to a critical length and introduced a catastrophic fracture of the fan disk from the bore to the rim.

Fig. 5: Crack initiation site on fan disc [1]
