# Tenerife airport disaster

Tudor Andrei Dumitrascu

30 May, 2020

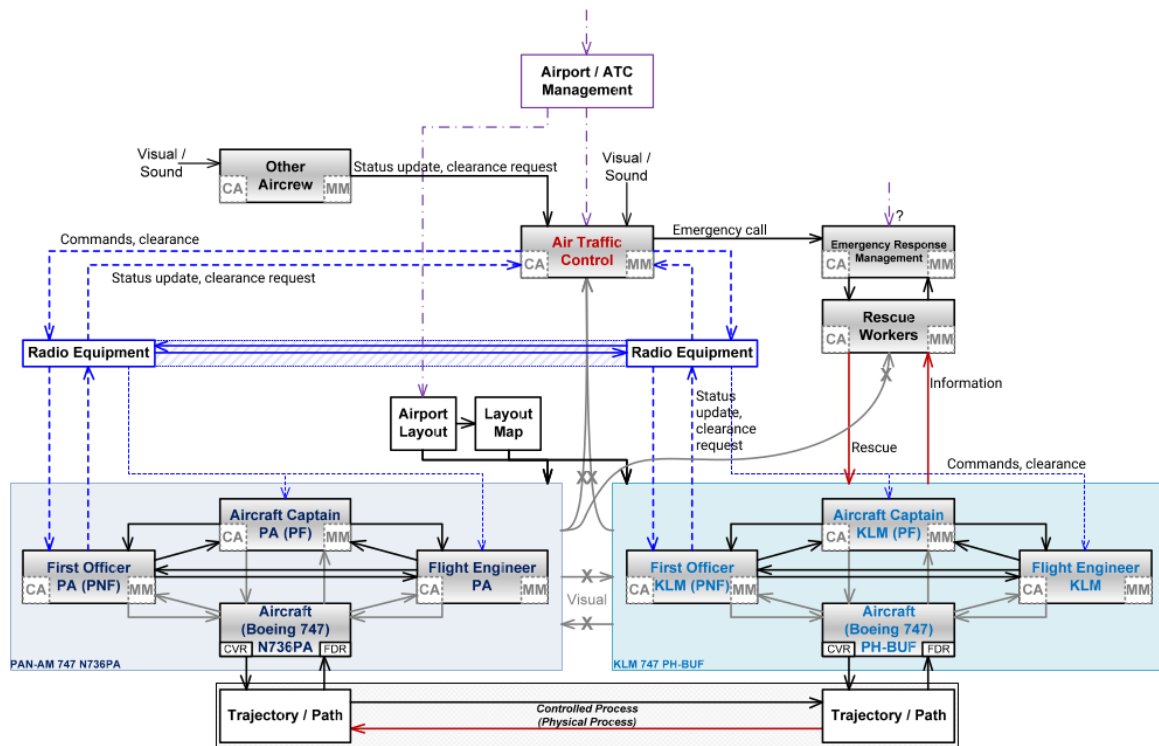
Figure 1: Control Structure

The diagram contains commands and feedback mechanisms given among the involved parties:

- The ATC gives commands and clearance to both aircrafts.

- The Aircrafts request clearance or give status updates
- The interaction between the two aircrafts is only through the radio equipment which can be only used by one party at a time.
